Field Note N8d2. Hydrology - De Hoop Vlei - Flash flood of May 2021

# Field notes on the GEOMORPHOLOGY, HYDROLOGY and ARCHAEOLOGY

Between CAPE AGULHAS and CAPE INFANTA

#### Field Note N8d2. Hydrology - De Hoop Vlei - 2021 flash flood

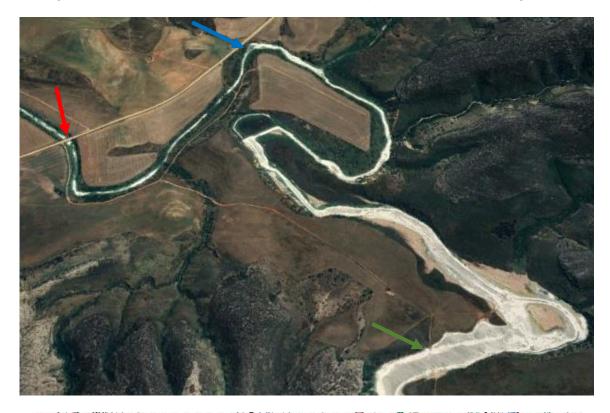
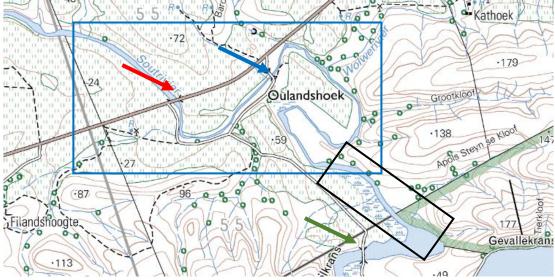
The bridges over the Salt River, which feeds the De Hoop Vlei, were flooded (Figures 1 to 5).

Figure 1. Bridges over the Salt River before it enters the De Hoop Vlei. Top - satellite image; bottom – topography map. Arrows indicate as follows: red – bridge of the road to Ouplaas; blue – bridge of the old road to Ouplaas; green – causeway of the road to the historic farm Windhoek. Blue box enlarged in Figure 2. Black box indicates the view shown in Figure 4.

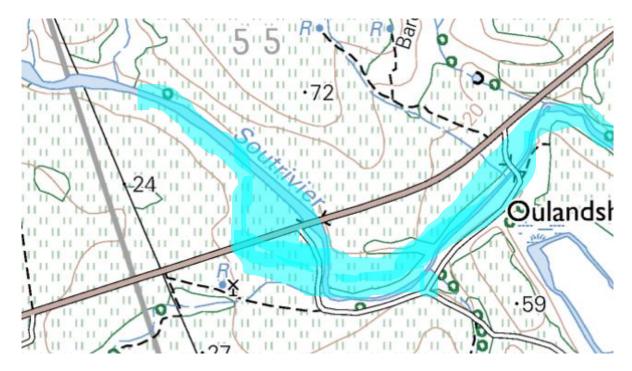
Figure 2. Blue paint indicates the approximate extent of the flooded road to Ouplaas. The water rose to ~18 m above sealevel, or ~3 m above the bridges in this map.

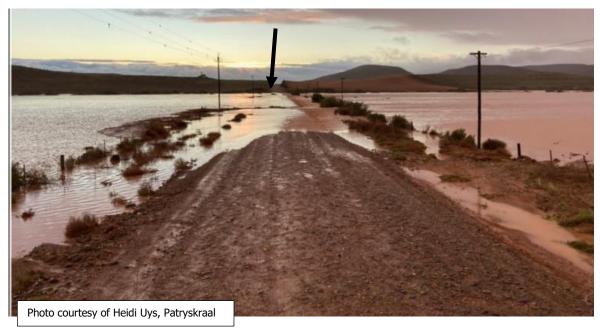
Figure 3. The bridge on the road to Ouplaas. Top – when flooded (arrow points to the bridge); Bottom – after the water receded. The water level is ~1.5 m below the road, or 13 m above msl.

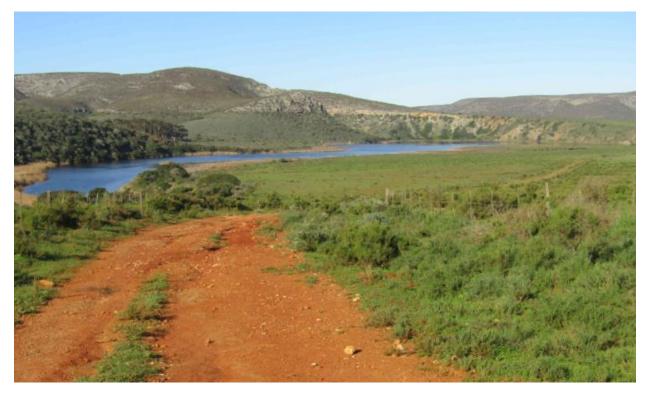
Figure 4. The Salt River between the road to Ouplaas and the causeway to the Windhoek Farm, two weeks after the flood. View to the SE.

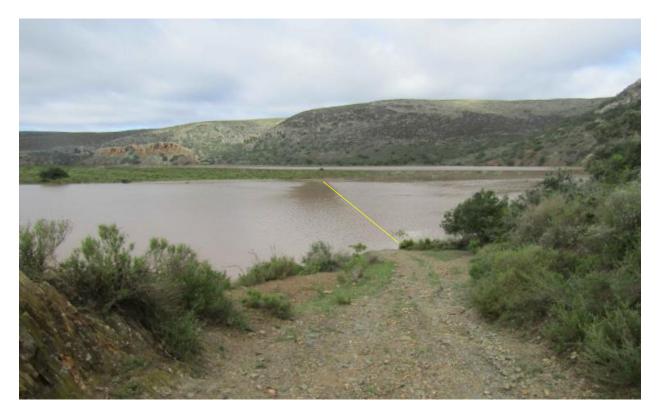
Figure 5. After the flood: the causeway over Salt River leading to Windhoek Farm is submerged under >1 m of water. Yellow line indicates the location of the causeway.

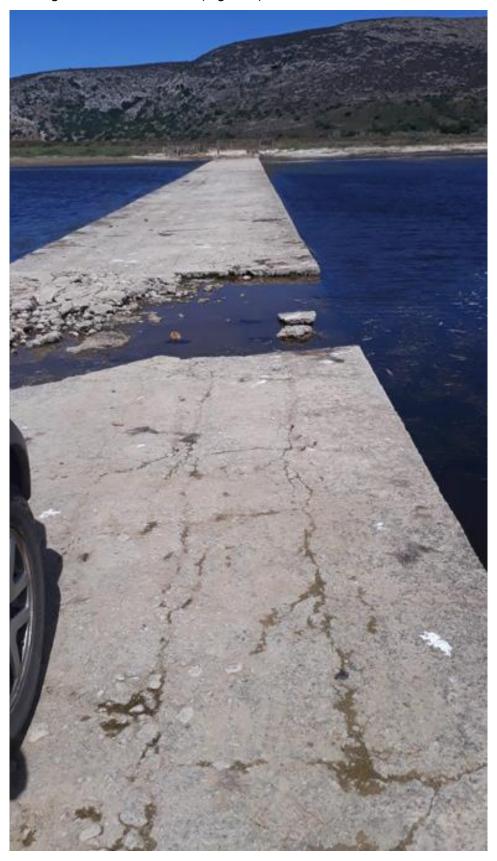
The causeway was only exposed again in the beginning of March 2022, or ten months after the flood. It was damaged bur is still drivable (Figure 6).

Figure 6. The damaged causeway.

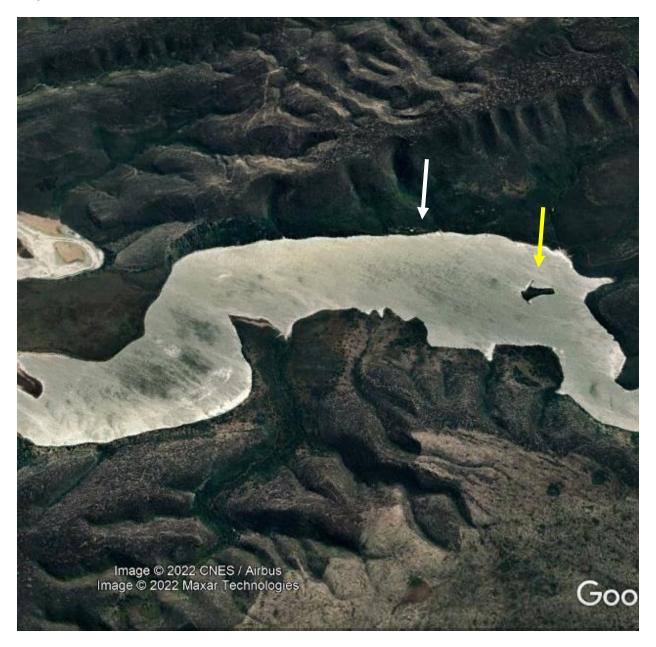
In the northern part of the De Hoop Vlei, only a small part of The Island protrudes the water (Figure 7).

Figure 7. Satellite image of the flooded northern part of the De Hoop Vlei after the flood (date unknown). Yellow arrow points to The Island; white arrow points to the historical Windhoek Farm.

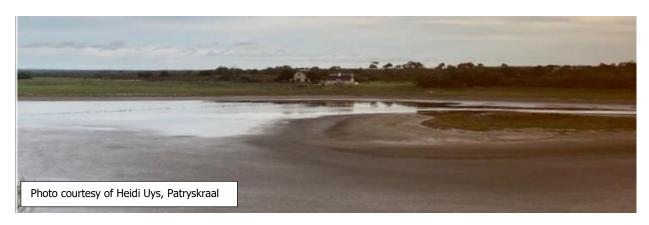
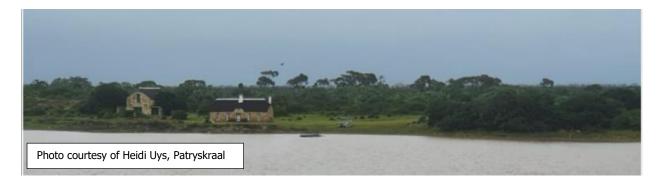
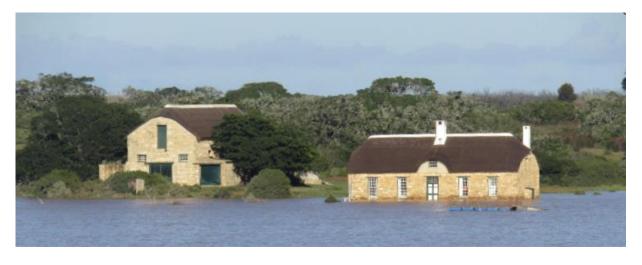
Figure 8. Melkkamer area. Top two photos – taken during the flood, while the water was rising.

Bottom two photos were taken after the flood.

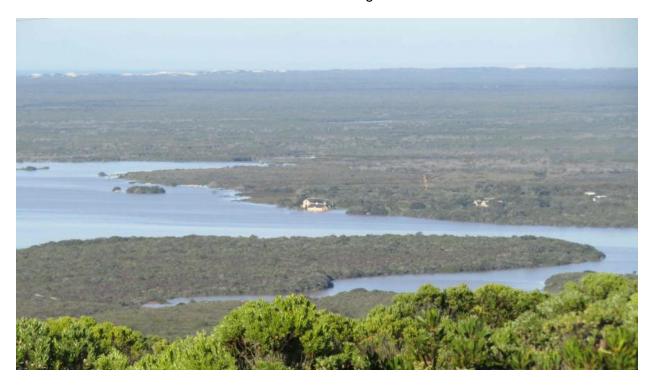
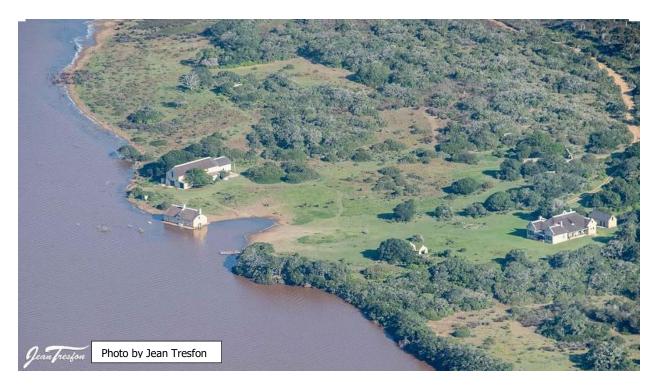
Figure 9. The flooded Melkkamer area. Top – photo taken from the entrance to De Hoop Nature Reserve. Bottom – oblique aerial view.

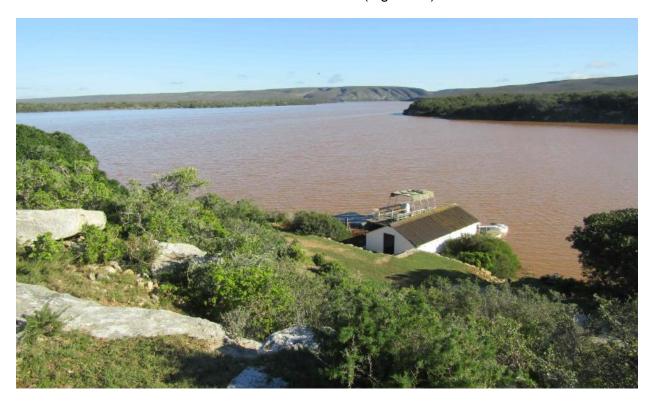
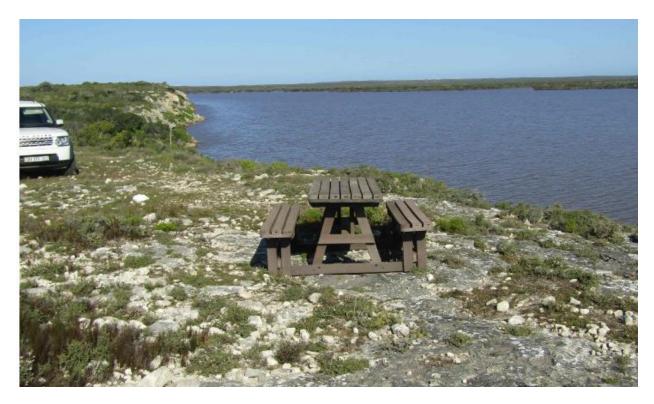
The water level in the vlei was ~13 m above sealevel (Figure 10).

Figure 10. View of the flooded vlei. Top – view from the resort to the NW. Bottom – between the resort and Die Mond – view to the south.

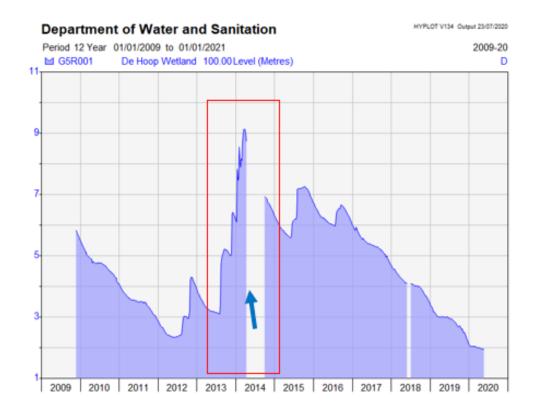
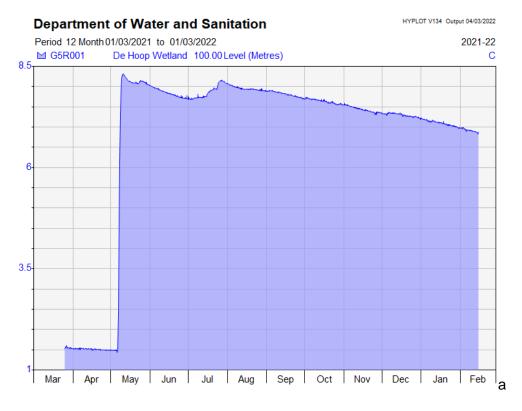
Figure 11. Water level in the vlei. Top – 2009 to 2020. Bottom – March 2021 to March 2022. Note that the level of the 2014 flood was higher than that of May 2021.

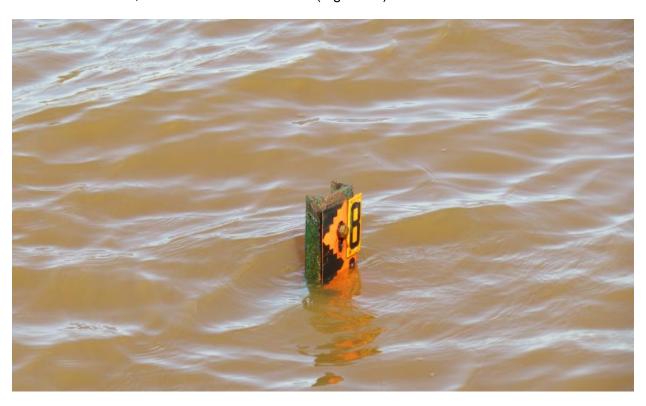
In the Die Mond area the water rose to above the very top of the hydrometer pole (Figure 12) and inundated the road, which leads to Melkkamer (Figure 13).

Figure 12. The top of the hydrometer pole near Die Mond. The base of the pole is believed to be  $\sim$ 5 m above sealevel (the author have could not get information on this).

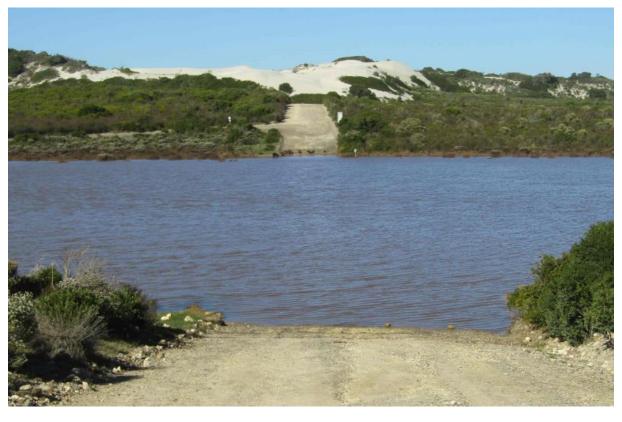
Figure 13. The road to Melkkamer, just before the turn-off to Koppie Alleen, is under ~1 m of water.

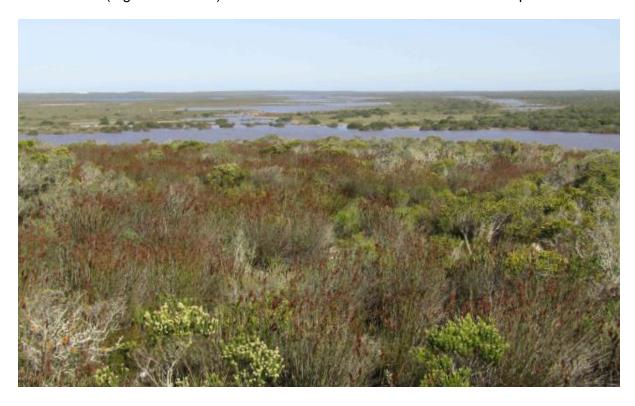
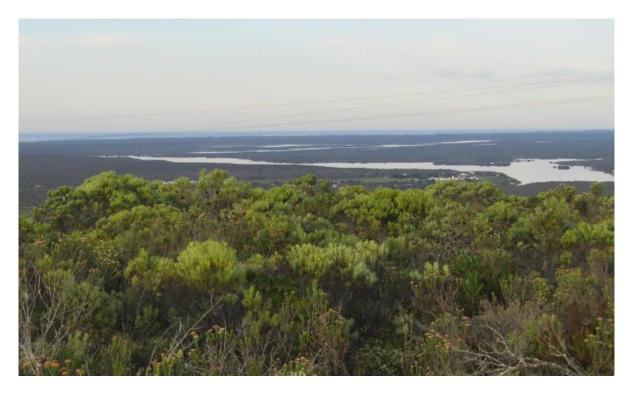
The areas southwest of the vlei are topographically low and were flooded nearly to the extent of the 1957 flood (Figures 14 to 16). See Desk Note on the 1957 flood in this Chapter.

Figure 14. Views on the flooded areas southwest of the vlei, Top – from the east bank of the vlei.

Bottom – from the gate to De Hoop Nature Reserve.

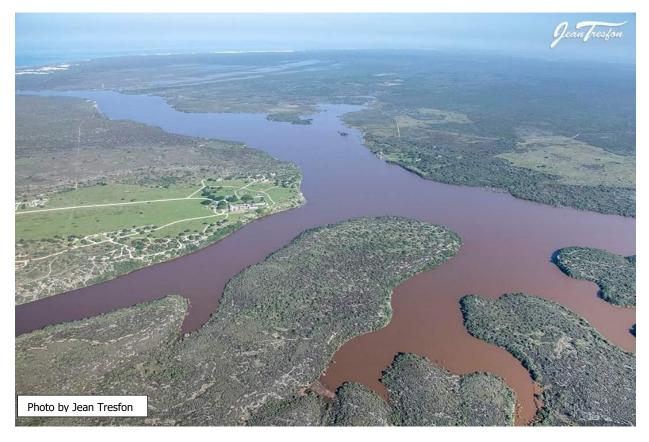
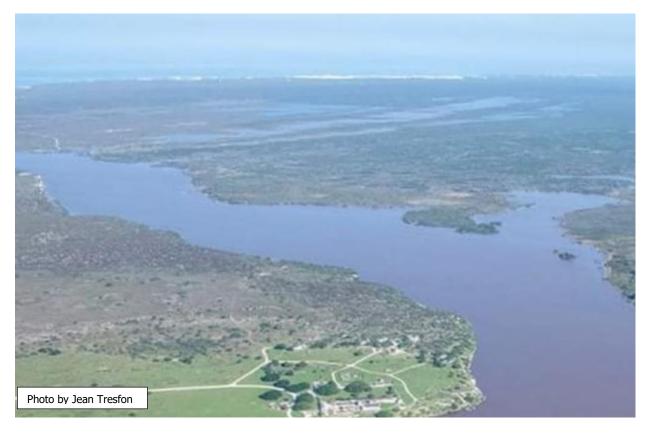
Figure 15. Oblique aerial views on the flooded vlei and the areas southwest of the vlei.

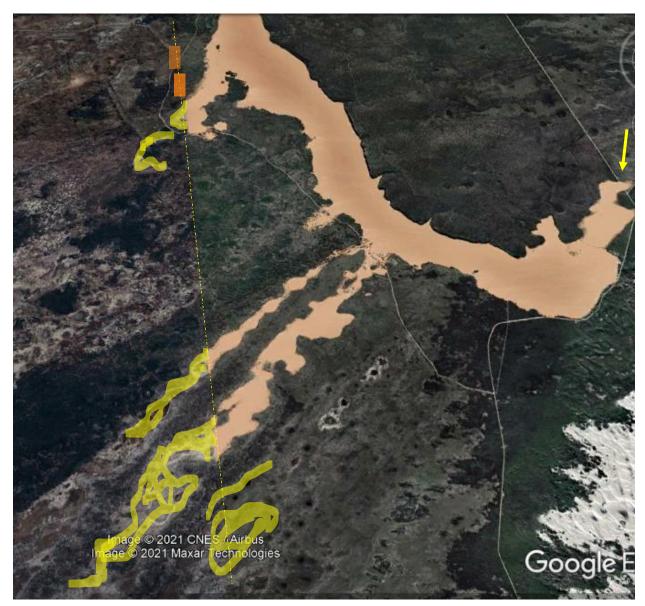
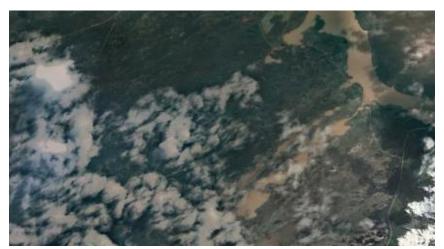
Figure 16. Satellite images of the vlei and the SW areas. Top - the image is a strip, which was pasted on an earlier image (dashed line showing contact line). The yellow paint indicates flooded areas, which can be seen through the clouds in the bottom image (taken two weeks later), as shown in Figures 14 and 15. The arrow in the top-right corner points to the submerged road in Figure 13.

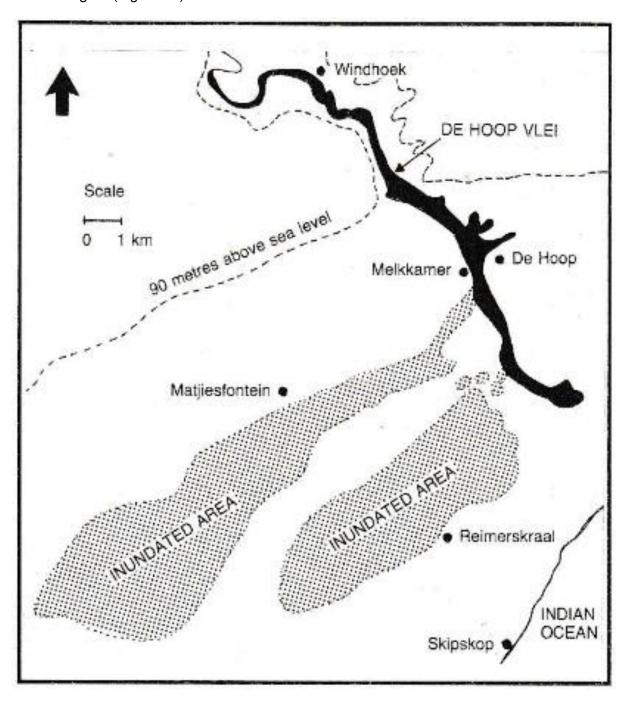
The extent of the flooded areas resulting from the 1957 flash flood was a little larger, as the water level was higher (Figure 17).

Figure 17. The extent of the 1957 flood. Map source unknown. Information source unknown.
