#### N. DE HOOP VLEI GORGE

Field Note N8e1. Hydrology - De Hoop Vlei - Flash flood of May 2021

## Field notes on the GEOMORPHOLOGY, HYDROLOGY and ARCHAEOLOGY

Between CAPE AGULHAS and CAPE INFANTA

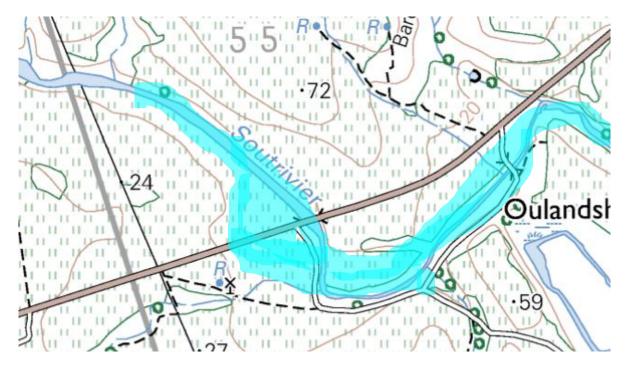
Figure 2. Blue paint indicates the approximate extent of the flooded road to Ouplaas. The water rose to ~17 m above sealevel, or ~2 m above the bridges in this map.

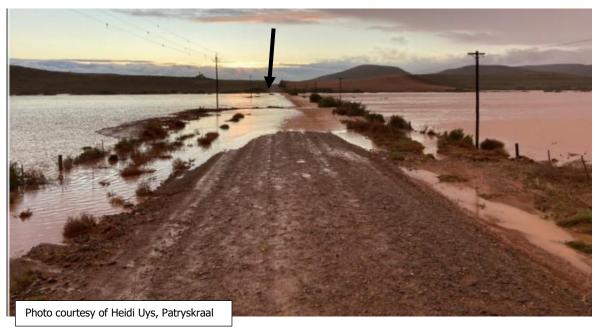
Figure 3. The bridge on the road to Ouplaas. Top – when flooded (arrow points to the bridge); Bottom – after the water receded. The water level is ~1.5 m below the road, or 13 m above msl.

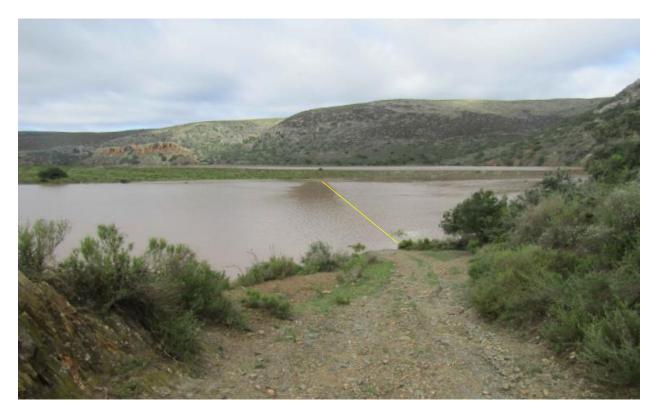
Figure 5. After the flood: the causeway over Salt River leading to Windhoek Farm is submerged under >1 m of water. Yellow line indicates the location of the causeway.

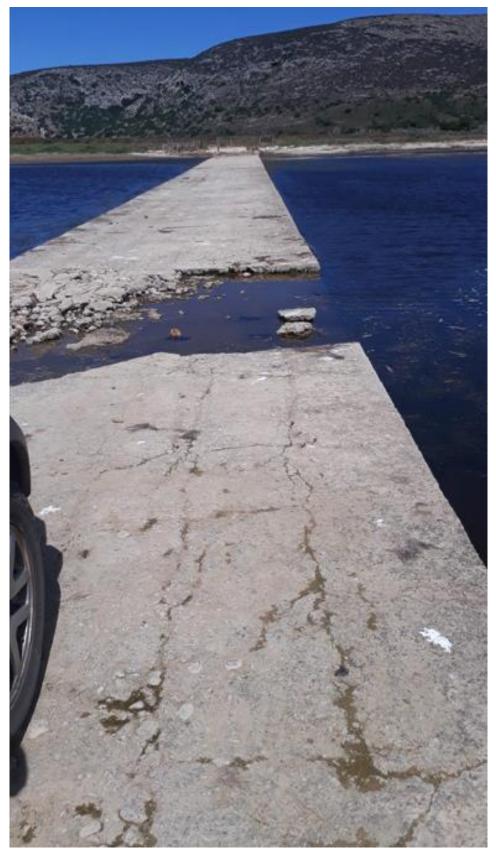
The causeway was only exposed again in the beginning of March 2022, or ten months after the flood. It was damaged bur is still drivable (Figure 6).

Figure 6. The damaged causeway.

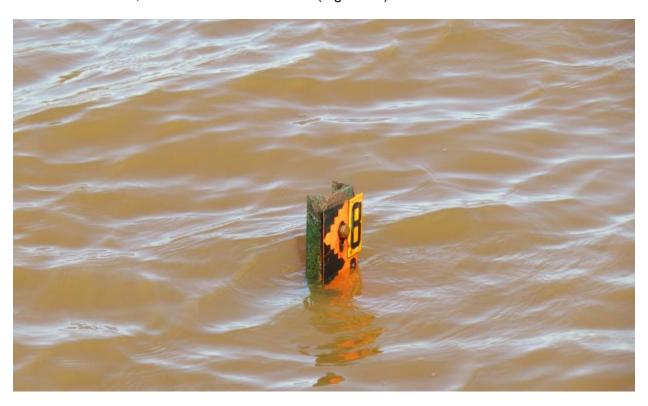
In the Die Mond area the water rose to above the very top of the hydrometer pole (Figure 12) and inundated the road, which leads to Melkkamer (Figure 13).

Figure 12. The top of the hydrometer pole near Die Mond. The base of the pole is believed to be ~5 m above sealevel.

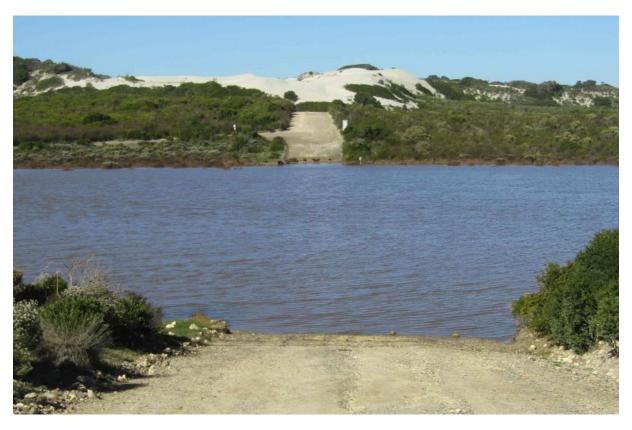
Figure 13. The road to Melkkamer, just before the left turn-off to Koppie Alleen, was under ~1 m of water.

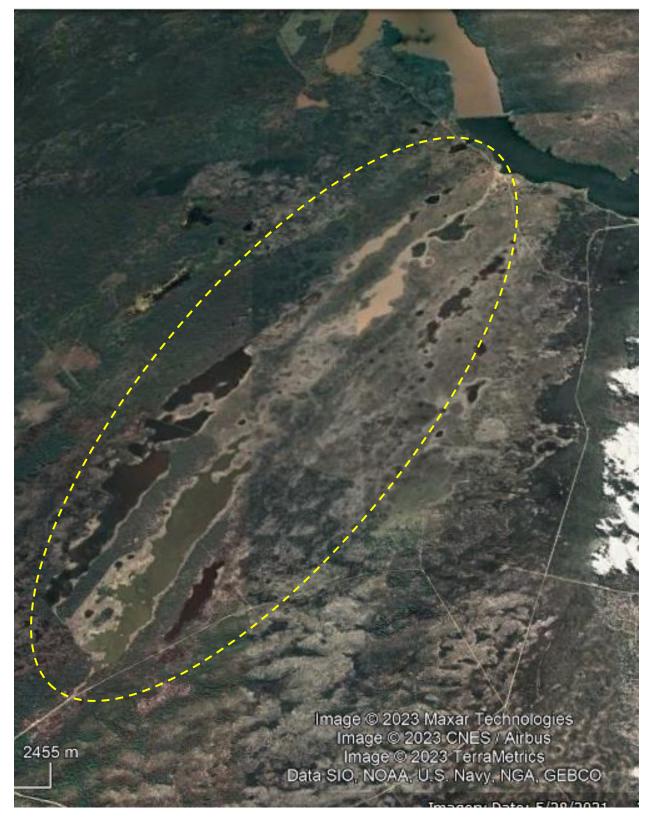
The areas southwest of the vlei are topographically low and were flooded nearly to the extent of the 1957 flood (Figures 14 to 16). See Desk Note on the 1957 flood in this Chapter.

Figure 16. Satellite images of the vlei and the SW areas, showing the extent of the May 2021 flash flood (within the ellipse).
