**M. SALT RIVER GORGE**

**Field Note M6a. Hydrology - The Salt River Marsh**

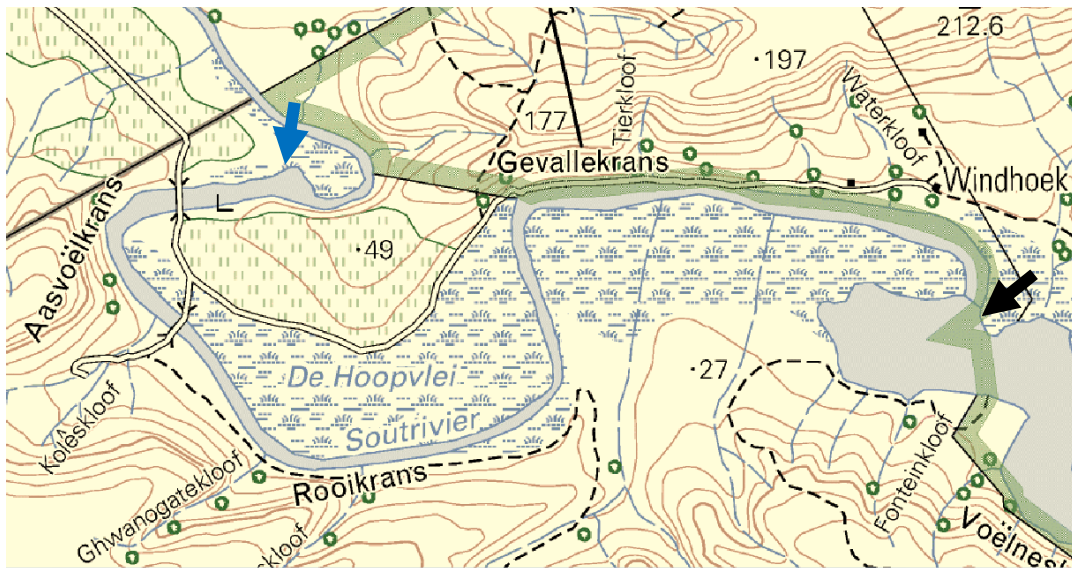
**Figure 1. Topographic map showing the course of the Salt River from the entry point (blue arrow) through the marsh into De Hoop Vlei, near The Island (black arrow).**

East of the concrete causeway the Salt River enters a marsh (the north end of De Hoop Vlei), as shown in Figure 1. The marsh is very shallow and in years of poor rainfall it is partially or totally dry (Figures 2 to 6). [The De Hoop Vlei was declared a RAMSAR Site (see Appendix X), but the marsh is not part of it].

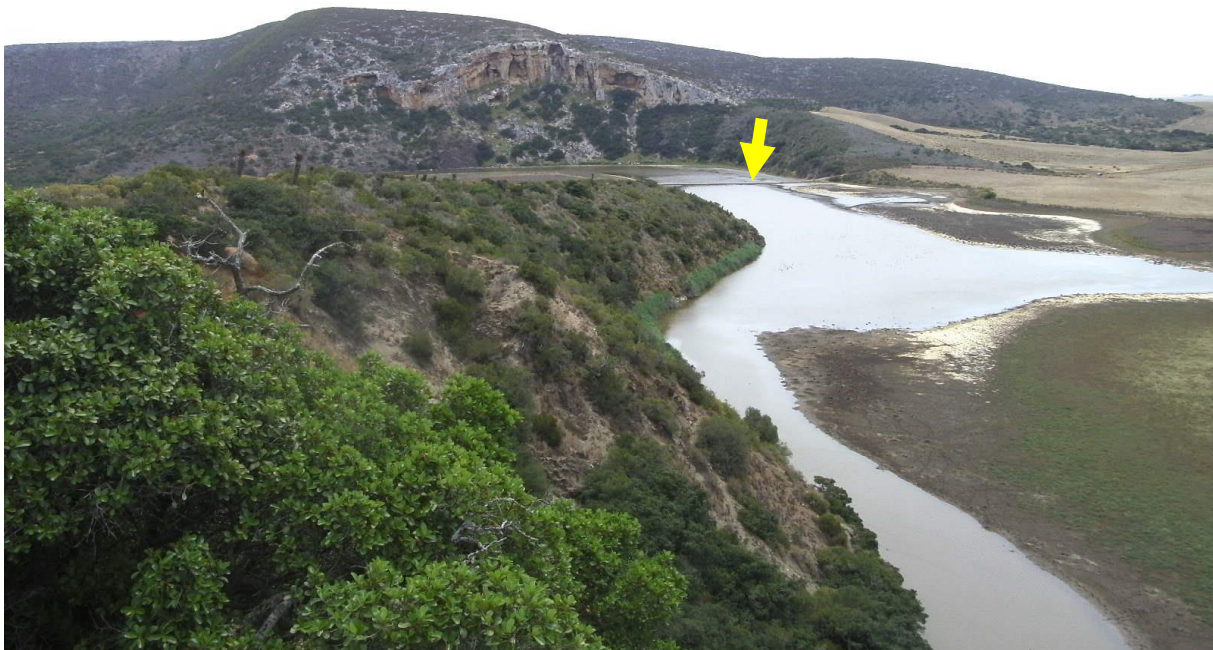
**Figure 2. The Salt River enters the Salt River Marsh, east of the concrete causeway (yellow arrow). View to the west from Riverbend Hill.**

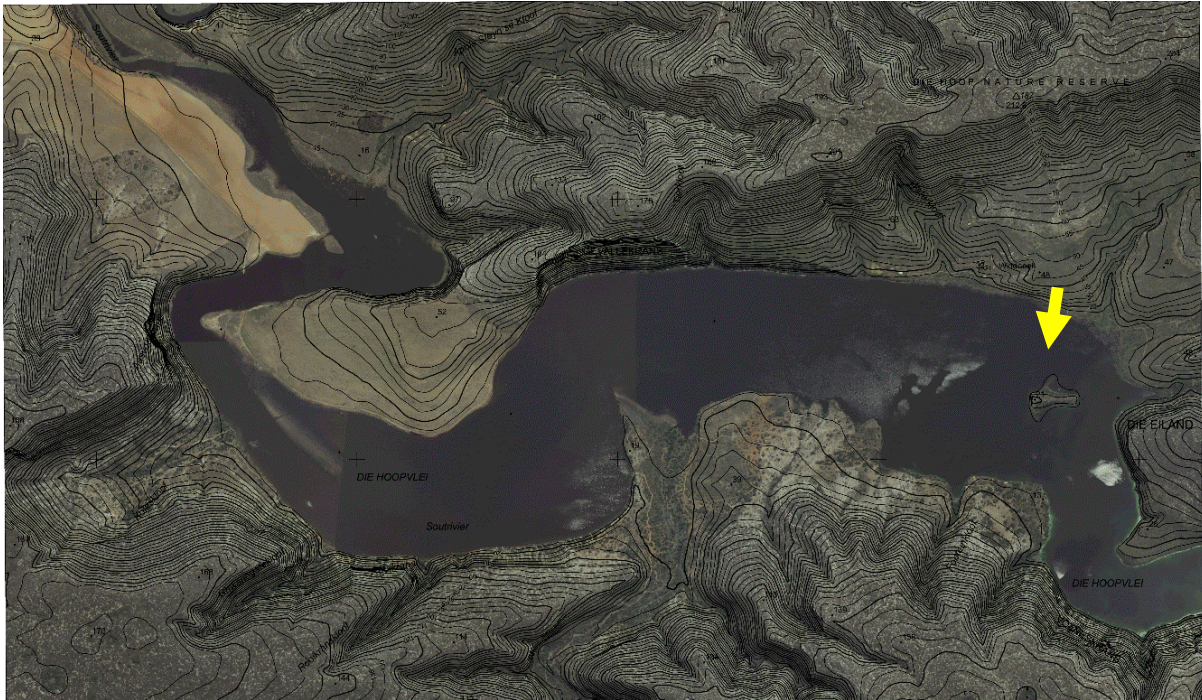
**Figure 3. Topography map (2014) of the Salt River Marsh when it was flooded. Note that the causeways and the roads along the shores are submerged and that The Island (arrow) is surrounded by water.**

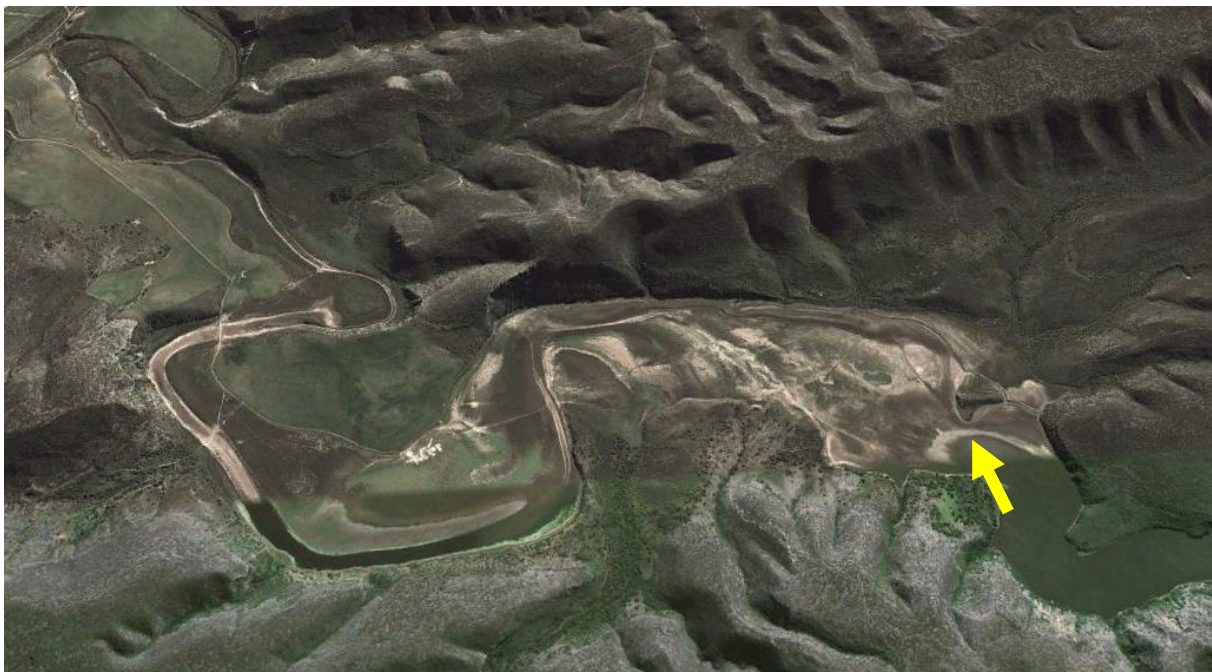
**Figure 4. Satellite image (2011) of the Salt River Marsh when it was partially dry. The northern limit (arrow) of the De Hoop Vlei is south of The Island (which is connected to the shore).**

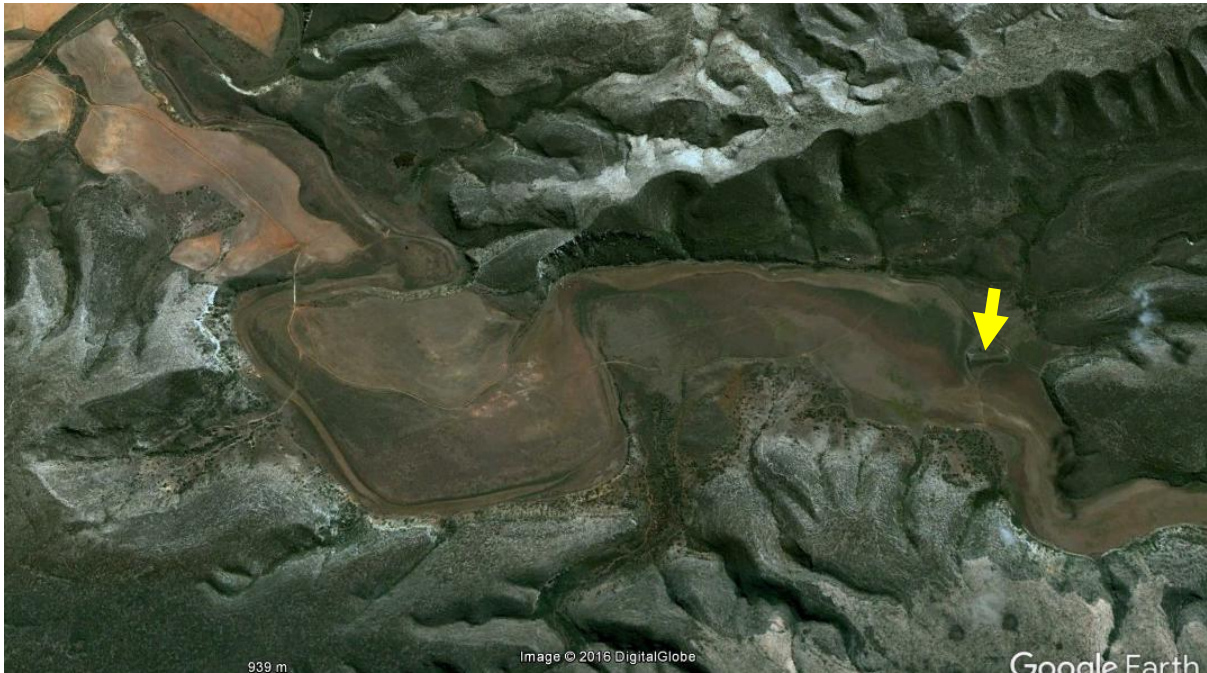
**Figure 5. Satellite image (2003) of the Salt River Marsh when it was totally dry. [The De Hoop Vlei was almost completely dry in that year]. Arrow points to The Island.**

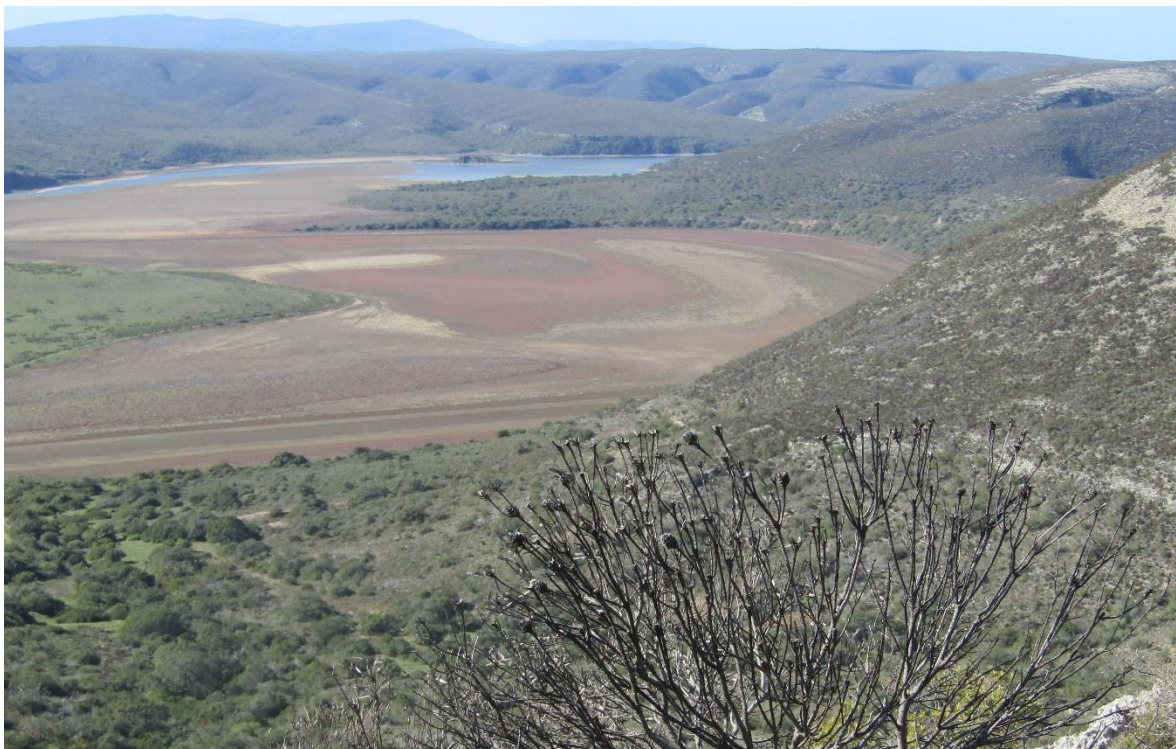
**Figure 6. The dry Salt River Marsh floor. View to the east from the top of Koleskloof.**

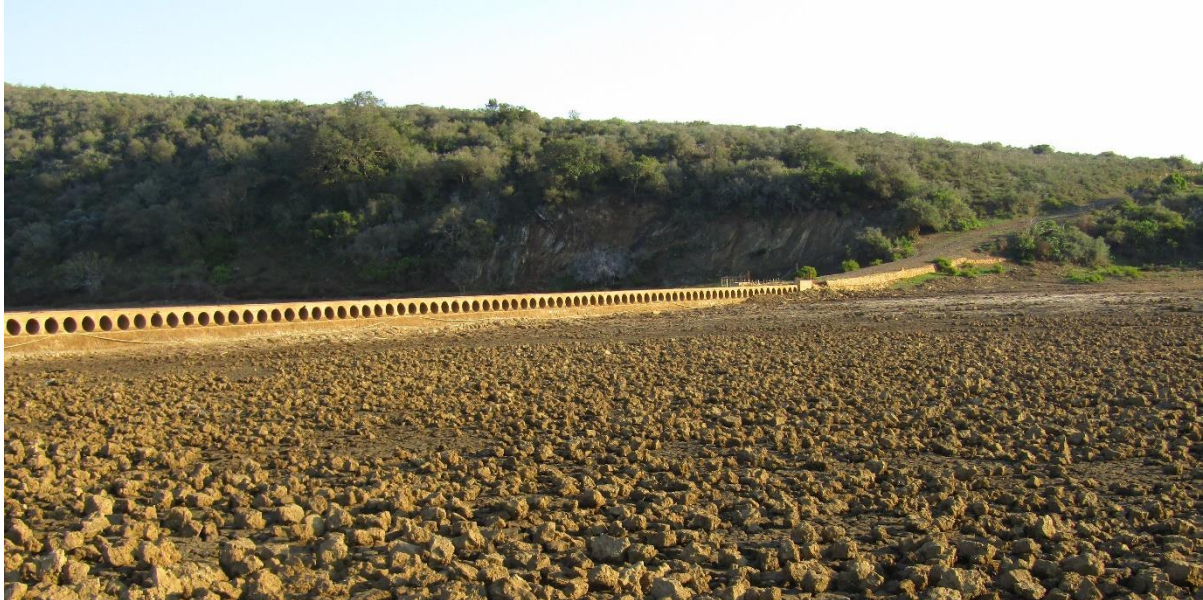
**Figure 7. The dry riverbed. View to the west-southwest on the concrete causeway. The riverbed next to, and south of, the causeway is about 2 m below its top, or ~8 m above sealevel.**

In dry periods, the riverbed and the marsh floor harden in several forms (Figures 7 and 8).

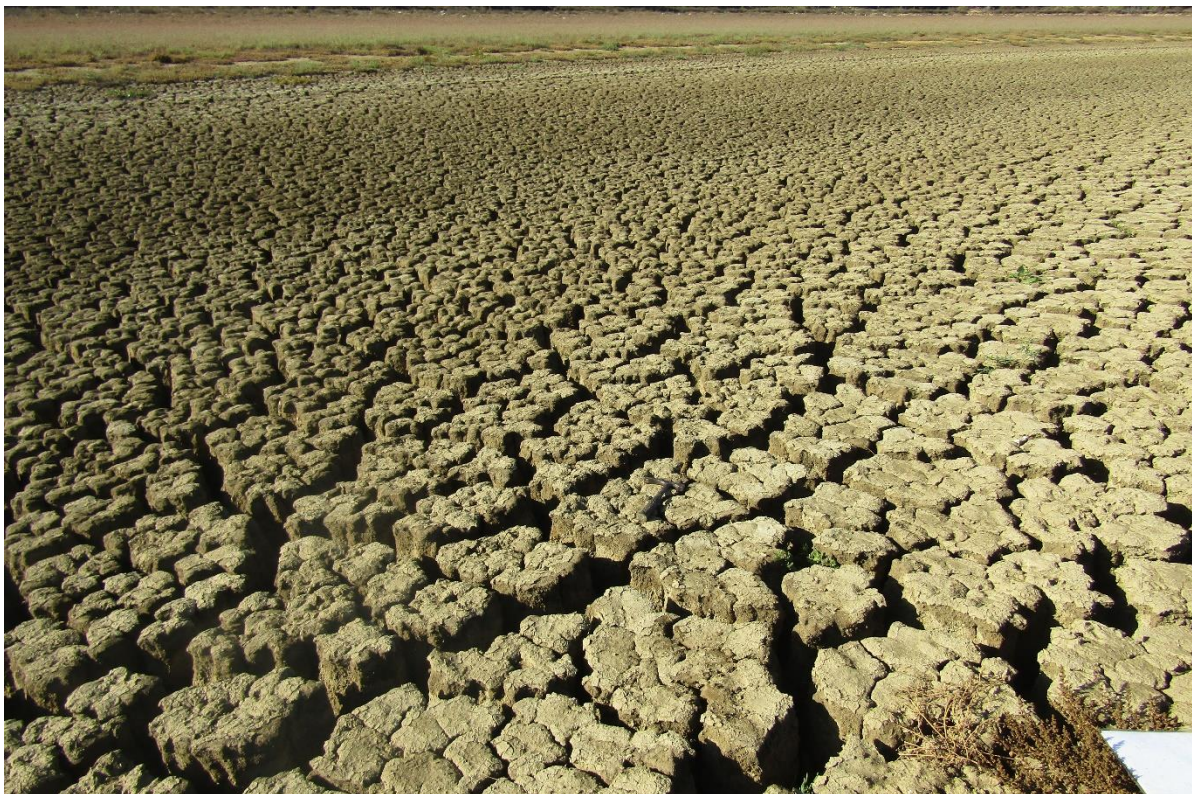
**Figure 8. The cracked, dry riverbed.**
