Field notes on the GEOMORPHOLOGY, HYDROLOGY and ARCHAEOLOGY Between CAPE AGULHAS and CAPE INFANTA

N. DE HOOP VLEI GORGE

Desk Note N8a. Hydrology - De Hoop Vlei - Overview

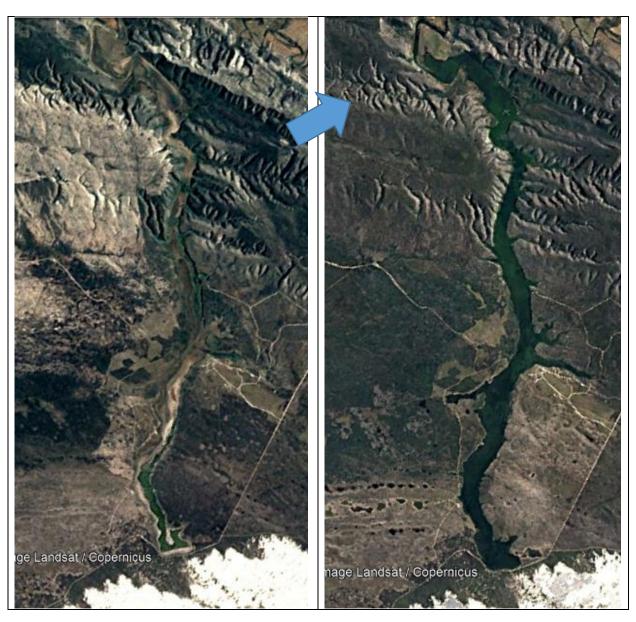
Figure 1. Satellite images of a dry vlei (left) and of a full vlei (right). Arrow indicates the north.

A regime of floods and droughts of the vlei has already been observed by the early settlers of the area, but the records are poor. This regime can now be studied via satellite images (Figure 1).

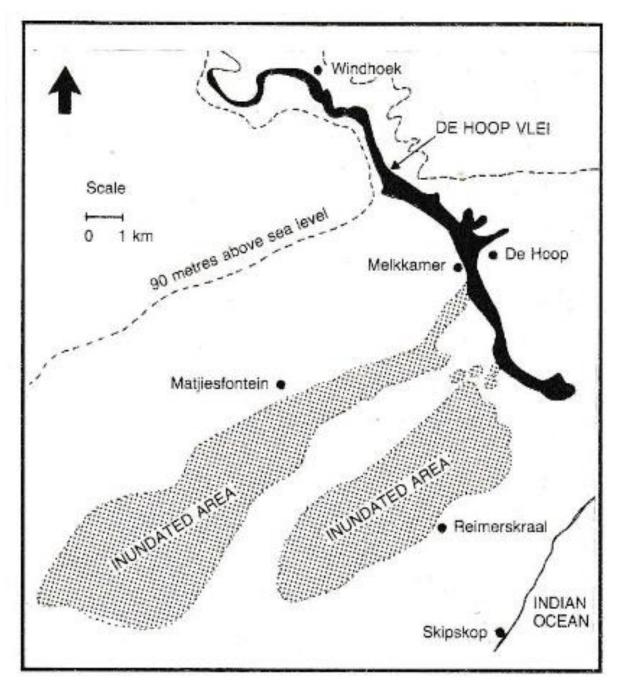
Figure 2. The extent of the 1957 flood.
Source: unknown.

Some of the floods were gradual: the vlei was filled during winters of good rains. The latest of such floods occurred in 2007 and 2014. Several floods were flash floods: the vlei was filled over two to three days due to cloud bursts or unusual weather patterns. Such events occurred in 1792, 1906, 1957 and 2021. During some floods, the low-lying areas south-west of the vlei were inundated (Figures 2 and 3).

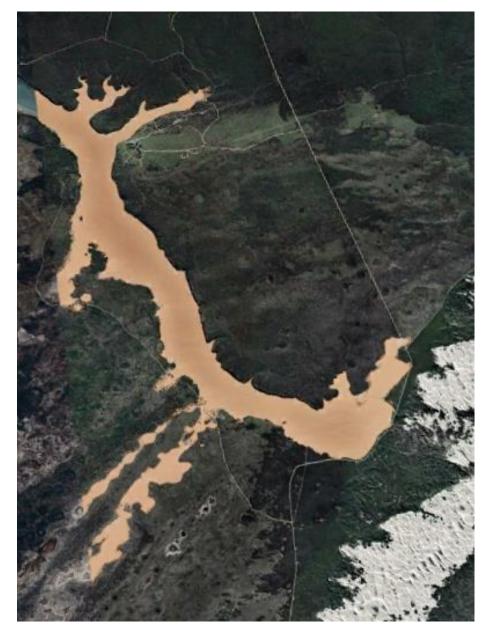
Figure 3. Satellite image showing the extent of the May 2021 flood. The water is brown due to clay in suspension.
