N. DE HOOP VLEI GORGE

Desk Note N8a. Hydrology – De Hoop Vlei – Overview

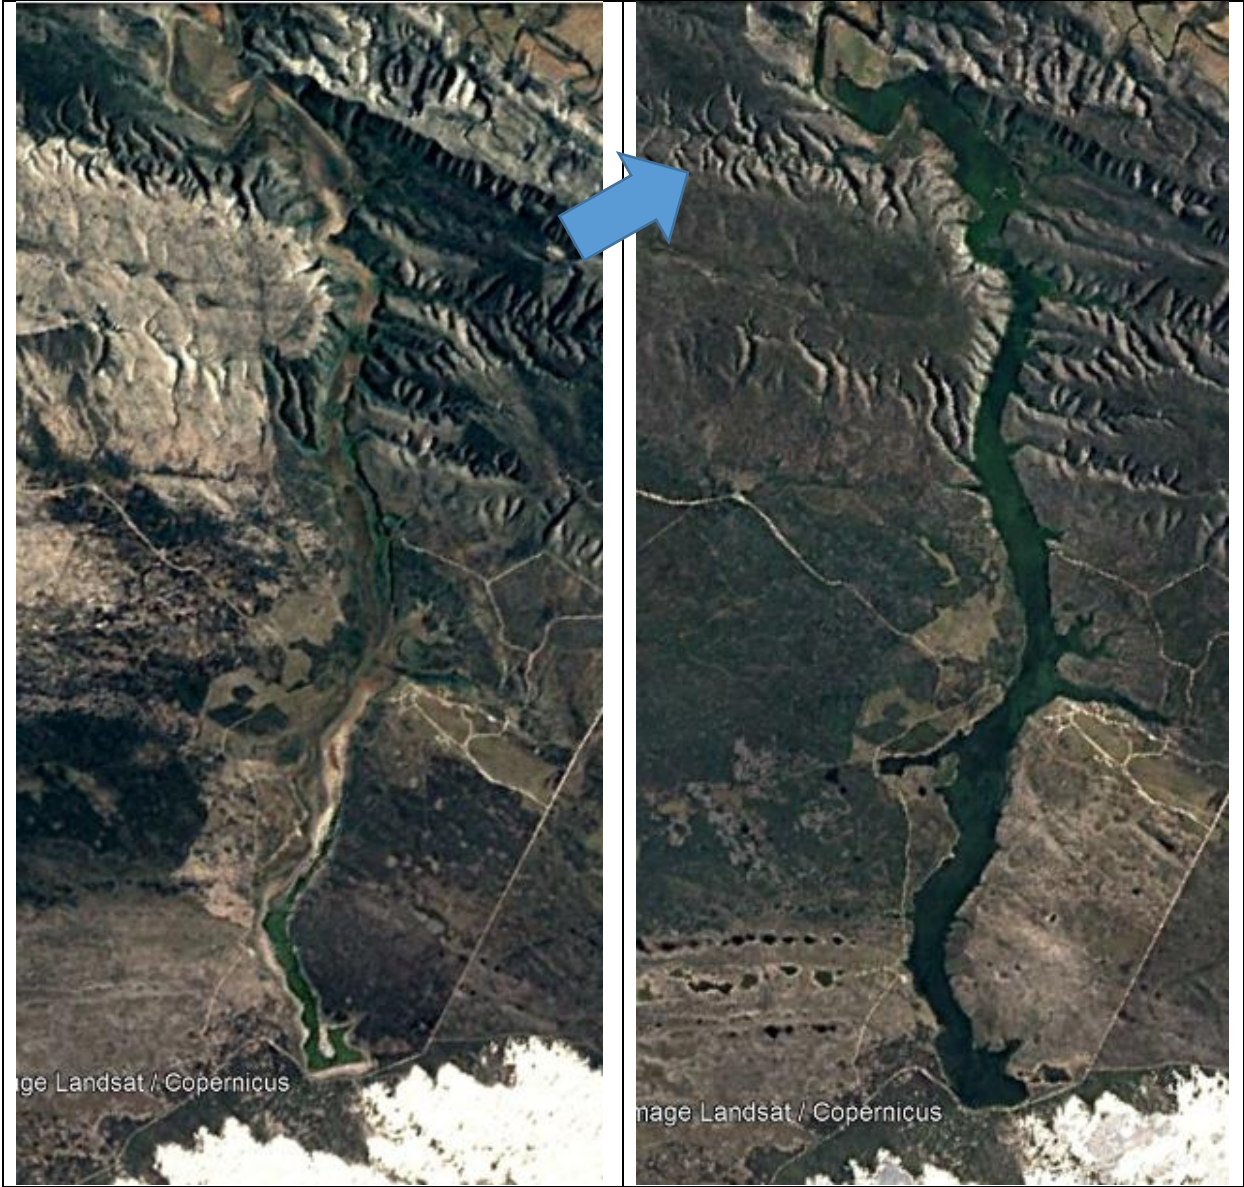
Figure1. Satellite images of a dry vlei (left) and of a full vlei (right). Arrow indicates the north.

A regime of floods and droughts of the vlei has already been observed by the early settlers of the area, but the records are poor. This regime can now be studied via satellite images (Figure 1).

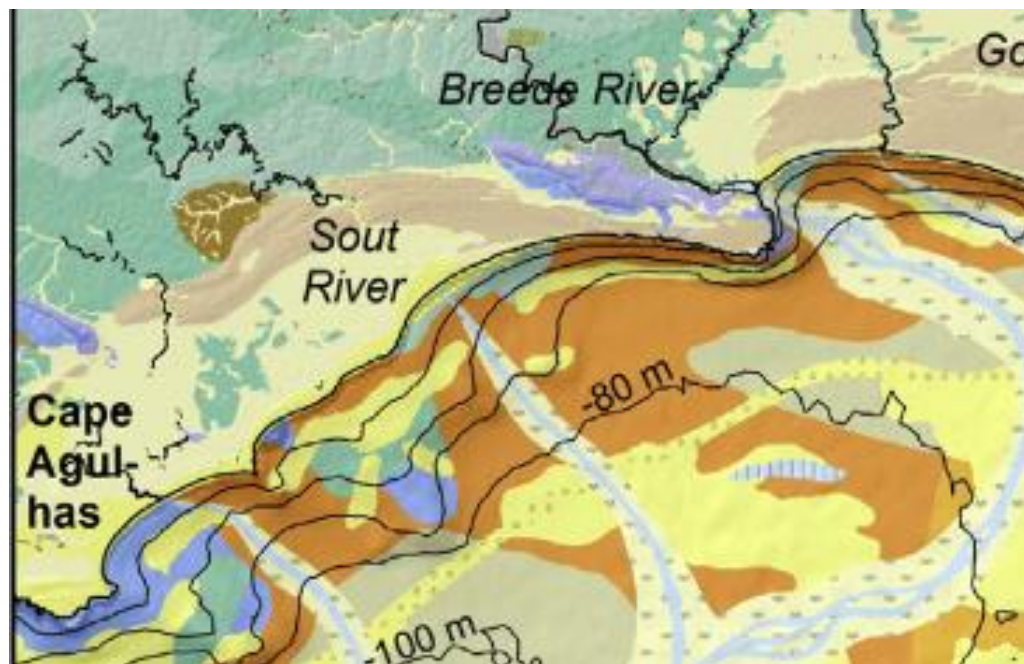
Figure 2. Geology map of the Palaeo Agulhas Plain, showing the rivers, which drained the South Coast, flowing to the ocean. Box in the top figure is enlarged at the bottom figure.

[The Salt River was flowing to the ocean during the late Pleistocene, as shown by HC Cawthra et al, 2020 (Figure 2)].

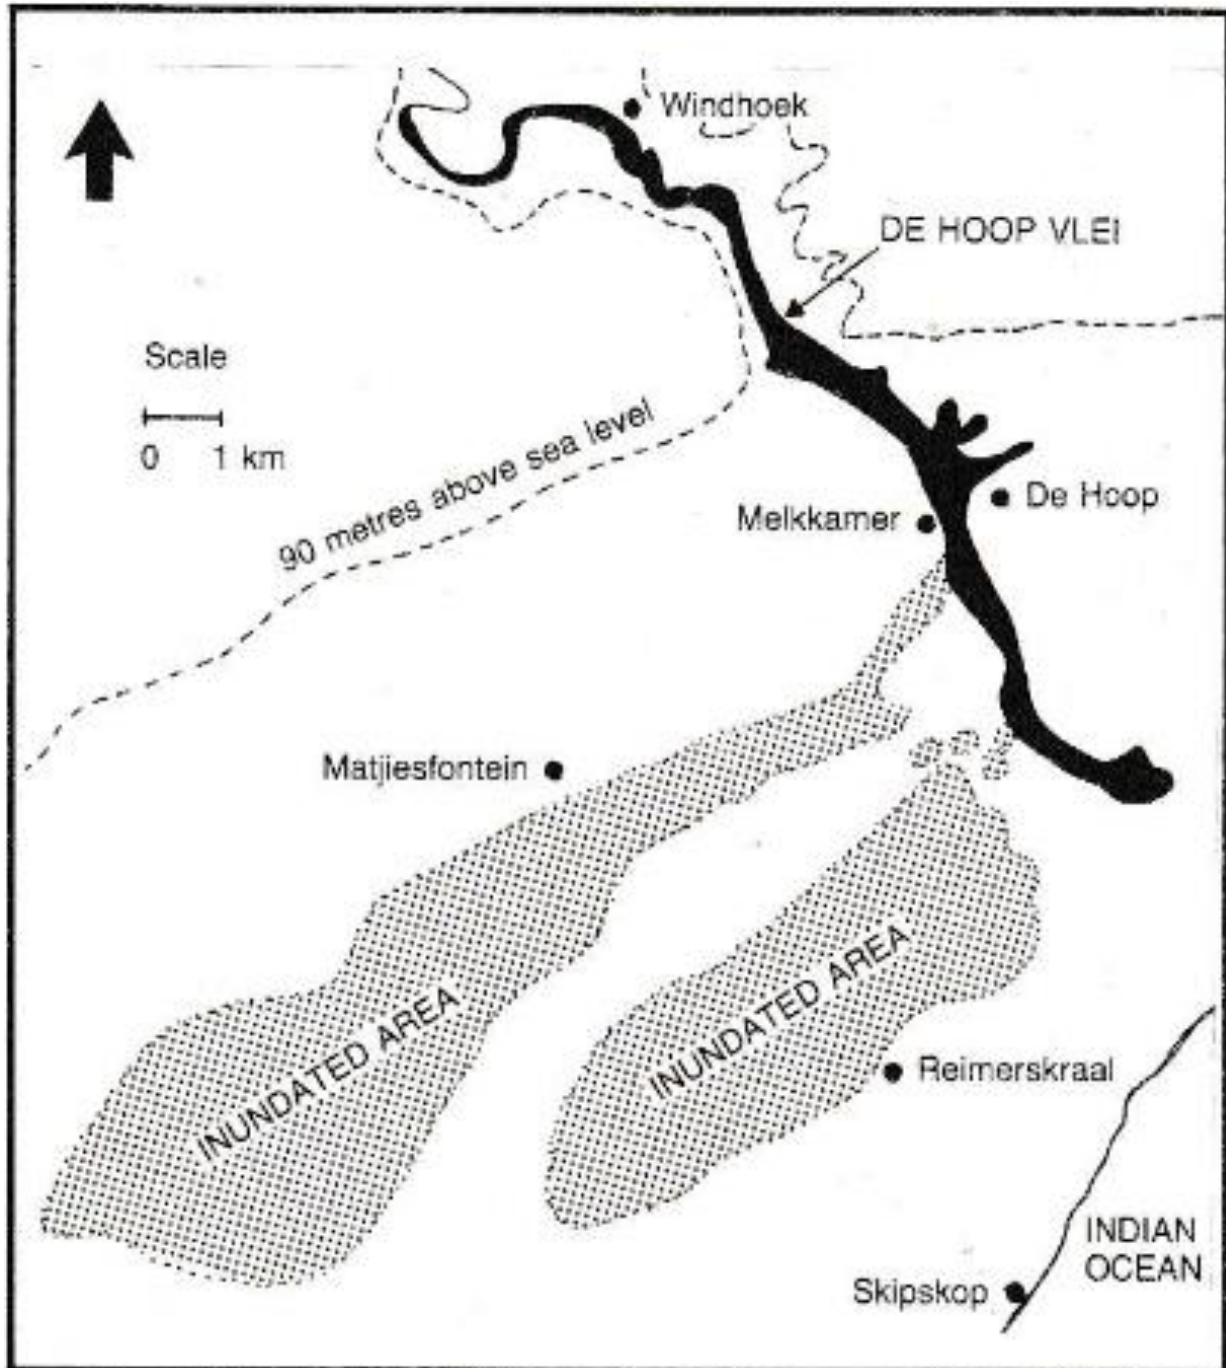
Figure 3. The extent of the 1957 flood.

Some of the floods were gradual, as the vlei was filled during winters of good rains. The latest of such floods occurred in 2007 and 2014. Several floods were flash floods: the vlei was filled over two to three days due to cloud bursts or unusual weather patterns over the Salt River catchment area. Such events occurred in 1792, 1906, 1957 and 2021. During some floods, the low-lying areas south-west of the vlei were also inundated (Figures 3 and 4).

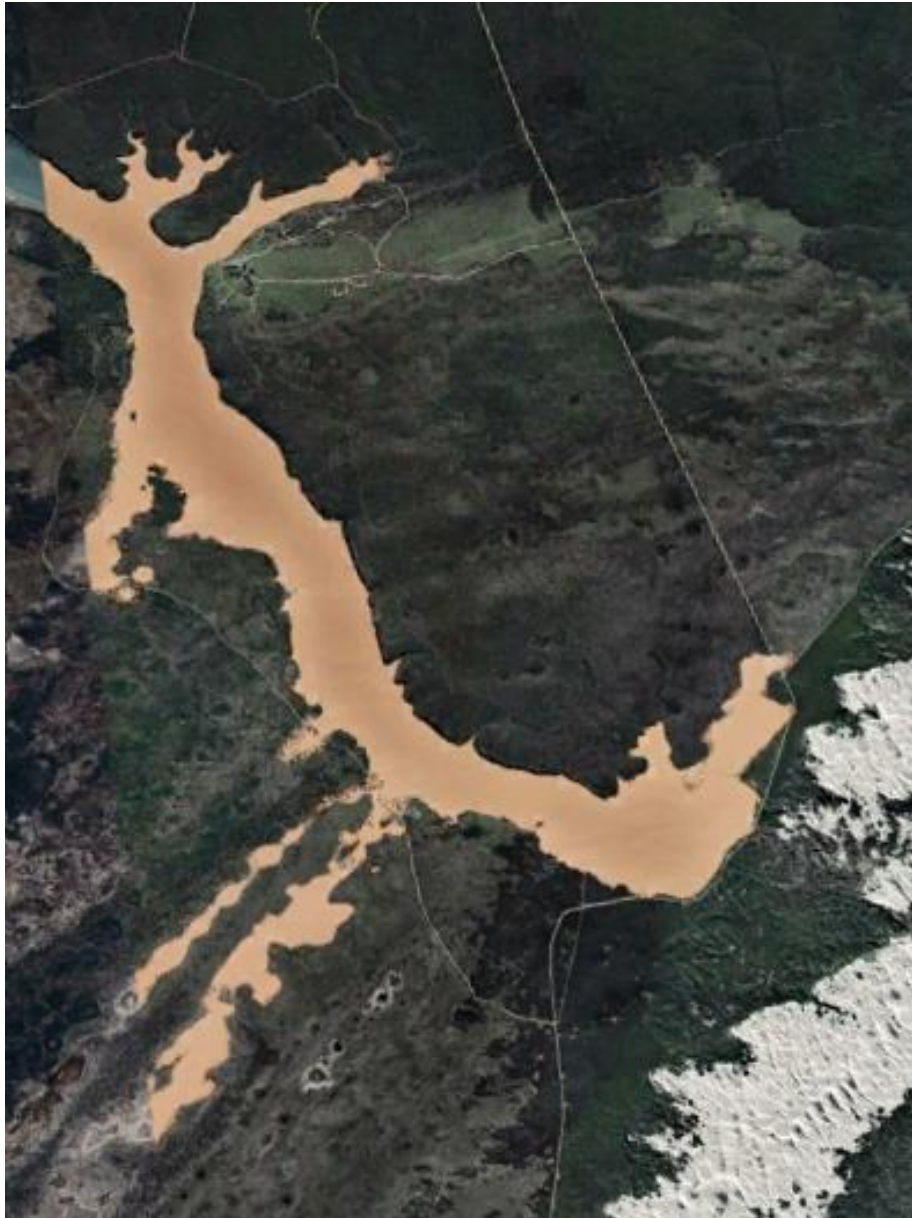
Figure 4. Satellite image showing the extent of the May 2021 flash flood. The water is brown due to clay in suspension.
