**N. DE HOOP VLEI GORGE**

**Desk Note N8d. Hydrology – De Hoop Vlei water level – 1960 to 2020**

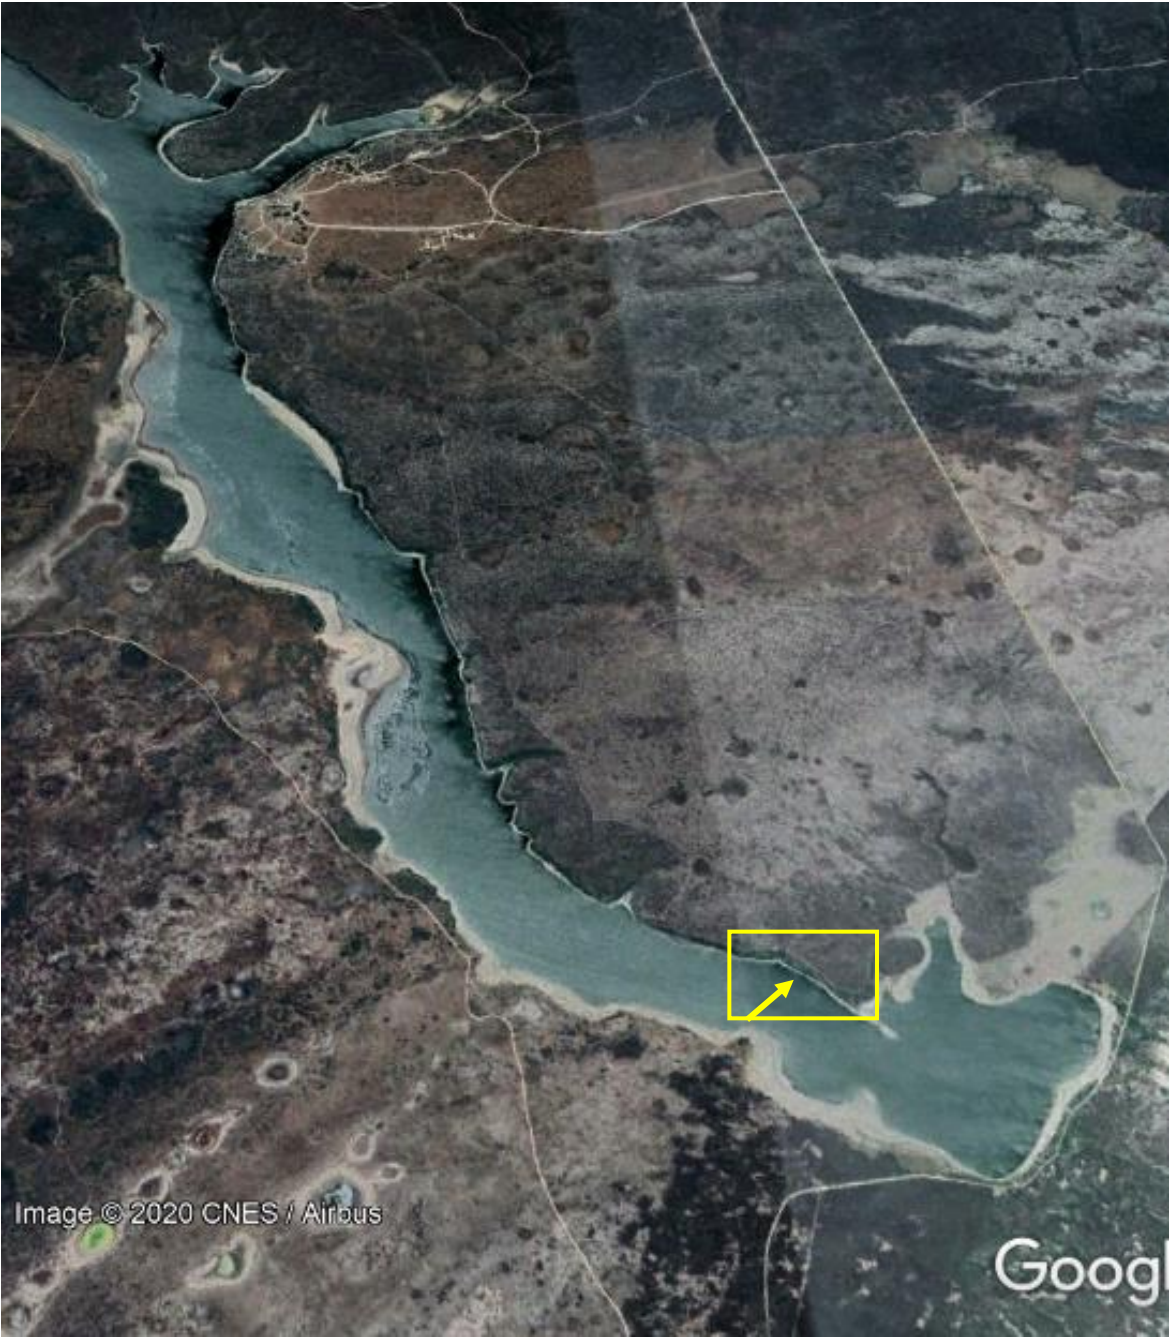
**Figure 1. Satellite image of the southern part of the De Hoop Vlei. Arrow points on the location of the hydrometry station. Boxed area enlarged in Figure 2.**

From 1960 onwards the De Hoop Vlei water level is monitored by the Department of Water and Sanitation at the hydrometry station on the southeast shore of the vlei, close the Die Mond (Figures 1, 2 and 3).

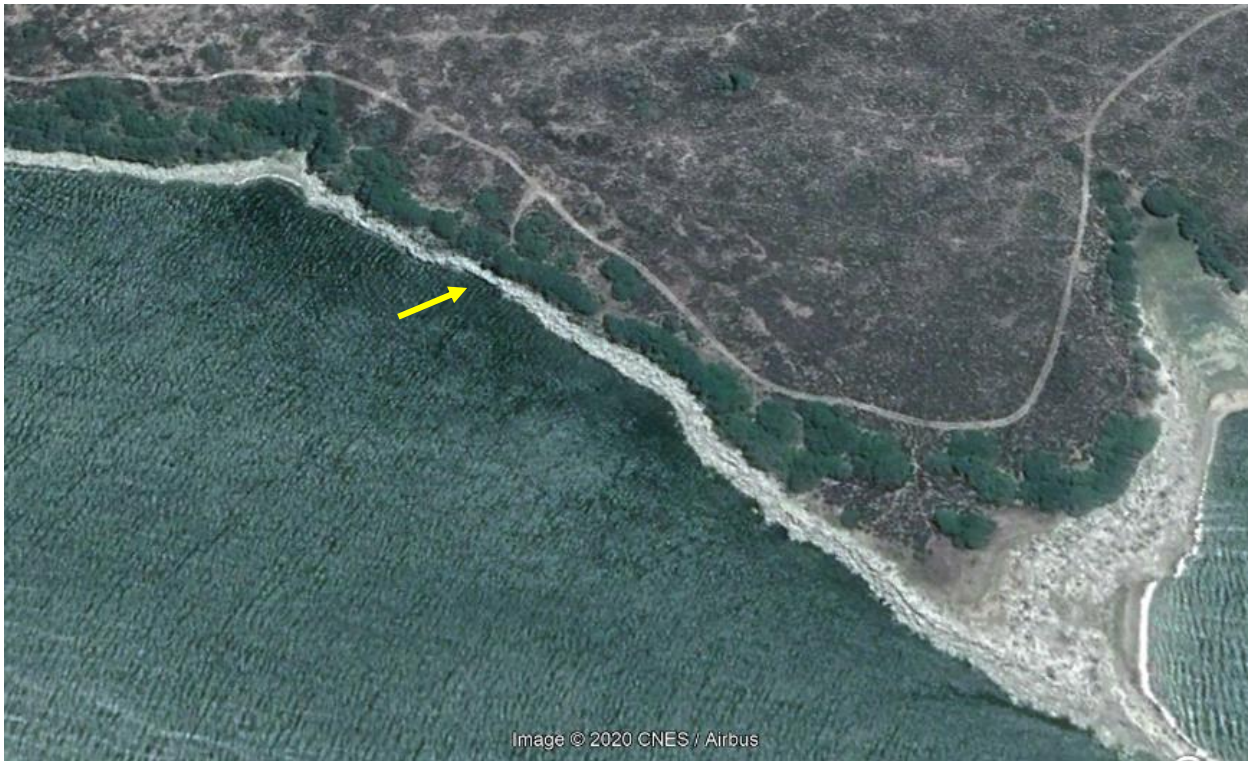
**Figure 2. Satellite image of a section of the east shore of De Hoop Vlei. Arrow points on the location of the hydrometry station.**

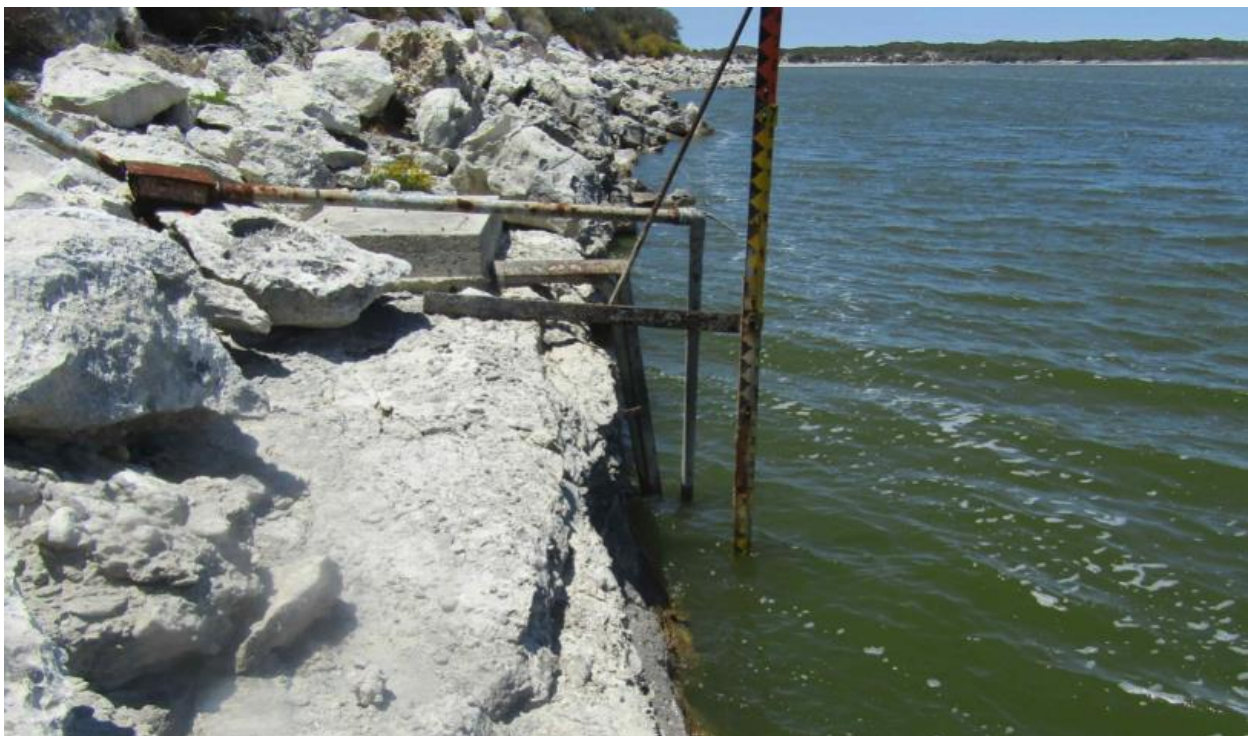
**Figure 3. The hydrometer on the southeast shore of the De Hoop Vlei. The south shore of Die Mond can be seen at a distance.**

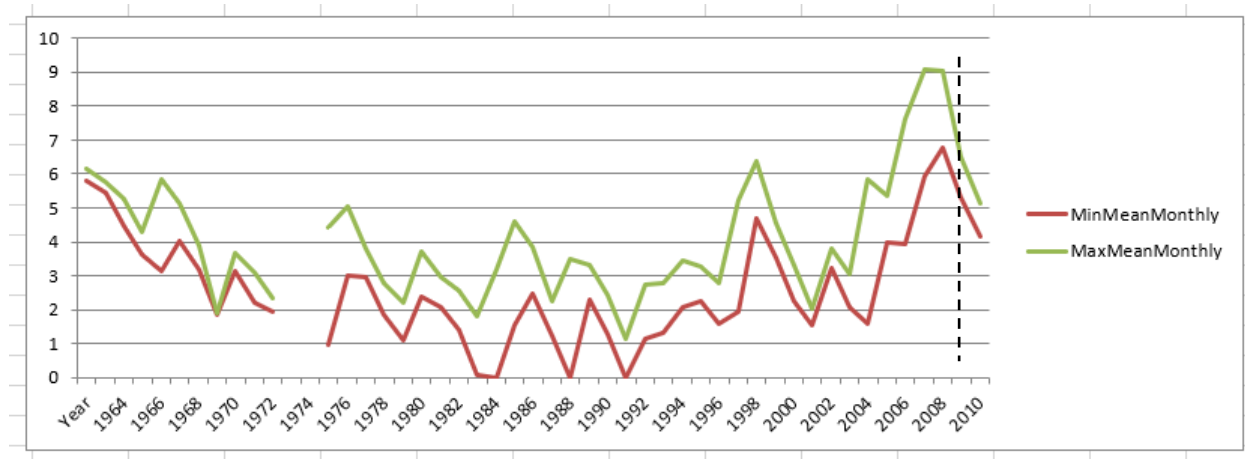
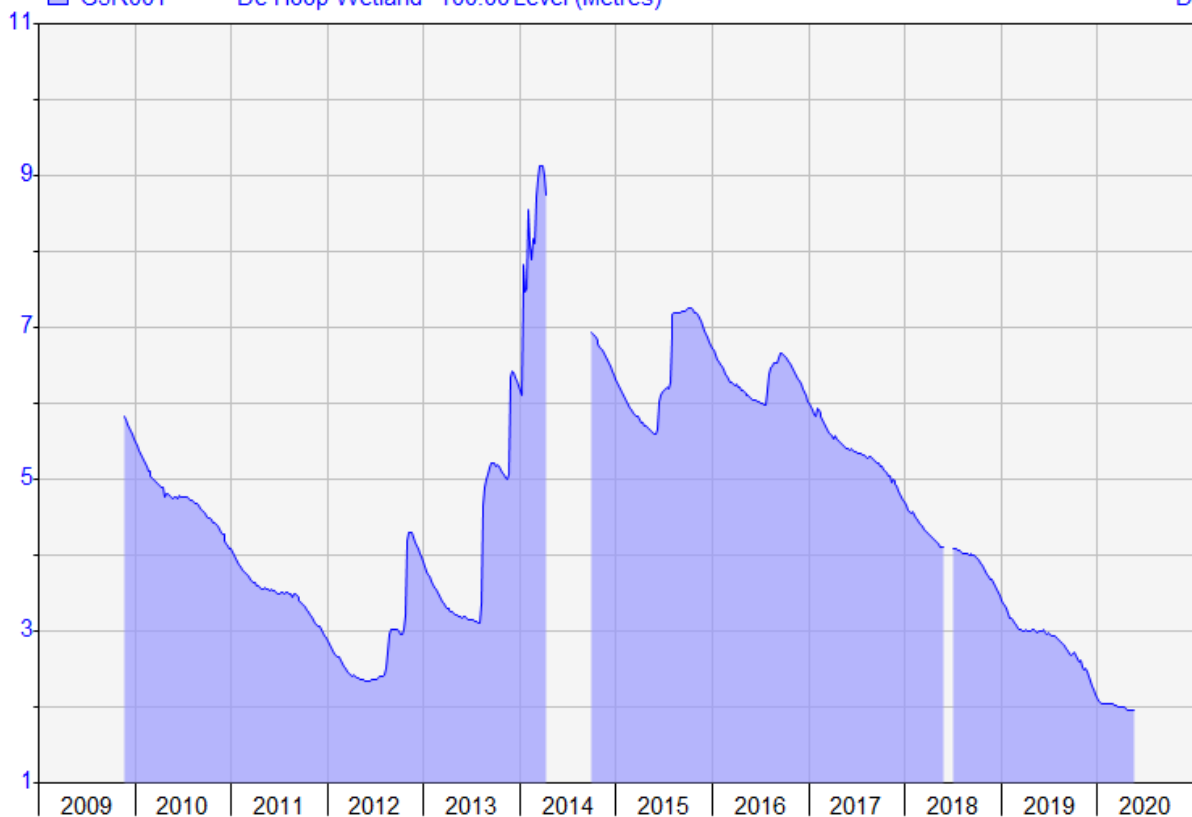
**Figure 4. De Hoop Vlei water levels 1960 to 2020. Top – 1960 to 2010; dashed line indicates the start of the bottom graph. Bottom – 2010 to 2020. The water level in the beginning of 2014 was the highest in the last 60 years. Between 2014 and 2020 the water level dropped ~1 m a year on average.**

The vlei water level fluctuations since 1960 are presented in Figure 4. The water level is dropping since 2013, and in August 2020 it is as low as it was 30-40 years ago (1983, 1988 and 1992), leaving only little water along the shore between the hotel and Die Mond and in Die Mond.
