**N. DE HOOP VLEI GORGE**

**Desk Note N8d1. Hydrology – De Hoop Vlei - 2007 and 2014 ‘floods’**

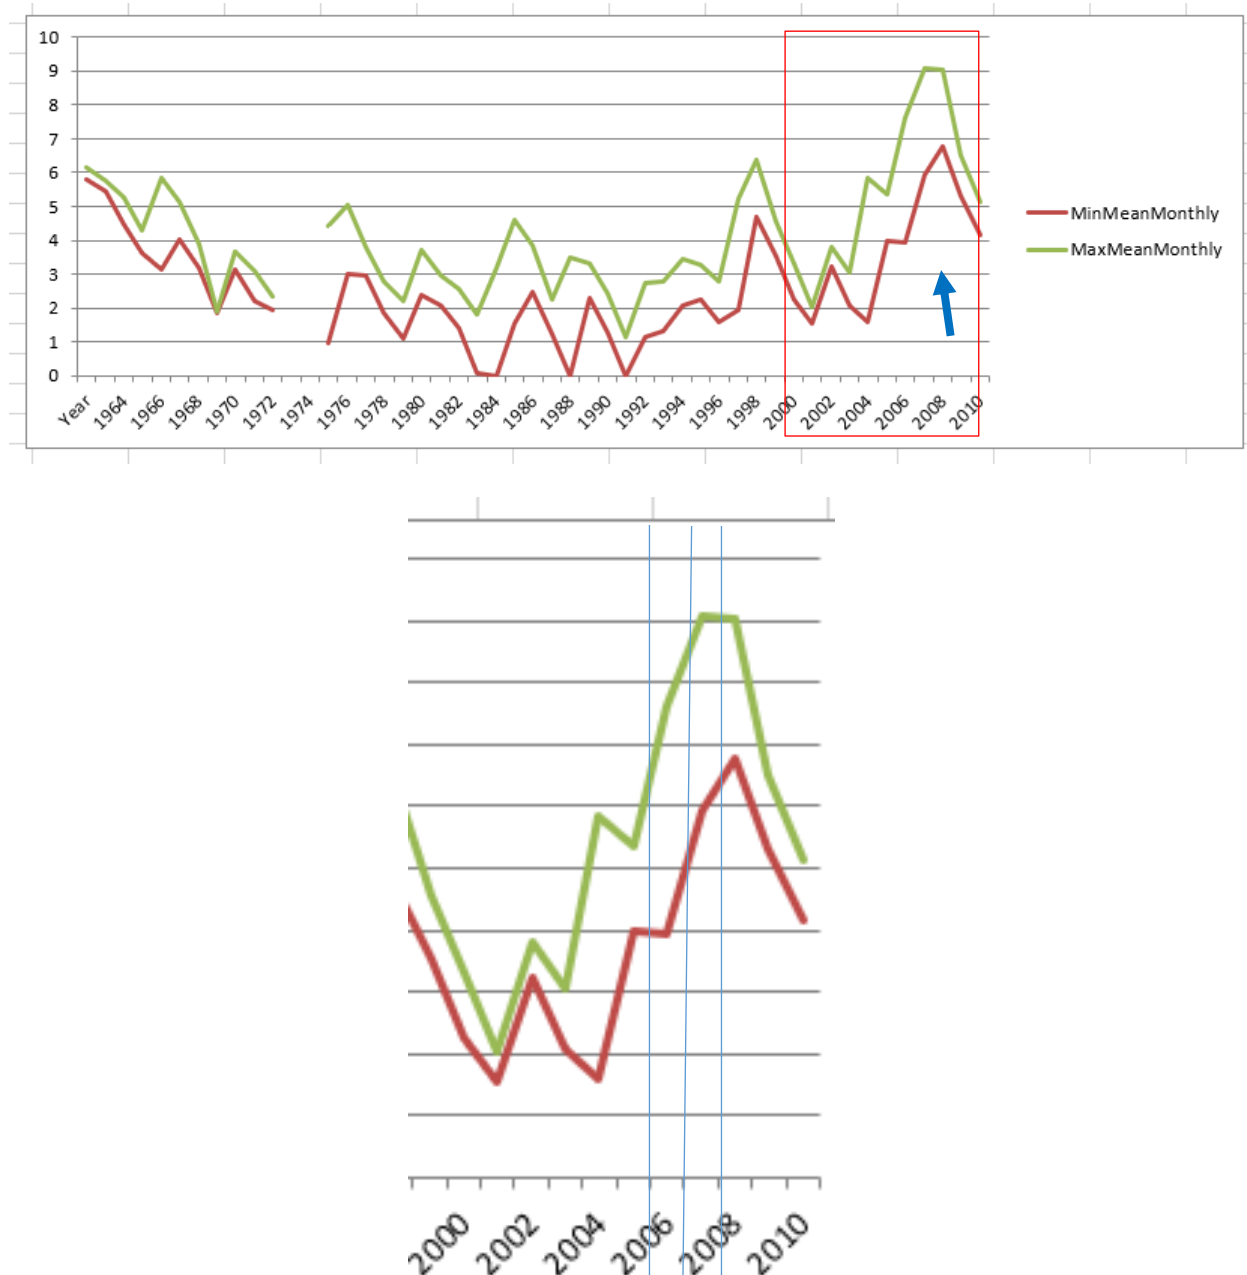
**Figure 1. De Hoop Vlei water levels 1960 to 2010 (red box enlarged at the bottom) showing the 2007 high-water level (arrow).**

This high-water level may not ‘deserve’ the term *flood*. The water level rose gradually during 2006, was the highest during 2007 and was maintained during the first half of 2008 (Figure 1).

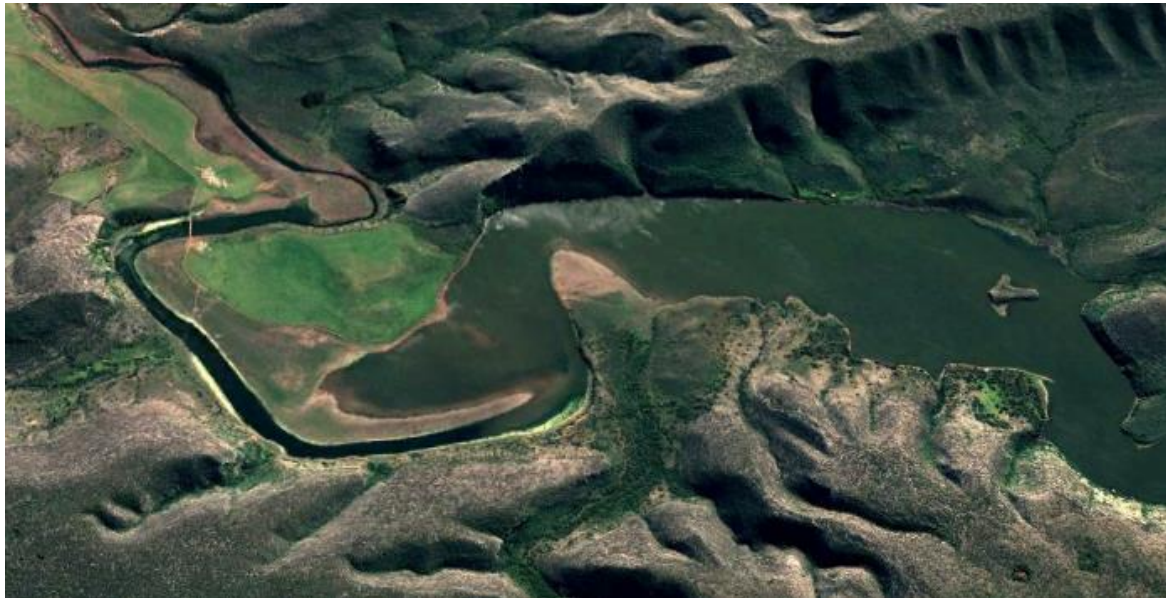
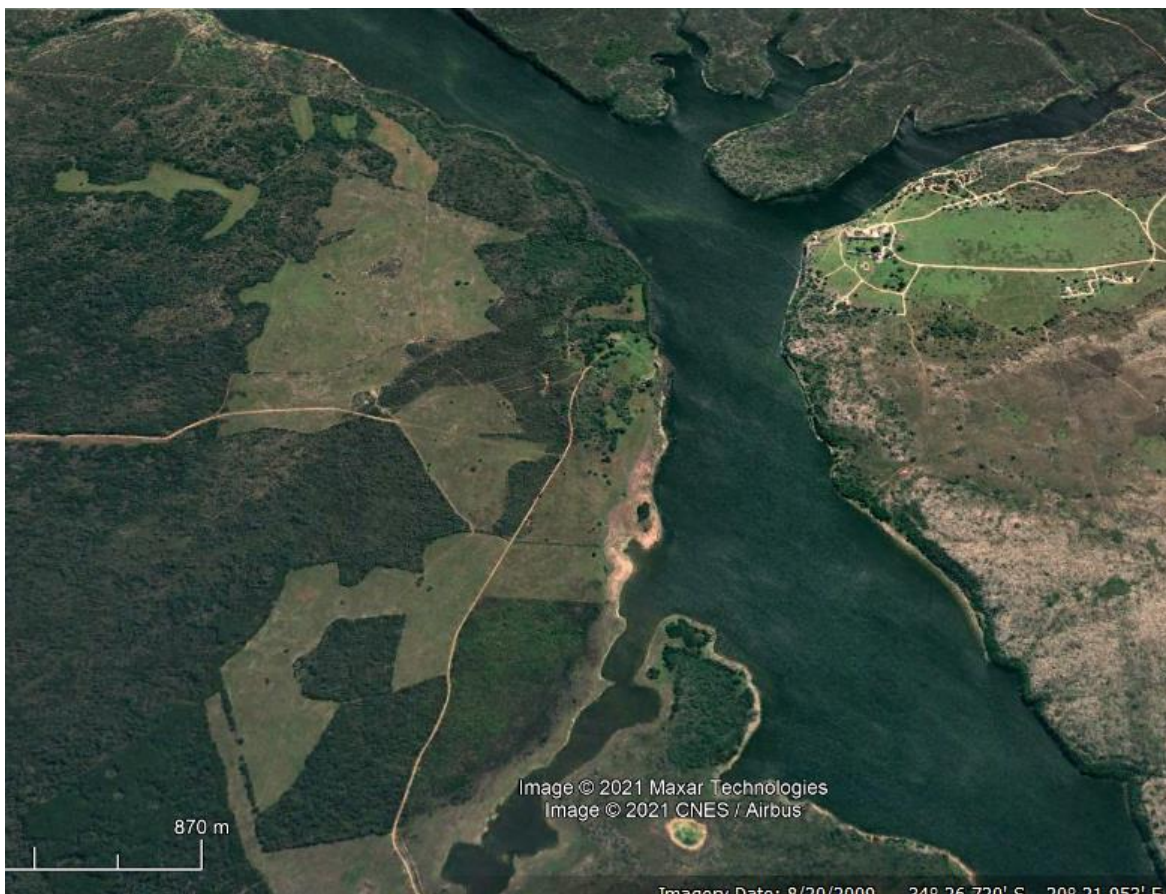
**Figure 2. Satellite images of the Salt River Gorge (top) and the middle section of the De Hoop Vlei Gorge (bottom) from August 2009, showing the extent of the flooded areas two years after the water level rise.**

The author has no written account, or ground photographs of the 2007 'flood', and there are no satellite images of the vlei from 2007 and 2008. Nevertheless, satellite images from 2009 show that the water level was very high (Figure 2).

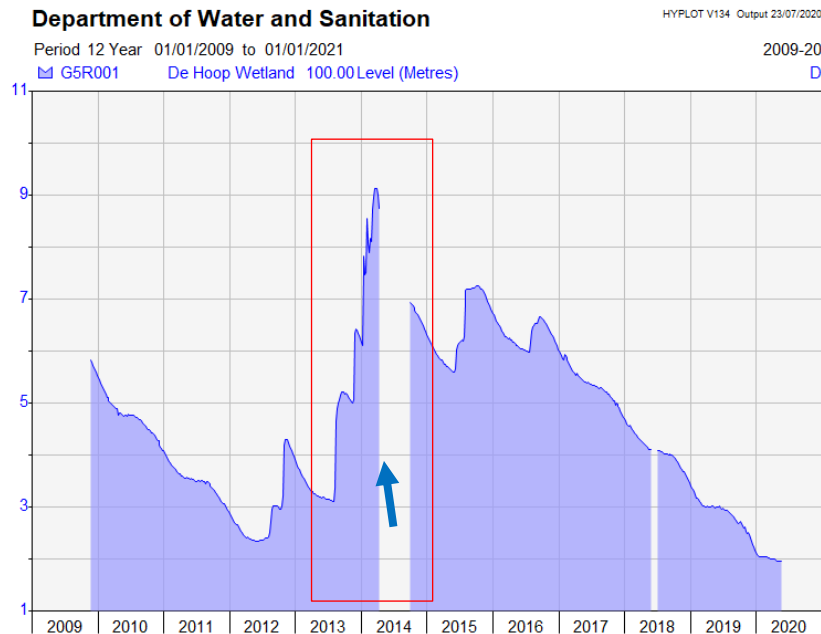
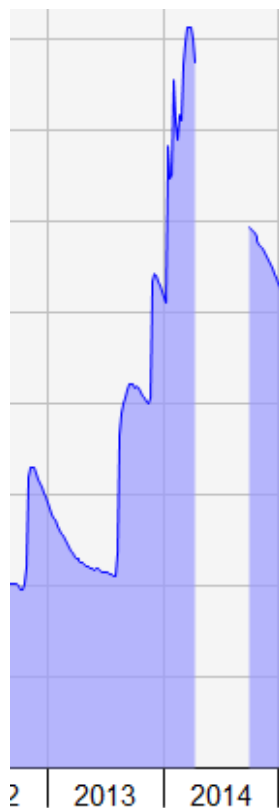
**Figure 3. De Hoop Vlei water levels from 2010 to 2020 (red box in the top graph is enlarged at the bottom) showing the 2014 high-water level (arrow). There is no record of the water level from April to September of that year.**

As with the 2007 high level, this high-water level may not 'deserve' the term *flood*. The water level rose gradually during 2013 and the first half of 2014 (Figure 3).

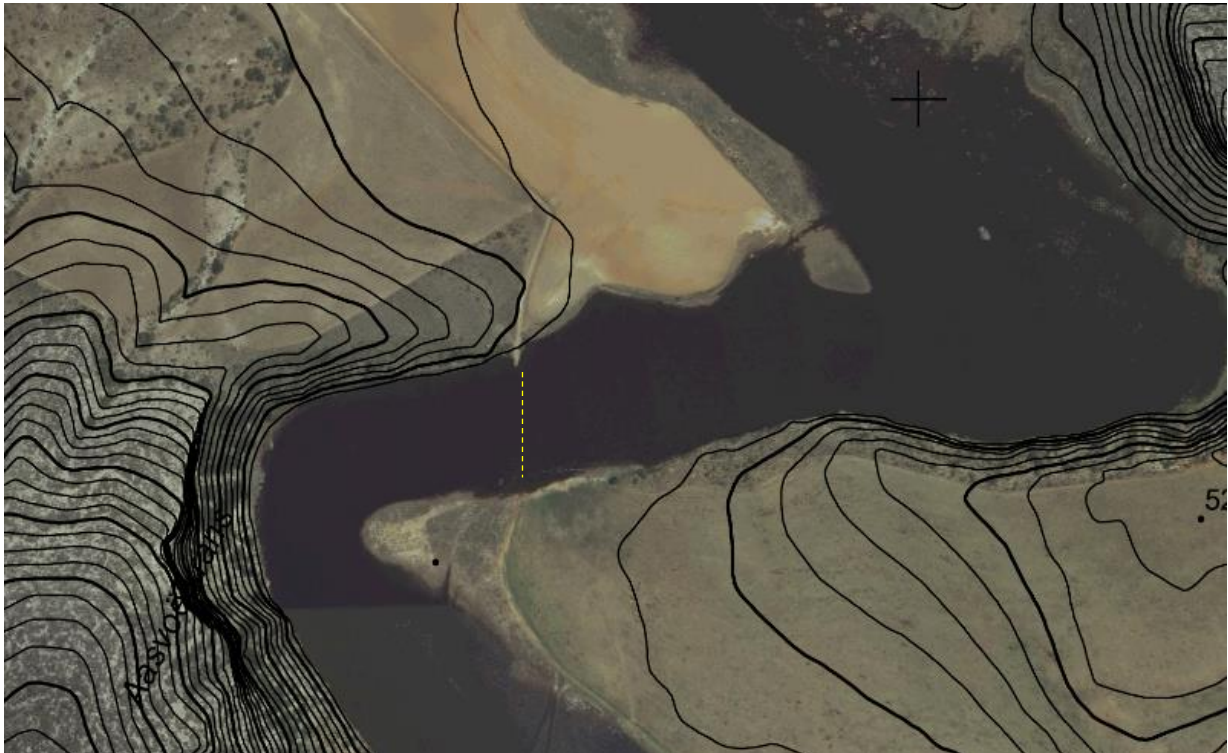
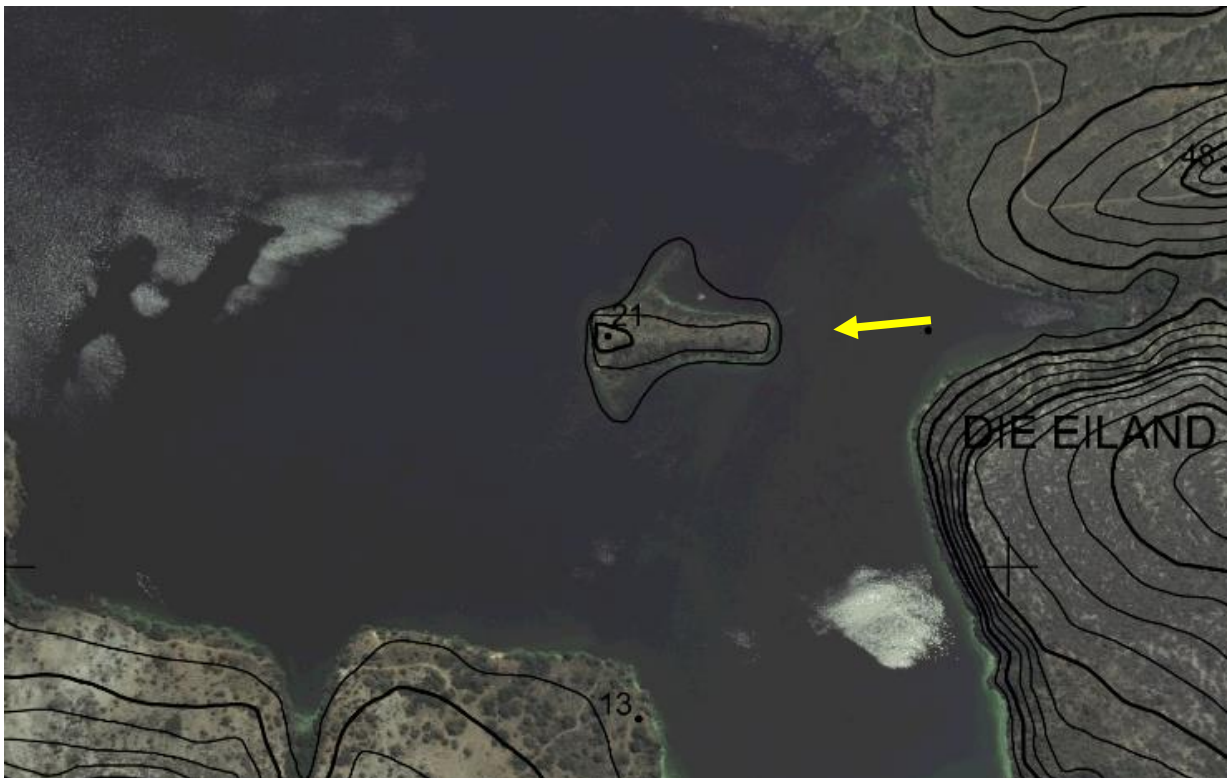
**Figure 4. Topography maps from 2014 of sections of the Salt River Gorge. Top: the concrete causeway (location is indicated by the dashed line) is submerged. Bottom: The Island (arrow) is surrounded by water.**

The author has no written account, or ground photographs of the 2014 'flood'. Nevertheless, satellite images and topography maps from 2014 show that the water level was very high (Figures 4, 5 and 6).

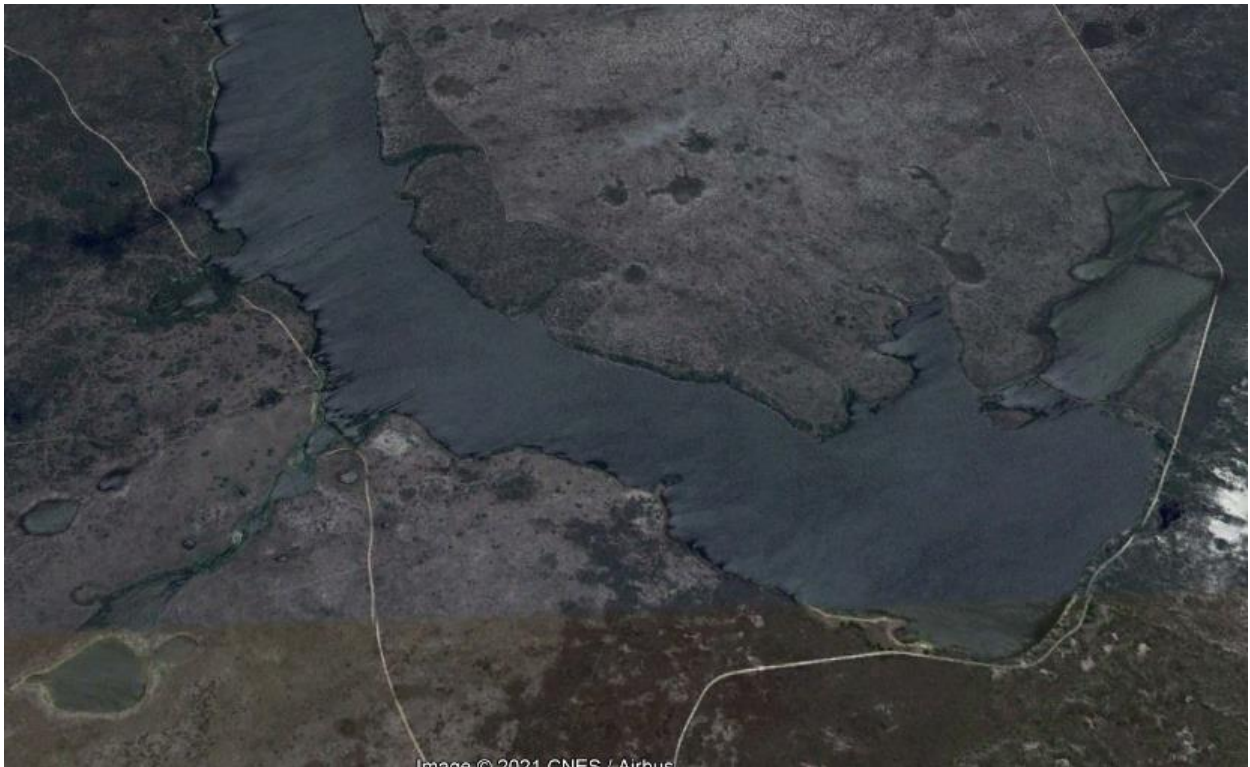
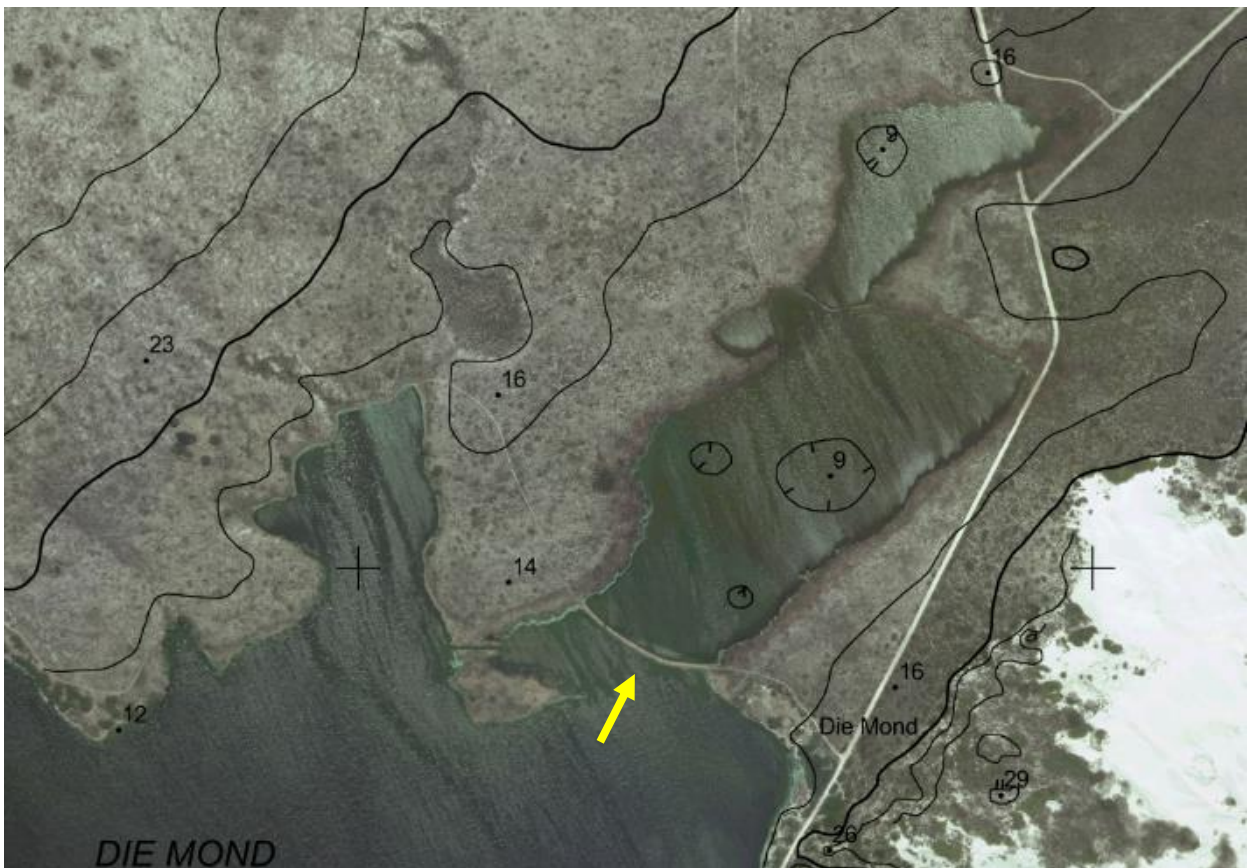
**Figure 5. Satellite image (top) and topography map (bottom) from 2014 of Die Mond, showing the extent of the flooded areas. The satellite image upon which the map was compiled (bottom) was obtained after the one at the top, as the dyke (arrow) is exposed.**

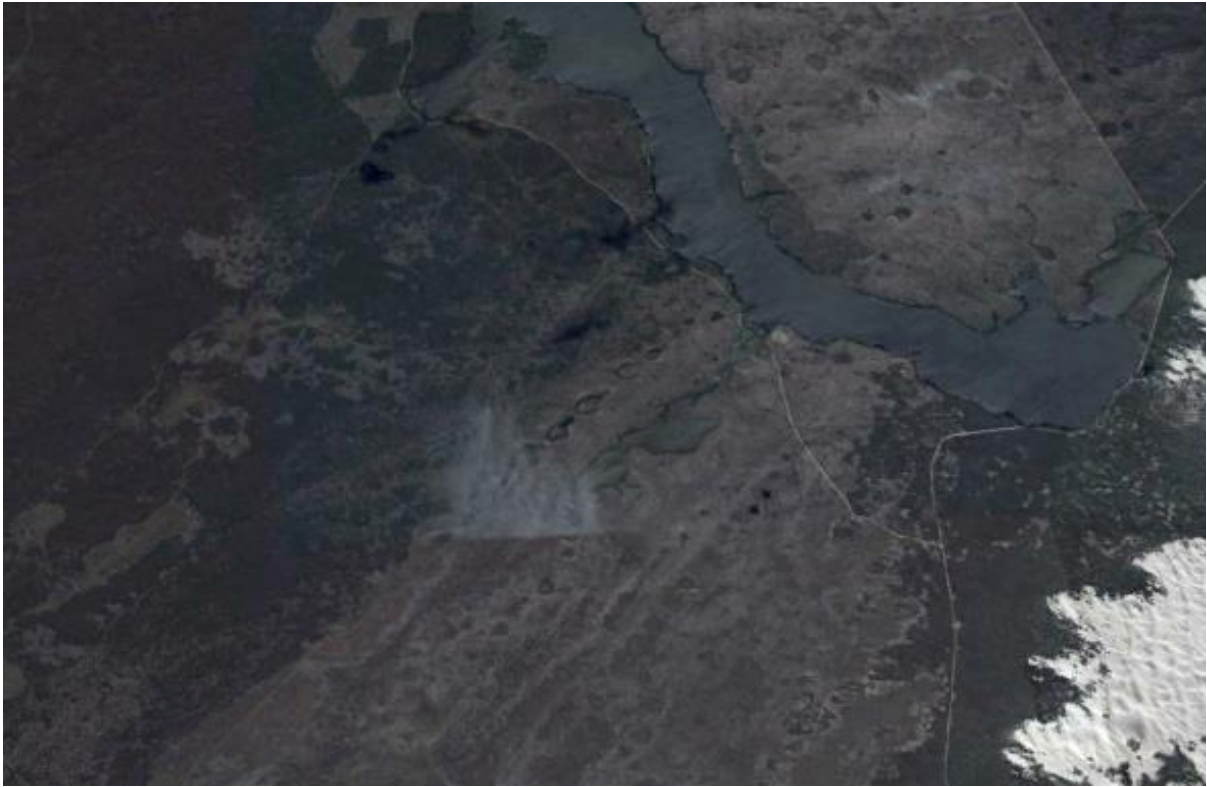
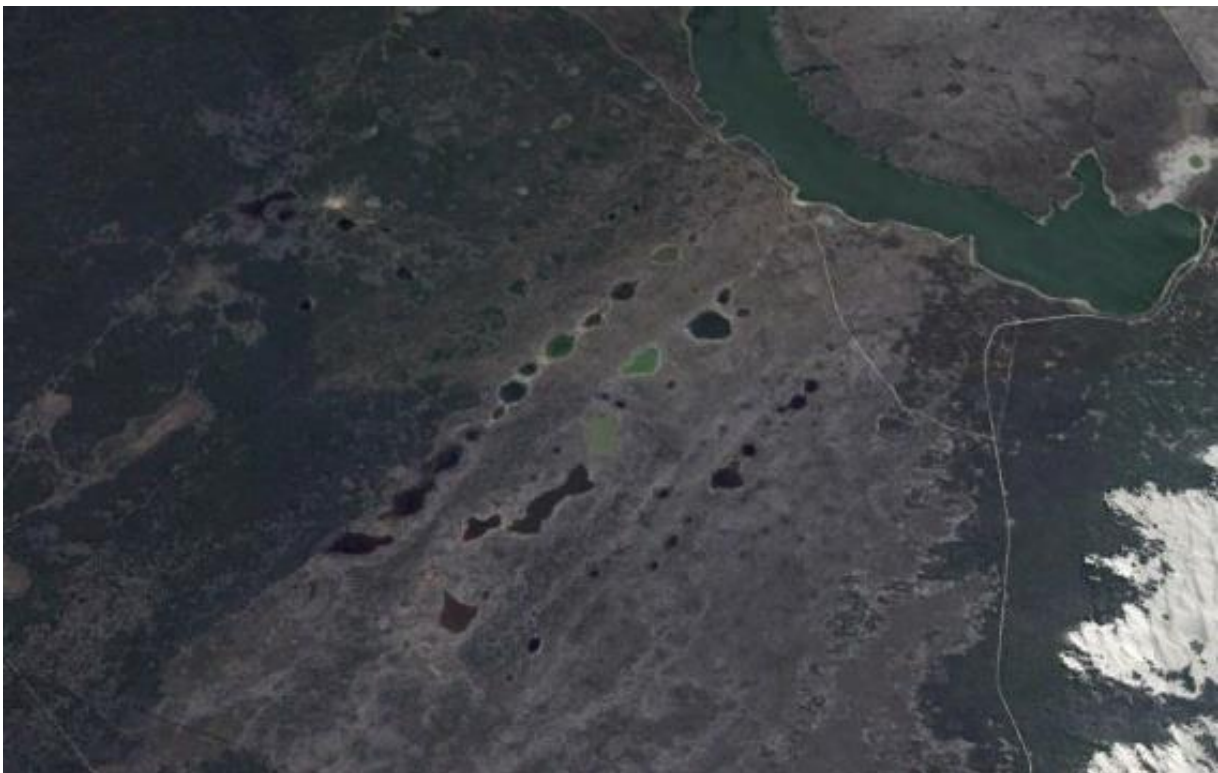
**Figure 6. Satellite images of the area SW of Die Mond, showing the extent of the 2014 high-water level (top) and the dolines, which still contained water in 2016 (bottom). Large spans of this area were inundated by the 1957 flash flood.**
