N. DE HOOP VLEI GORGE

Field Note N8f. Hydrology – Fountains

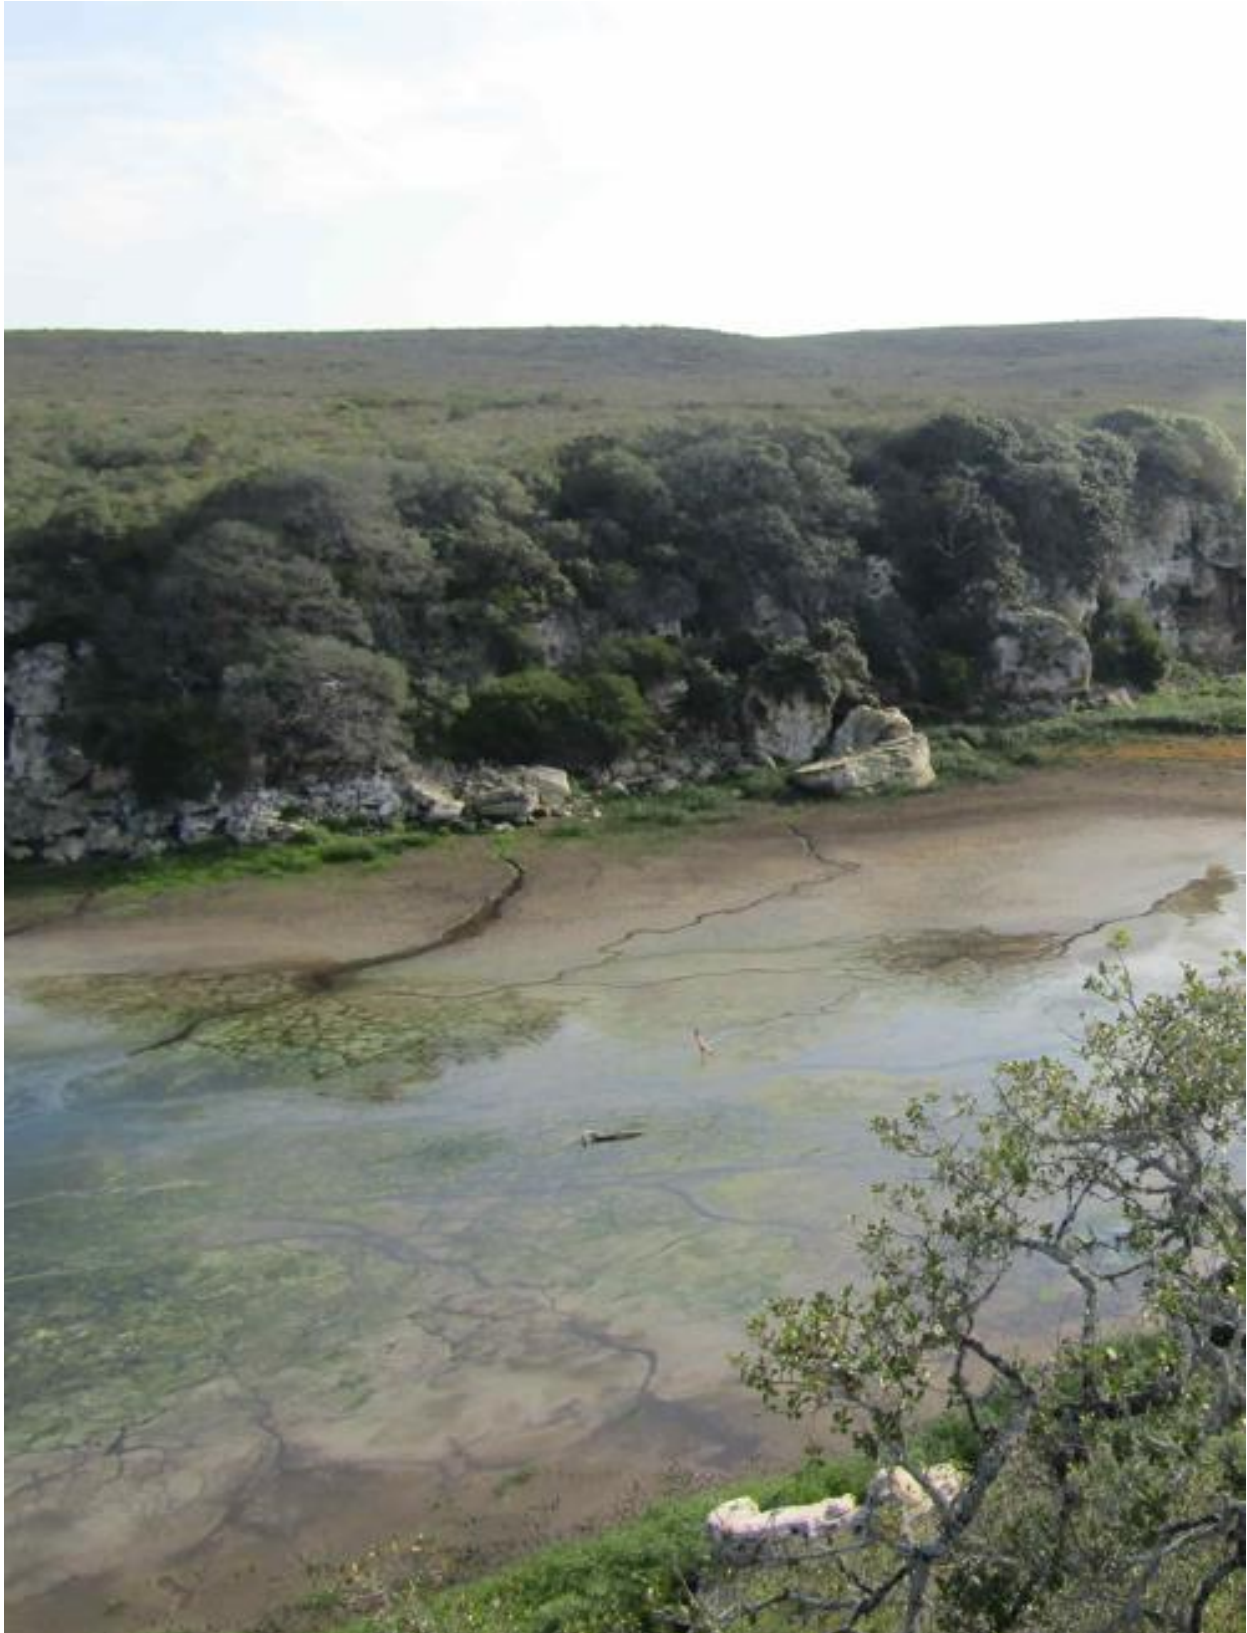
Fountains flowing into the De Hoop Vlei.

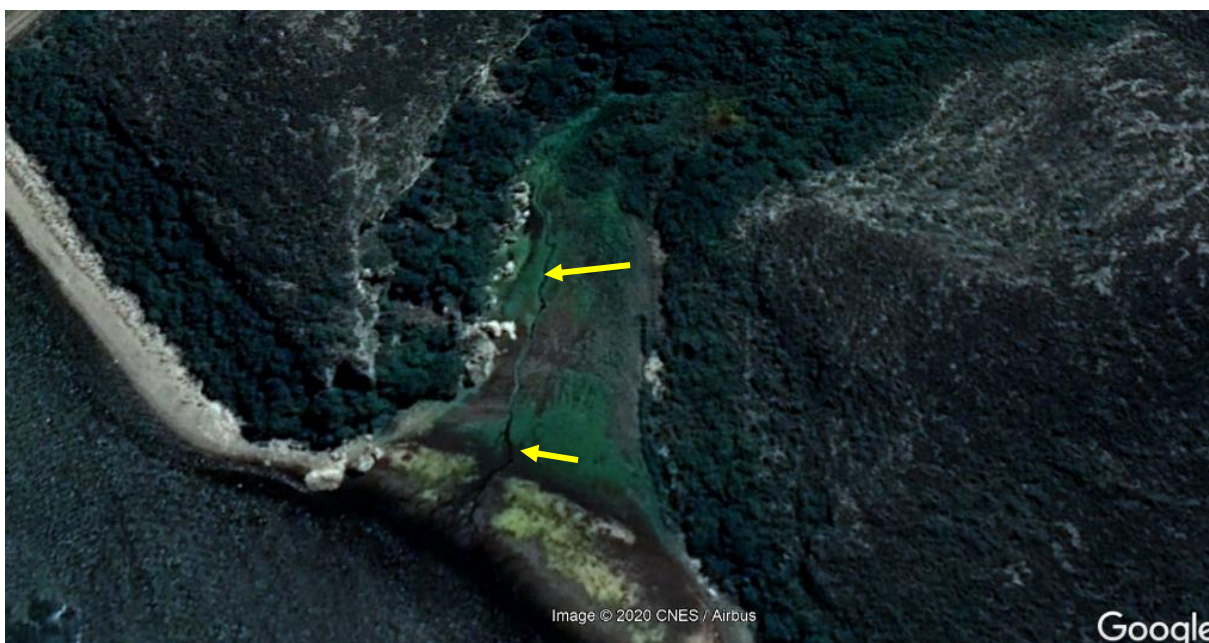
Figure 1. Satellite image of fountain water flowing into the vlei (arrows).

When the vlei level is low, the fountains can be discerned from the satellite images (Figures 1 to 3).

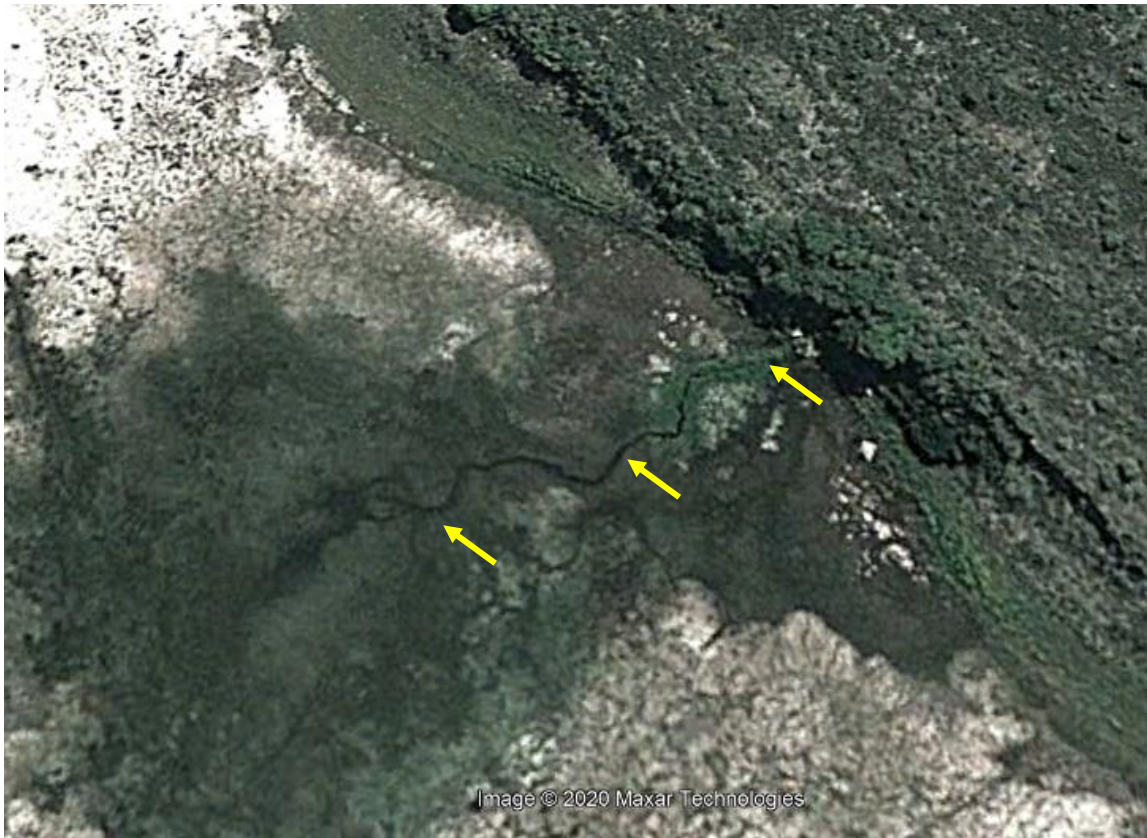
Figure 2. Satellite image of fountain water flowing into the vlei (arrows).

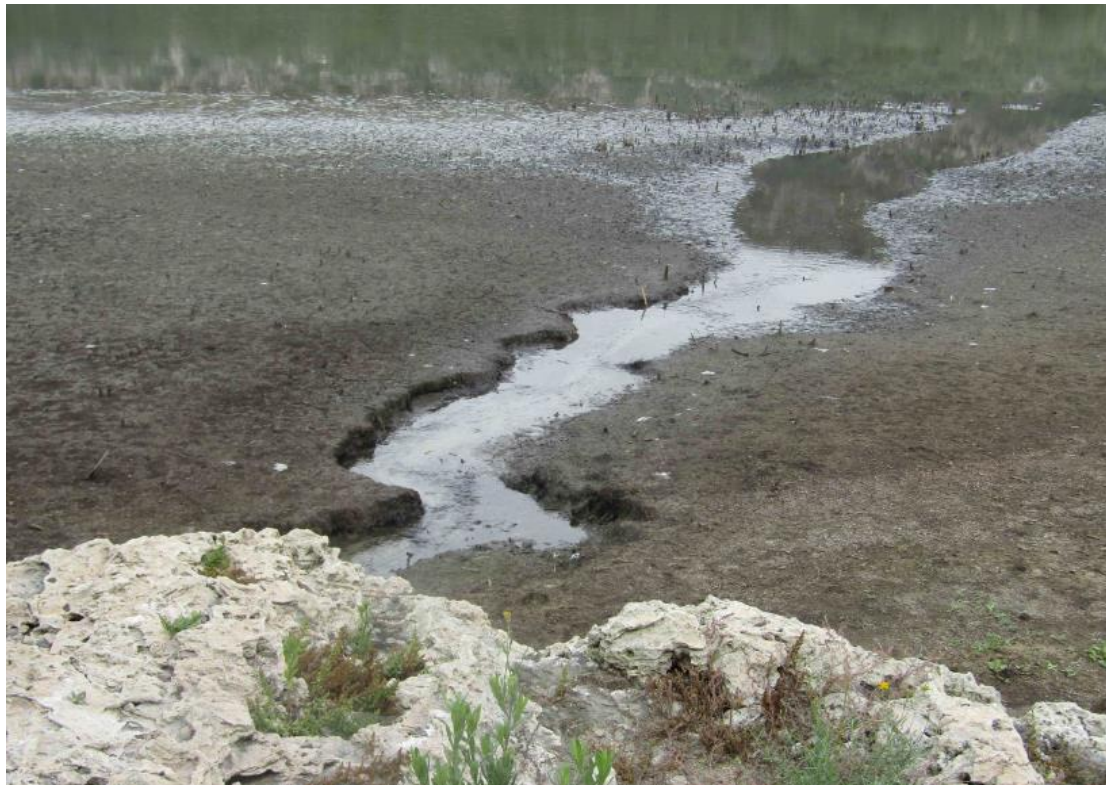
Figure 3. Fountain water flows into the vlei.

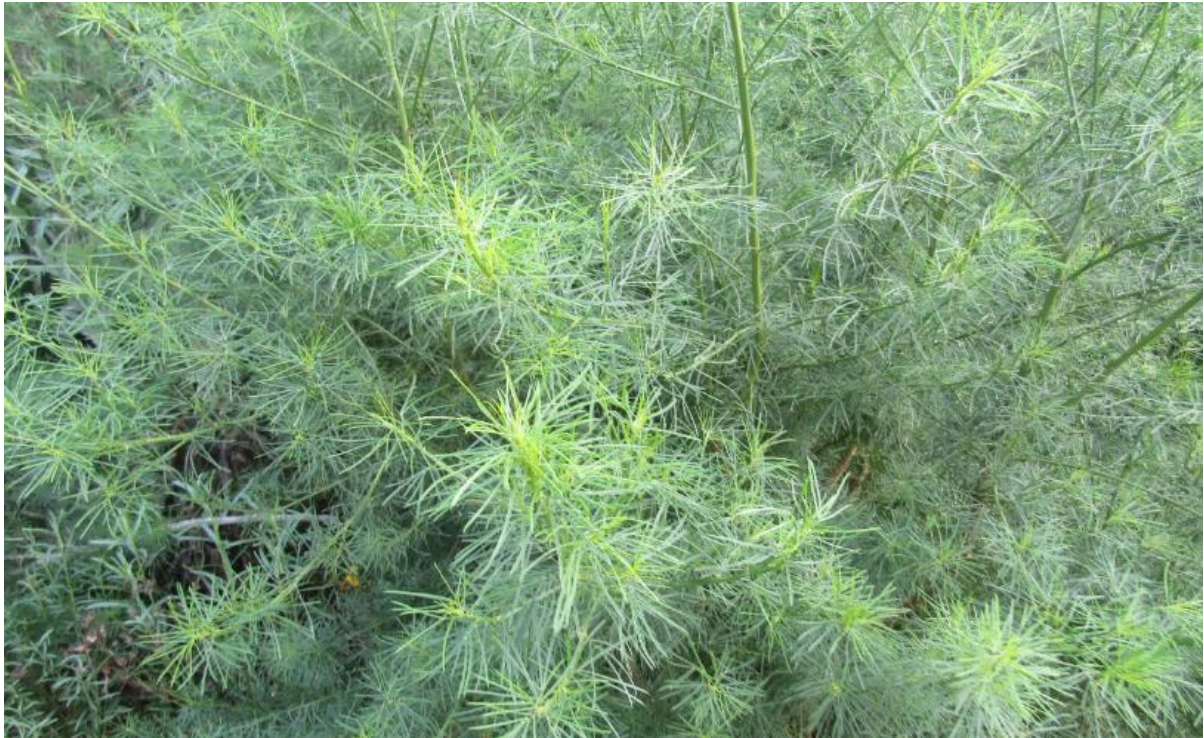
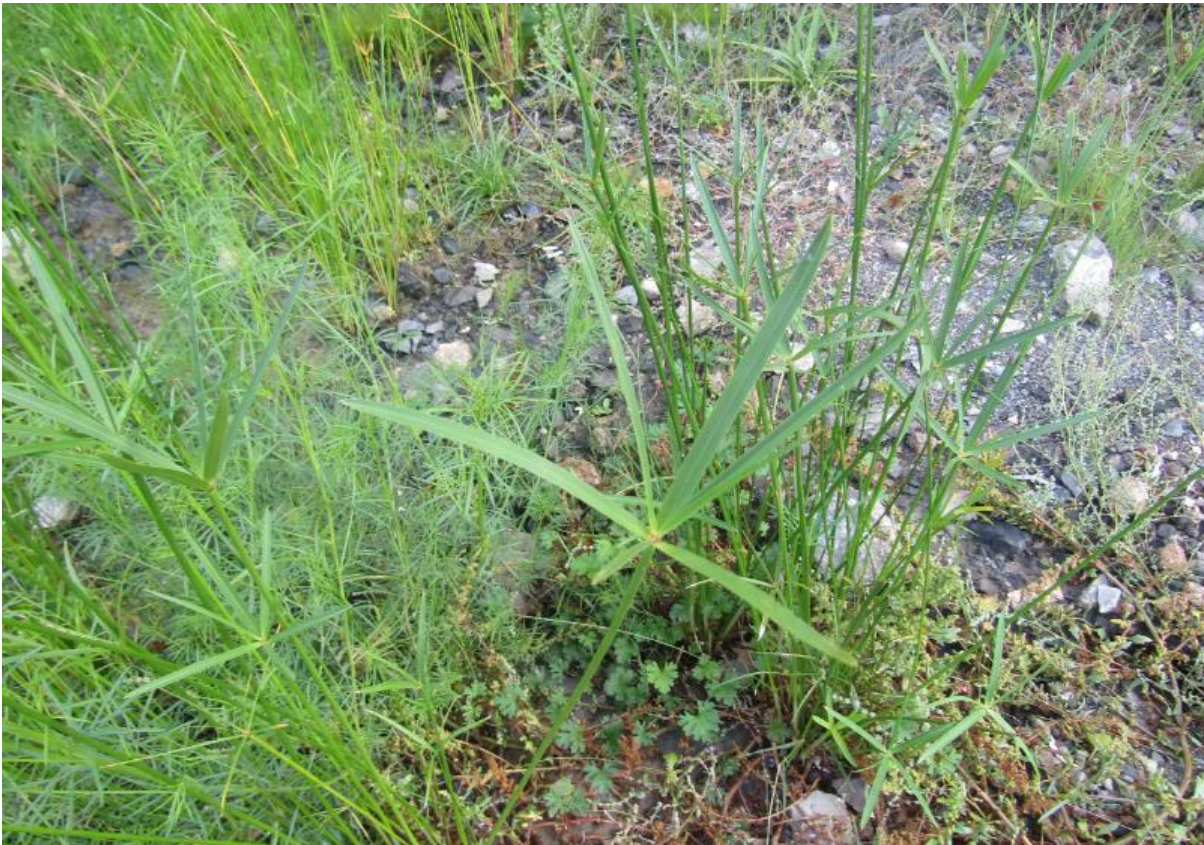
Figure 4. Top and bottom: typical vegetation around De Hoop Vlei Gorge fountains.

The vegetation around the fountains is different from the vegetation in the surrounding area (Figure 4).

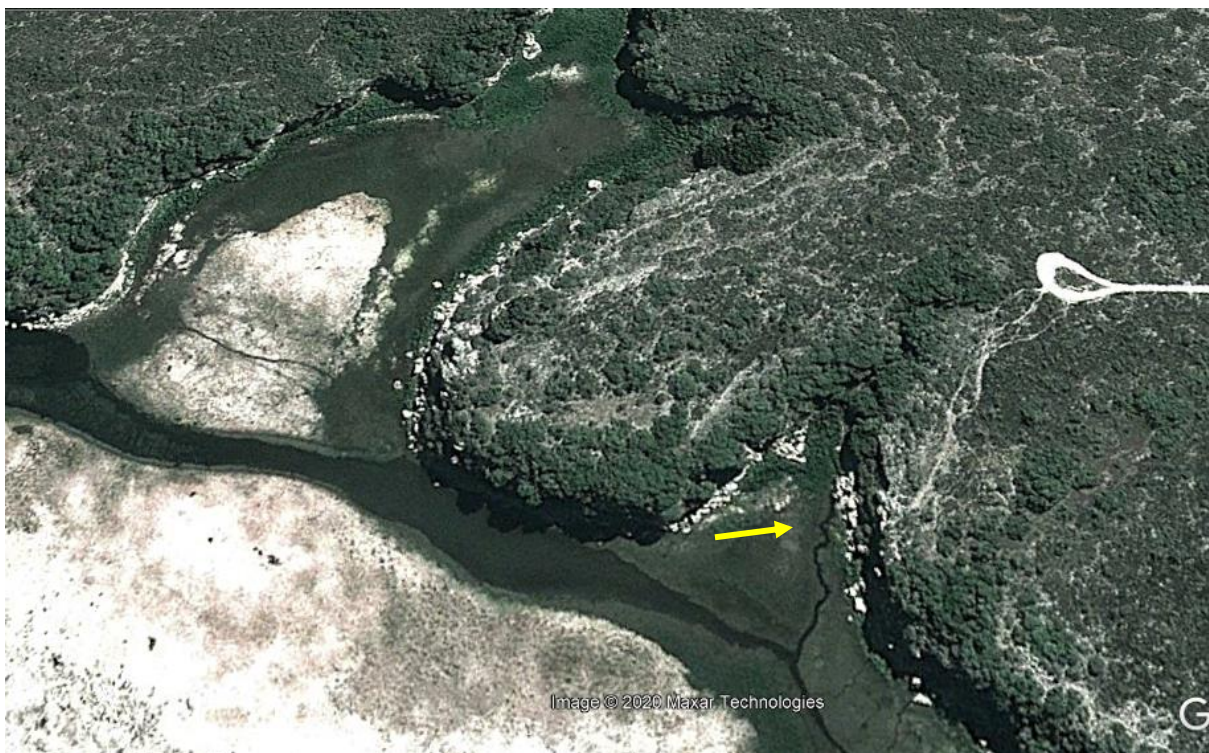
Figure 6. Satellite images showing the Tierhoek Coves. Arrow points to the fountain in the South Tierhoek Cove. [The white patches are dry, dead algal mats].

The fountains in the Tierhoek Coves (name given by the author) appear to yield not a little water (Figures 5 to 9).

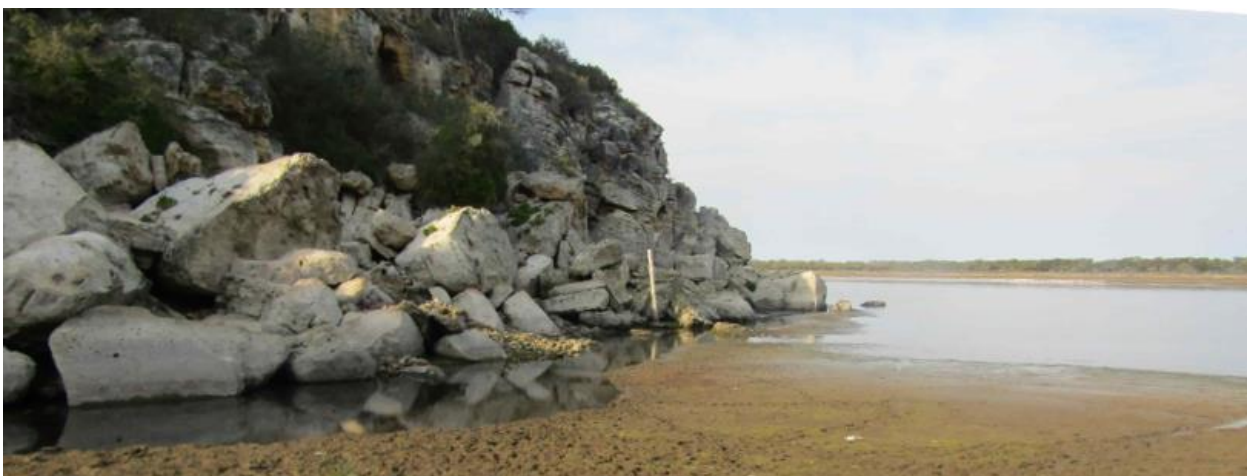
Figure 9. The South Tierhoek Cove fountain water flows into the vlei. View to the SW.

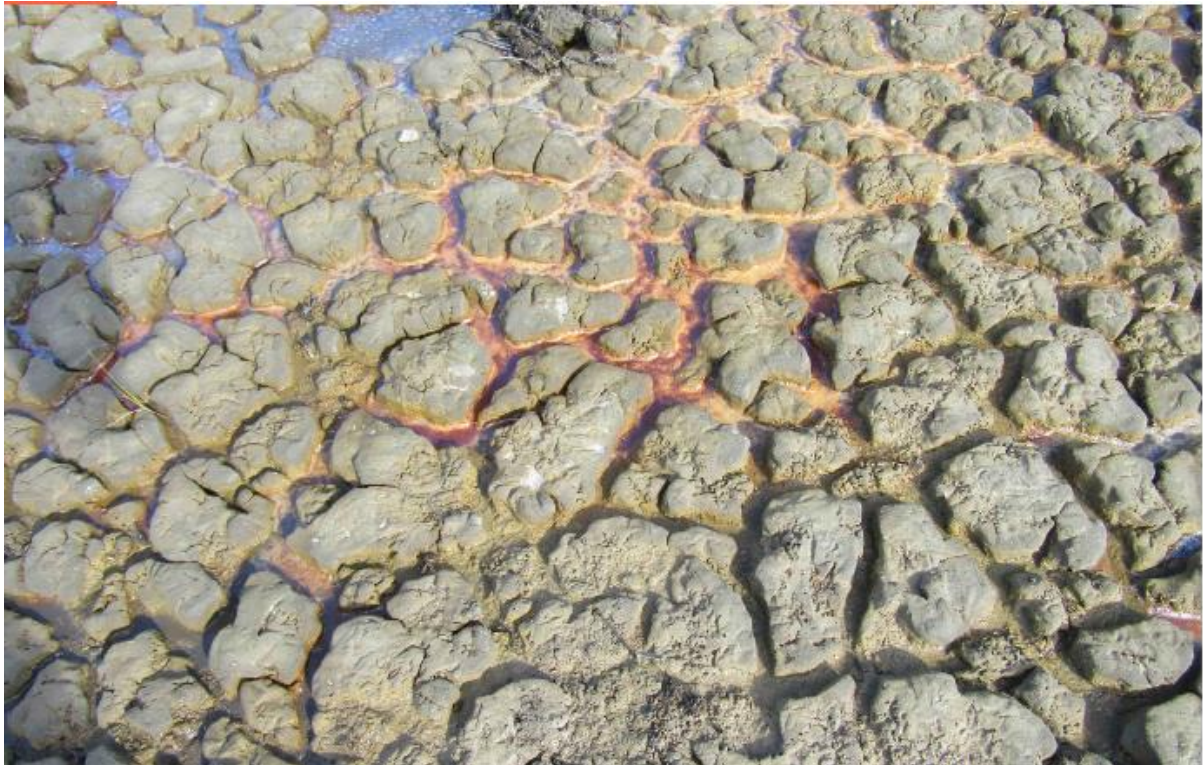
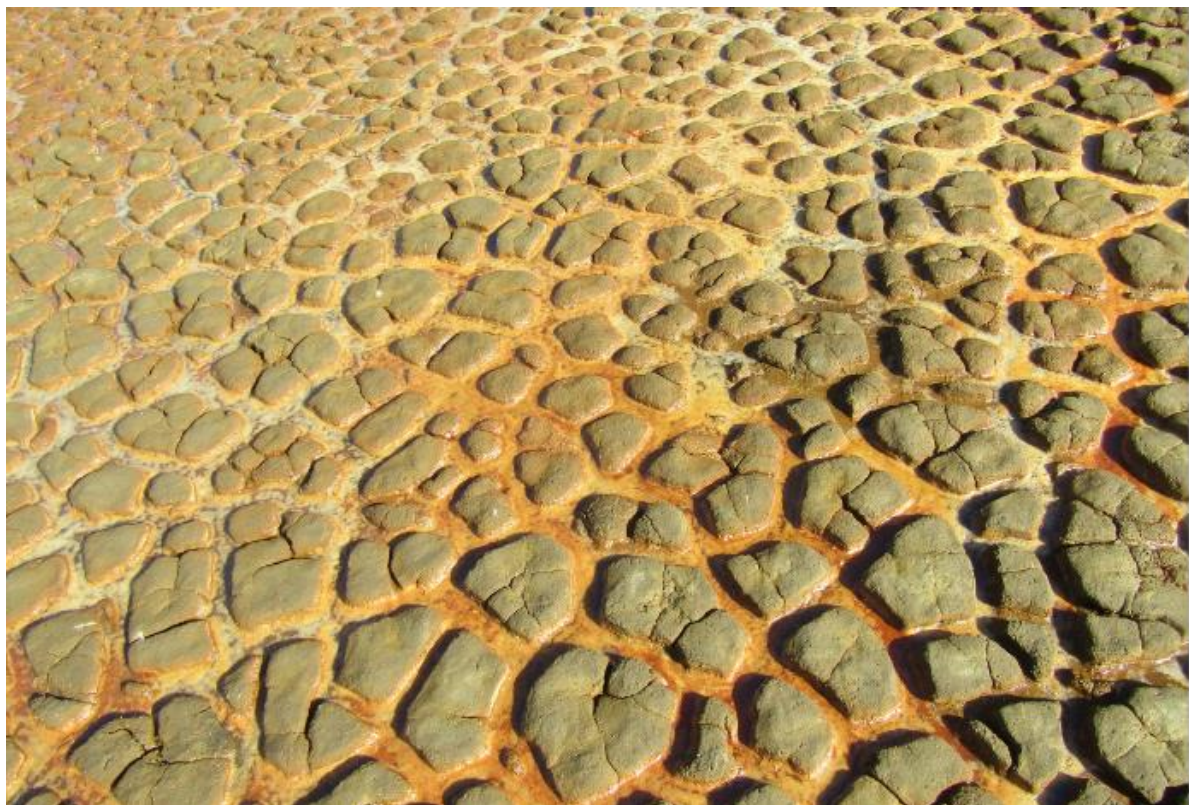
Figure 10. Reddish water between the mud cracks of the bottom of the vlei.

In places the water on the drying bottom of the vlei is reddish (Figure 10).
