N. DE HOOP VLEI GORGE

Field Note N9a. Archaeology – Dams and canals

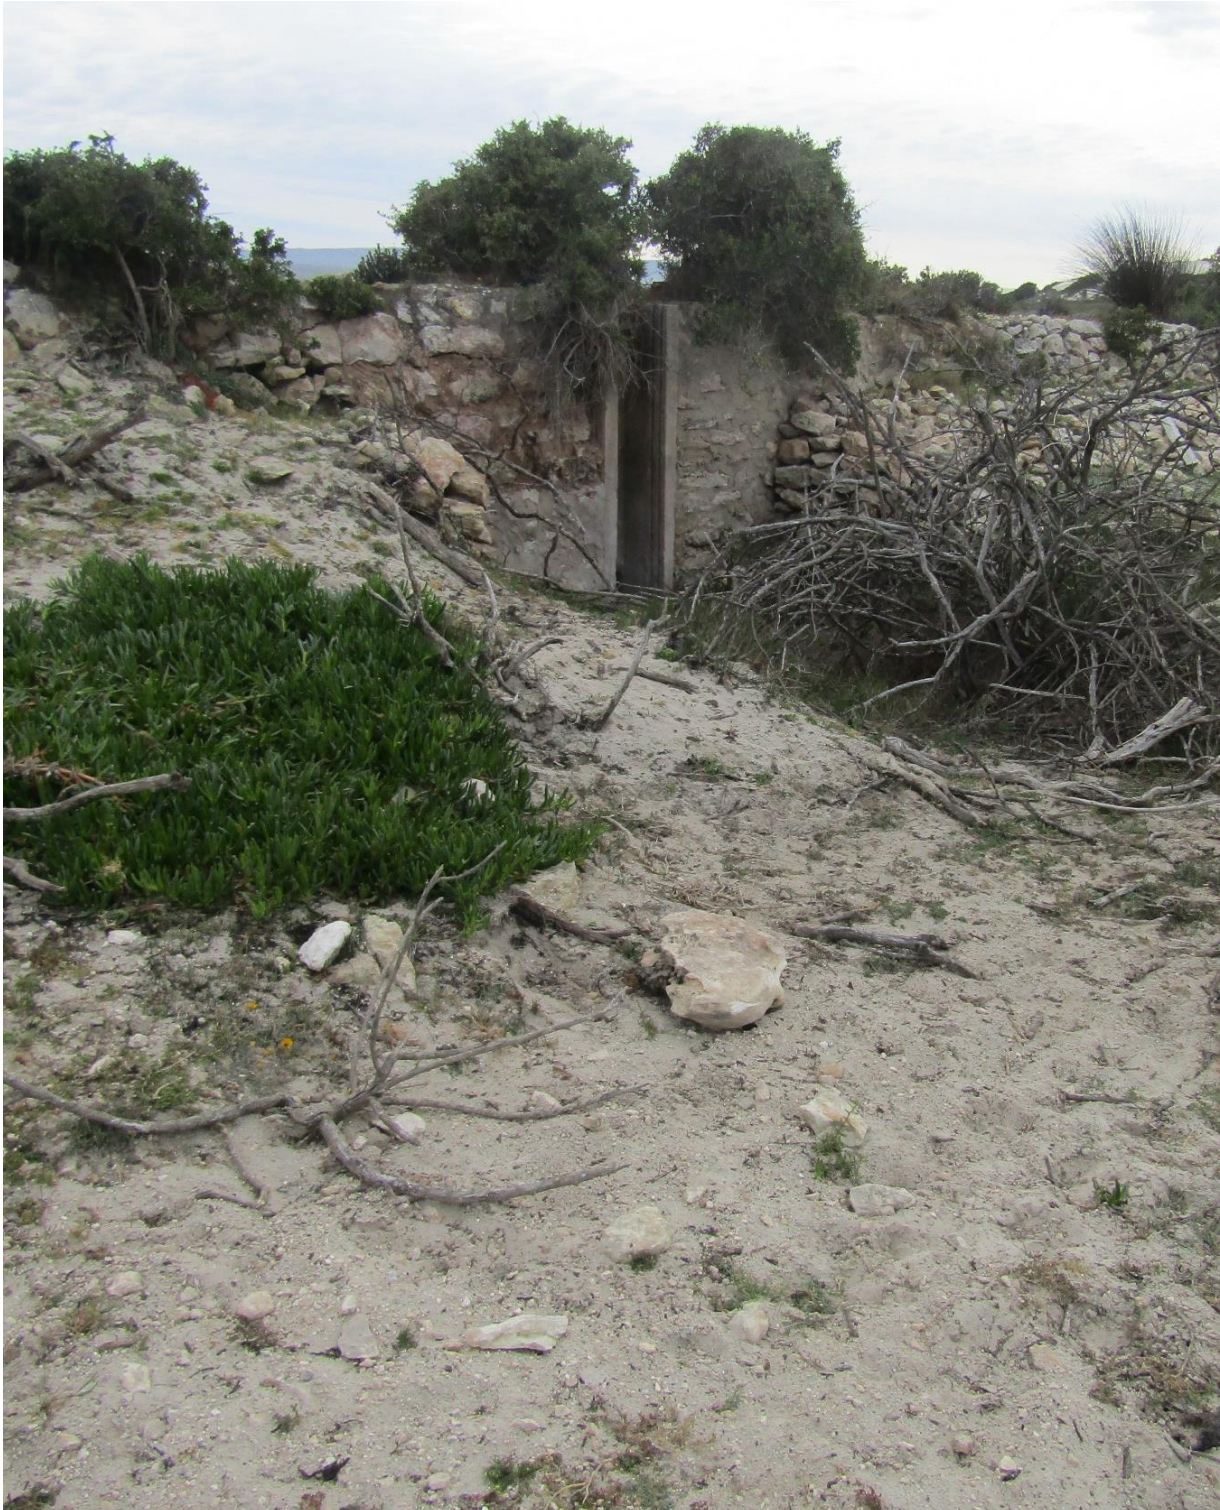
The gate in the dam wall in Die Mond.

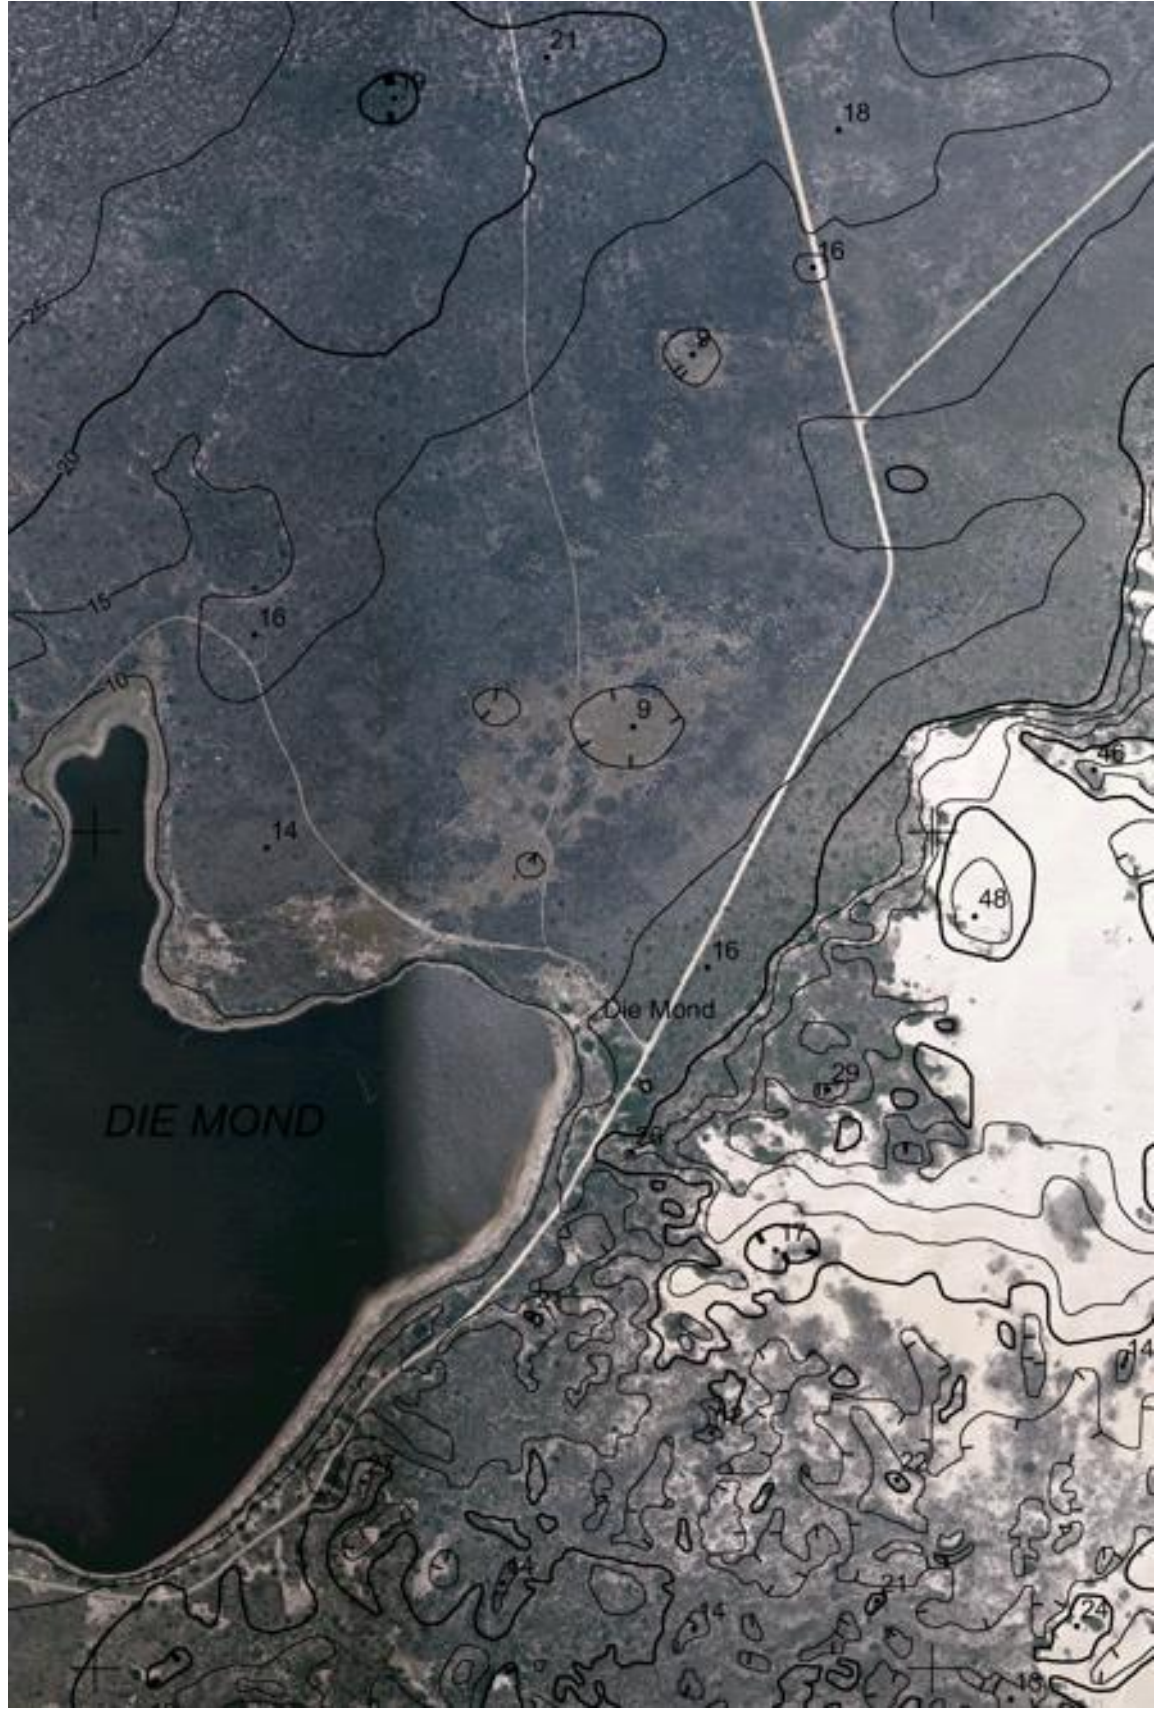
Figure 2. Topography map (1:10,000) of the Die Mond Depression.

The topography of the Die Mond Depression is shown in Figure 2.

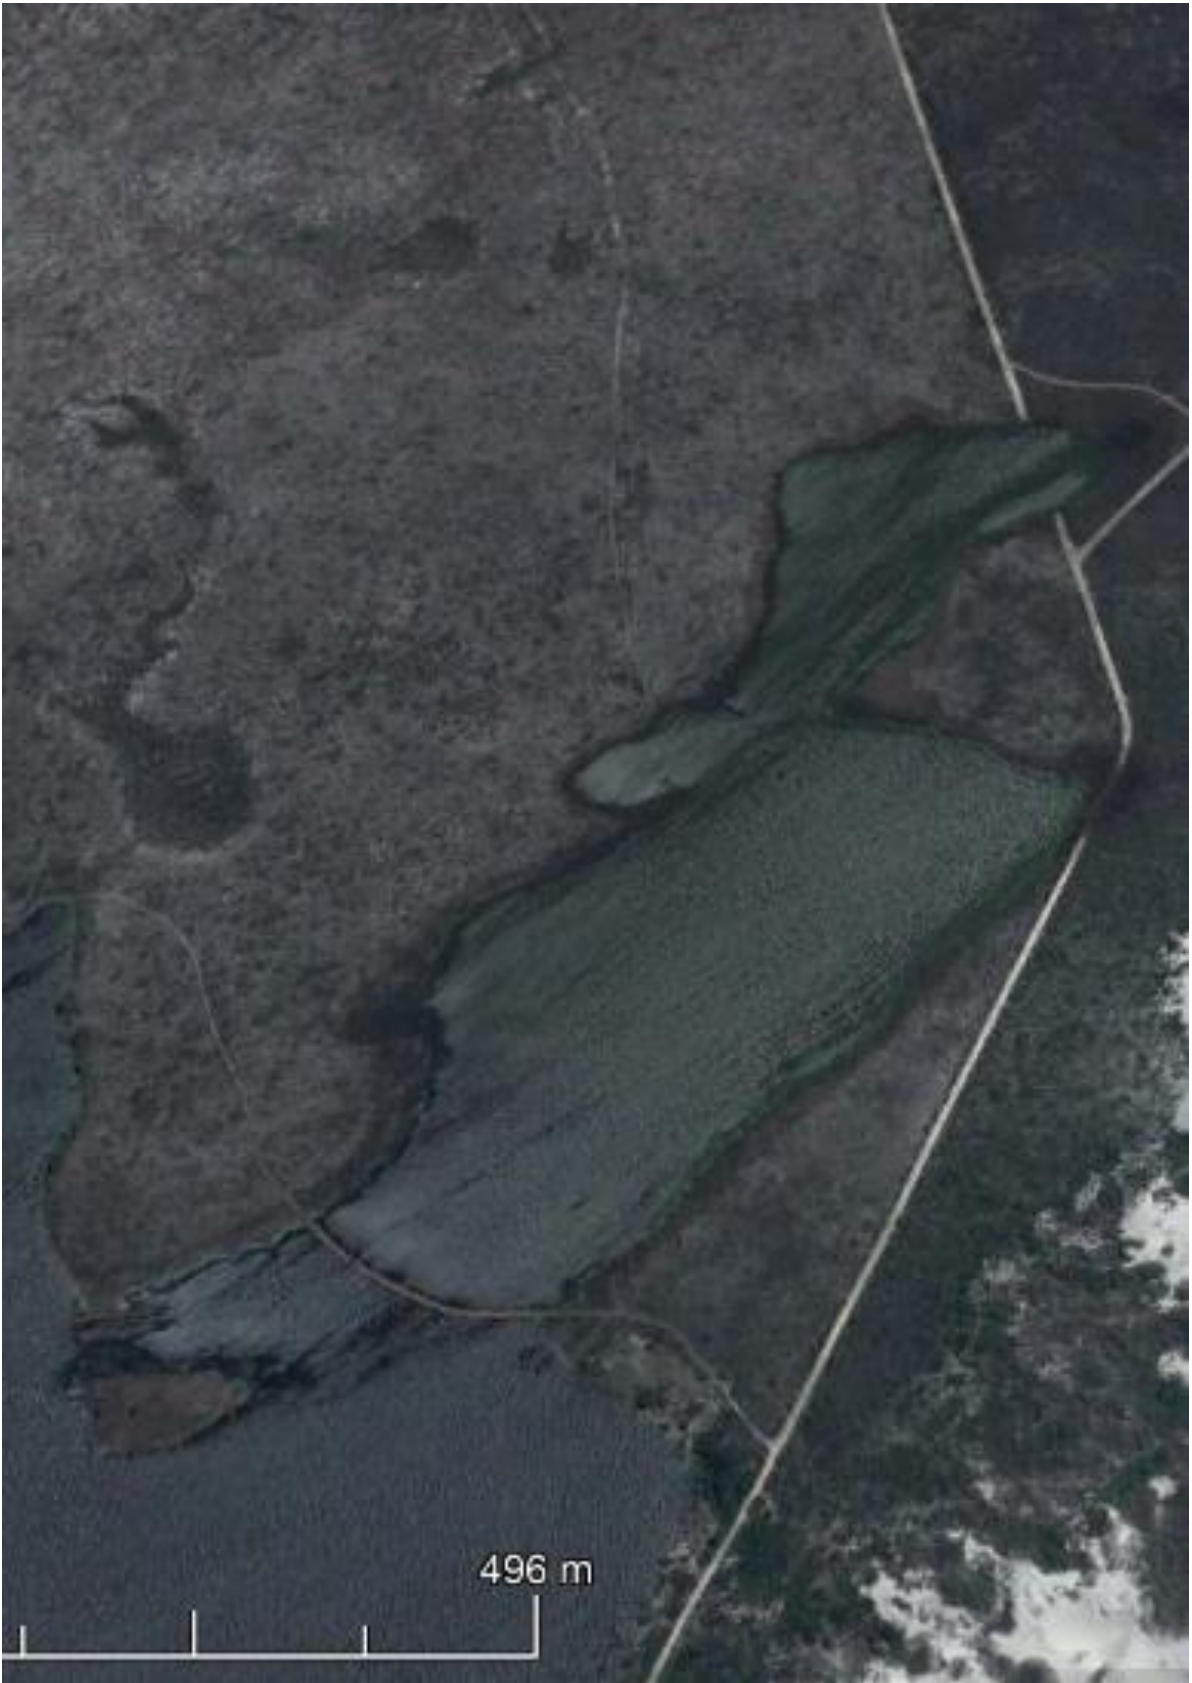
Figure 3. Satellite image of the Die Mond Depression after the 2014 flood.

Upon the water level in the vlei, the Die Mond Depression is at times full and at times dry (Figures 3 to 5).

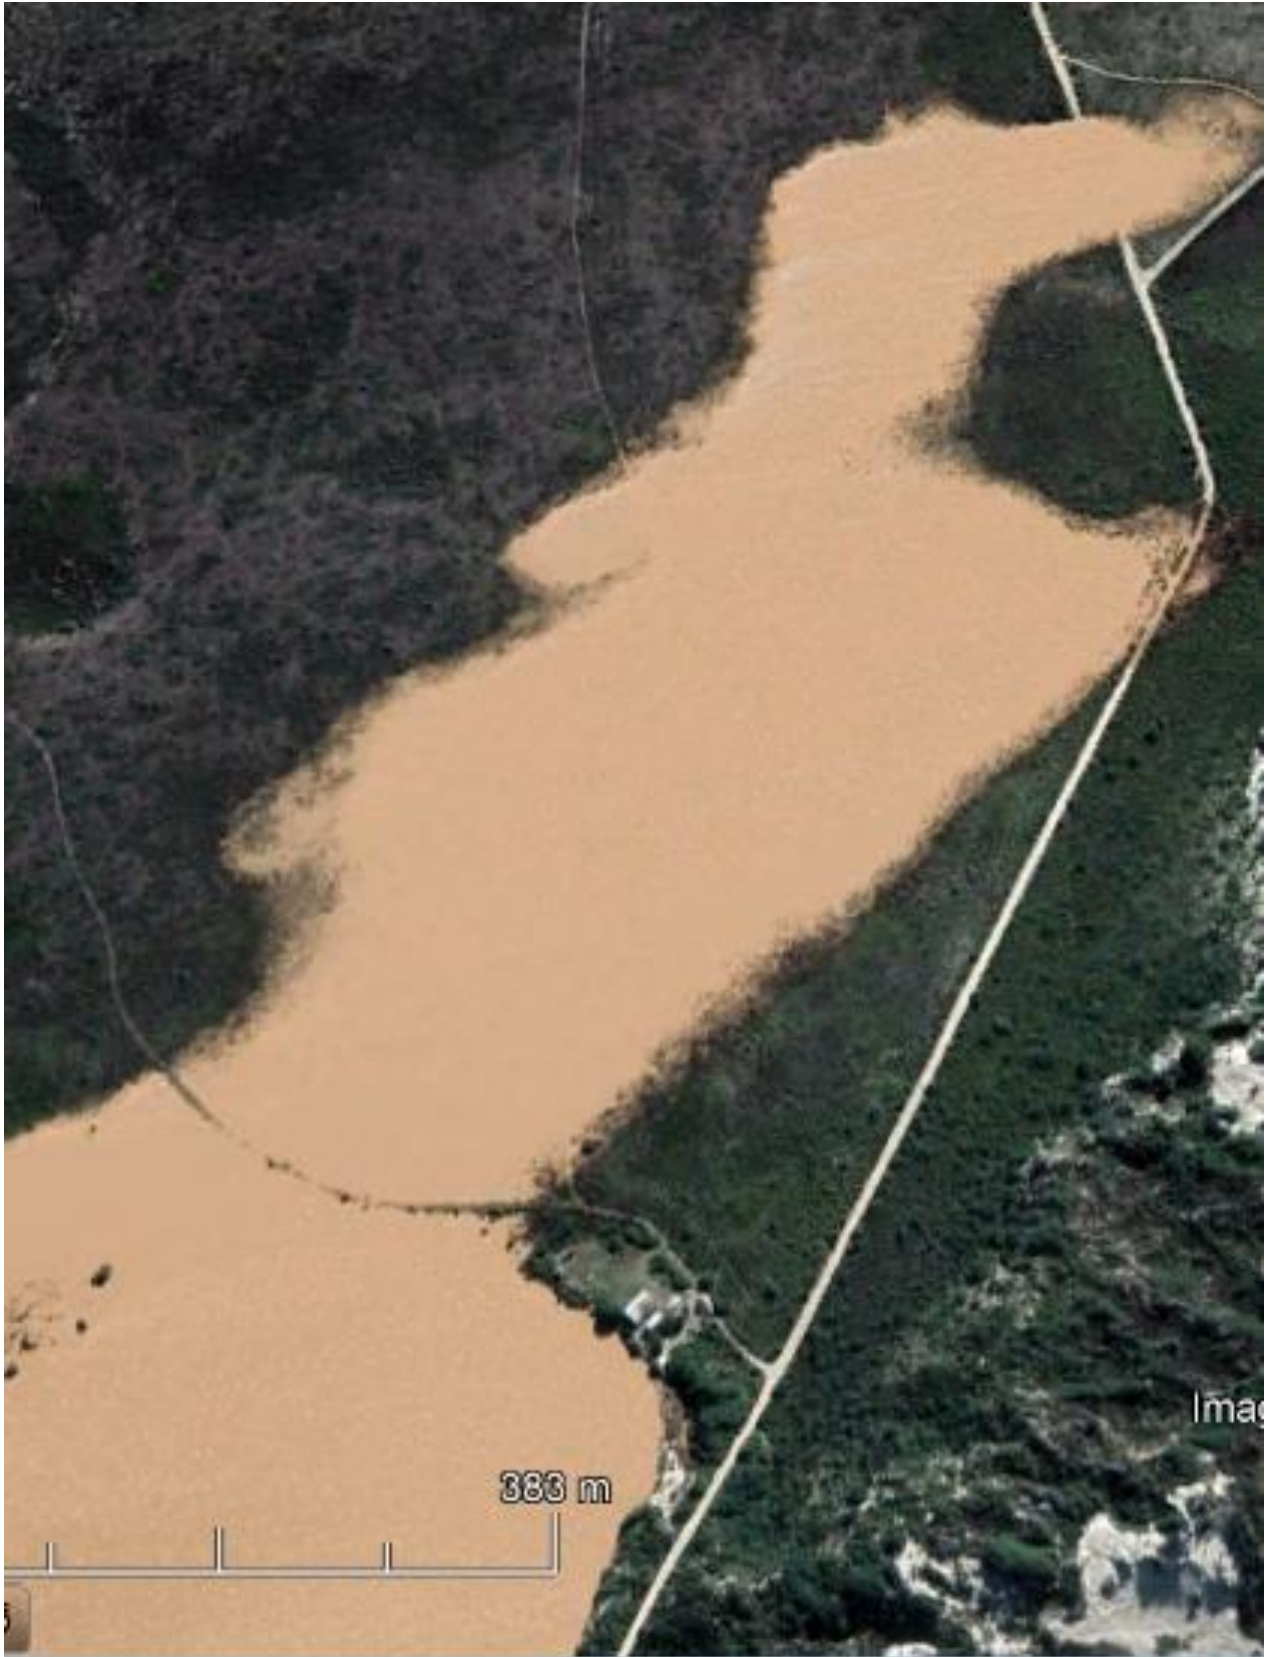
Figure 4. Satellite image of the Die Mond Depression after the May 2021 flood.

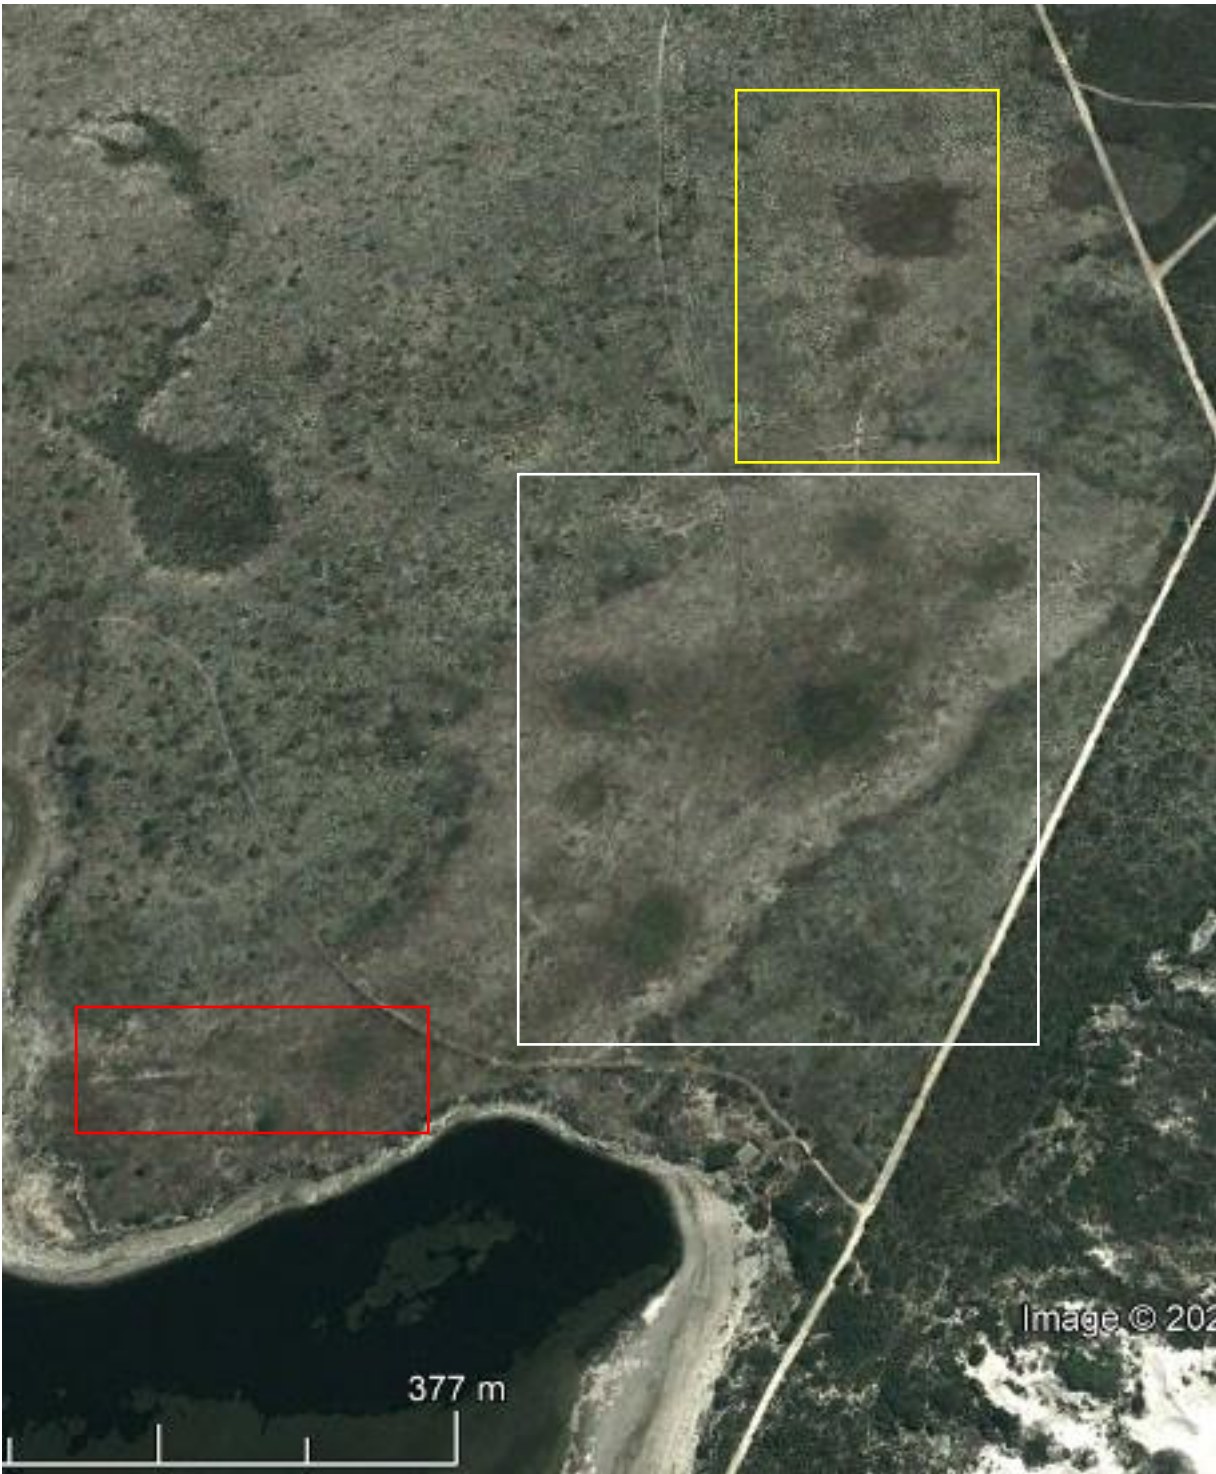
Figure 5. Satellite image of the Die Mond Depression when it is dry. Colour of boxes indicate: red – front doline; white – middle dolines; yellow – back dolines.

Dolines of the dam system in the Die Mond Depression are indicated in Figure 5.

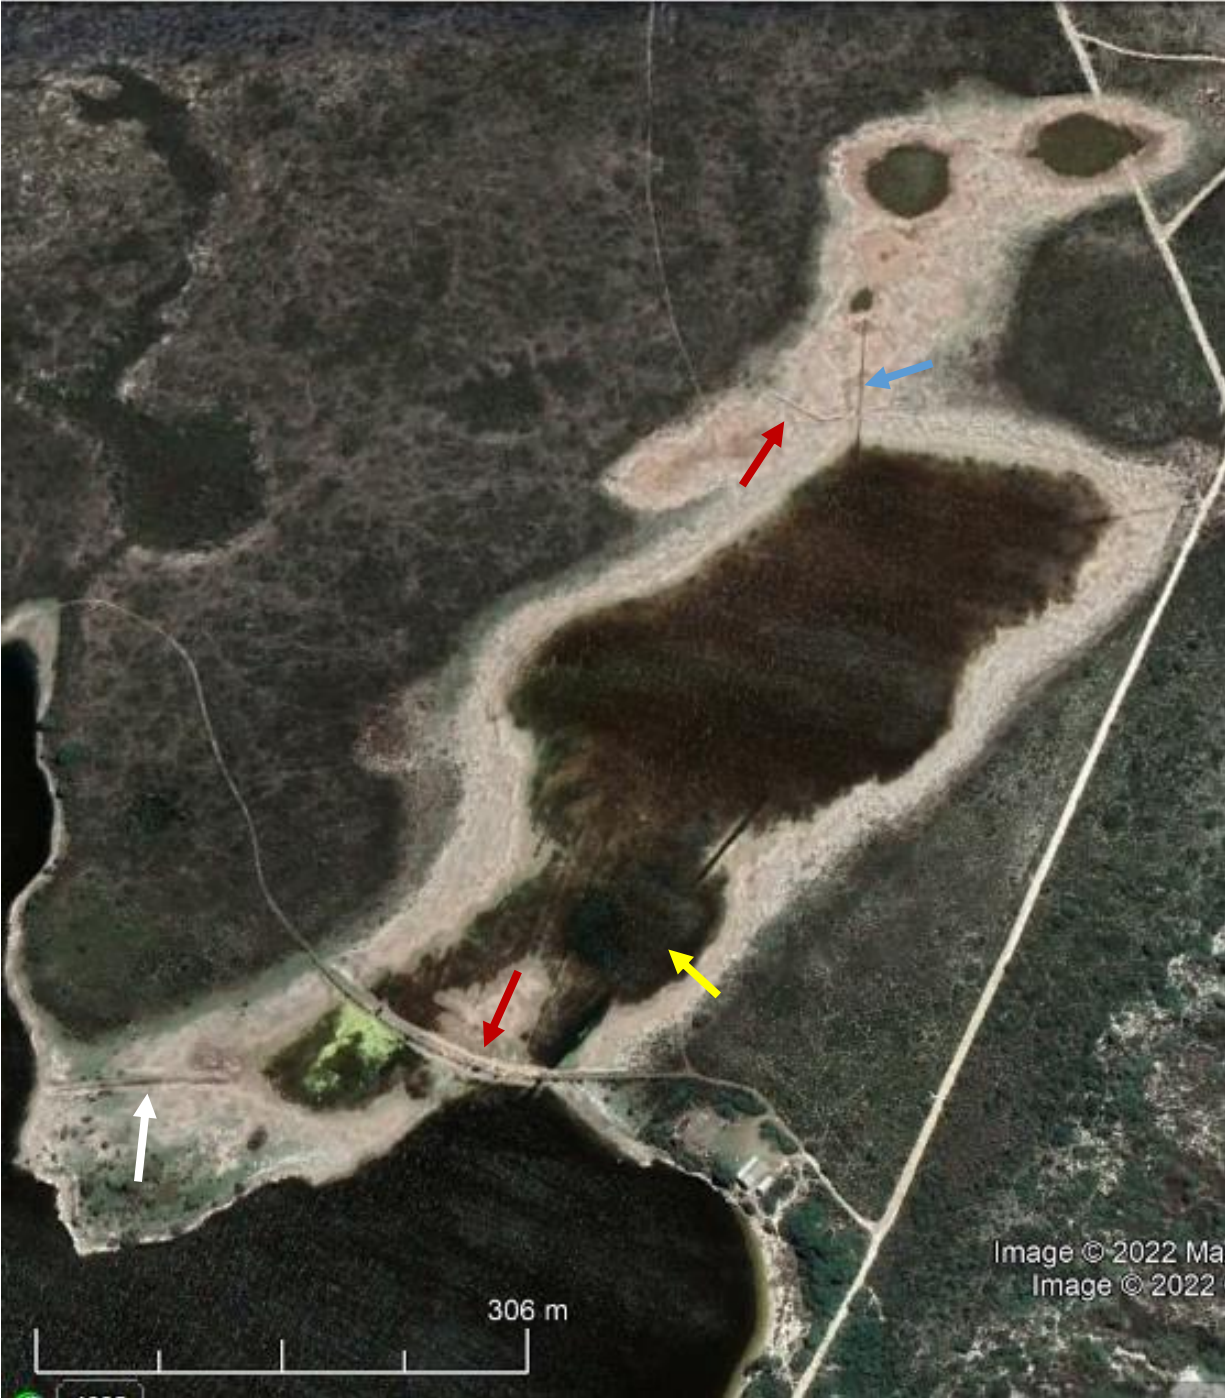
Figure 6. Satellite image of the features of the dam system in the Die Mond Depression. Arrows point to: white – front canal; yellow – middle canal; blue – back canal; red - dyke.

The canals and dykes of the dam system are shown in Figure 6.

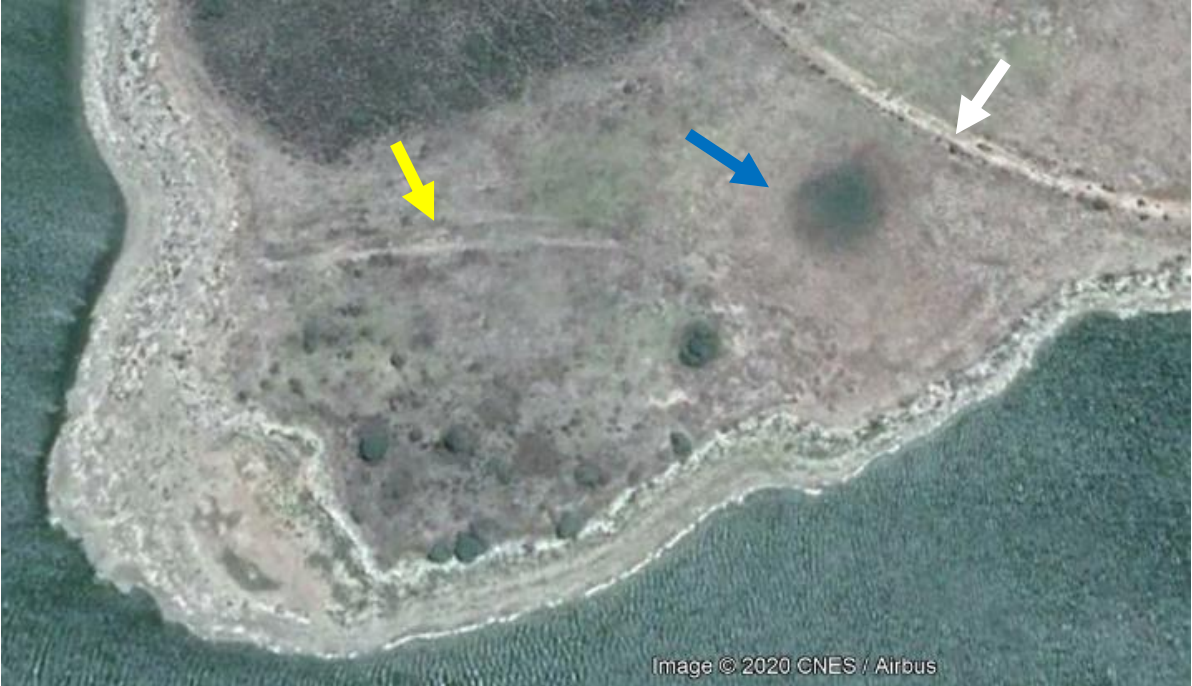
Figure 7. Enlargement of the red box in Figure 6. Yellow arrow points to the front canal, which delivered water to the front doline (blue arrow). White arrow points to the dyke.

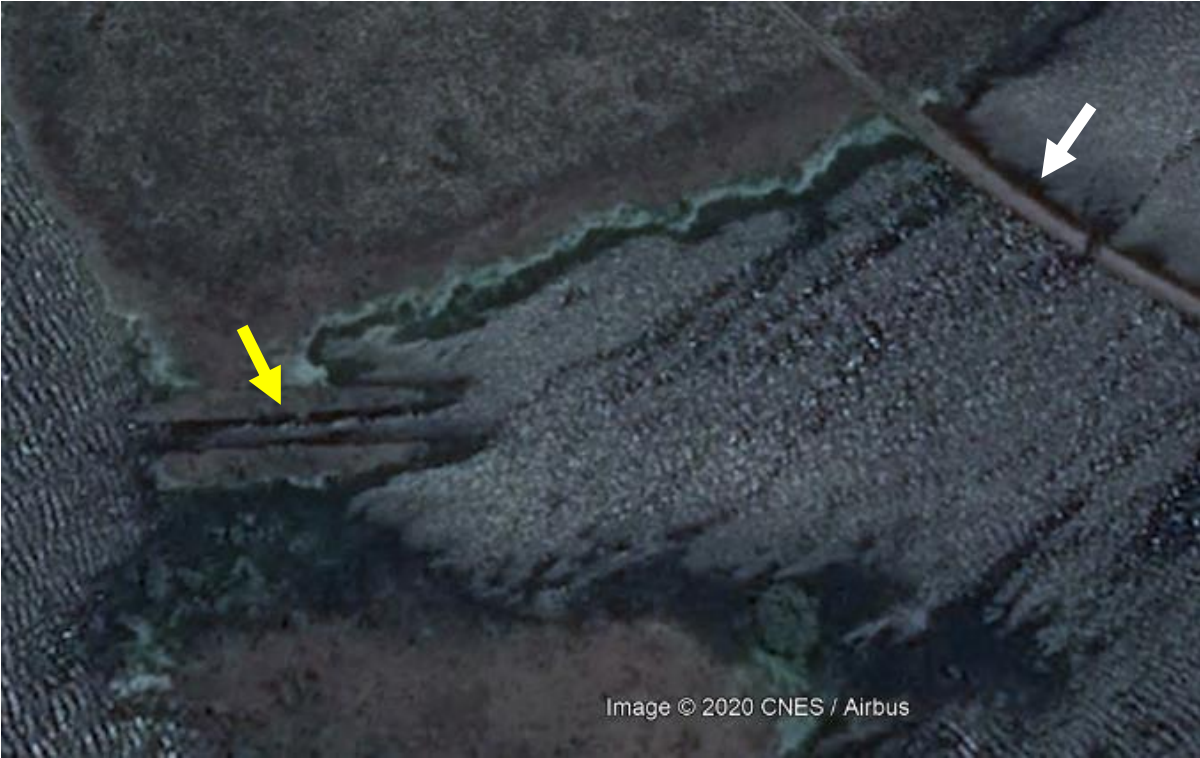
Figure 8. The canal (arrow) to the front doline is easily discerned when the depression is nearly totally flooded. White arrow points to the dyke.

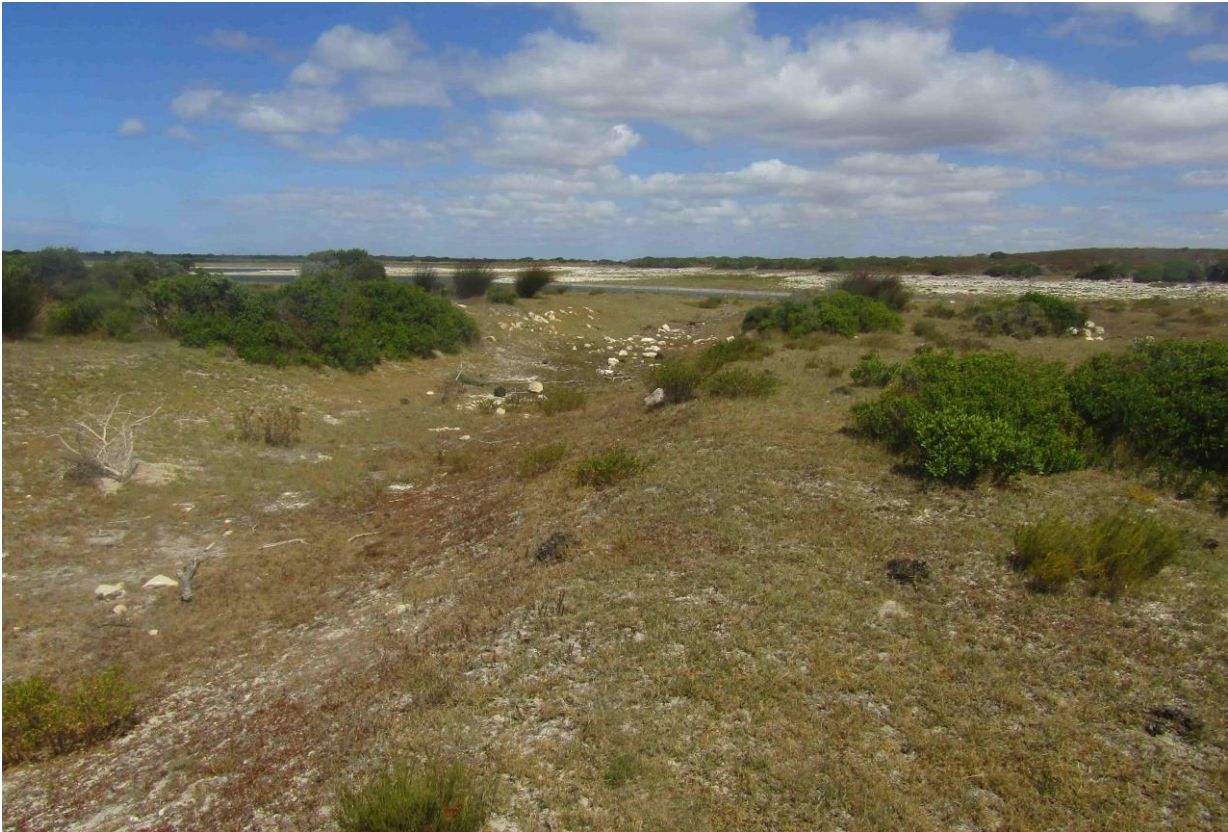
Figure 9. The front canal, delivering water from the vlei to the front doline. View to the west. The wall cladding was eroded.

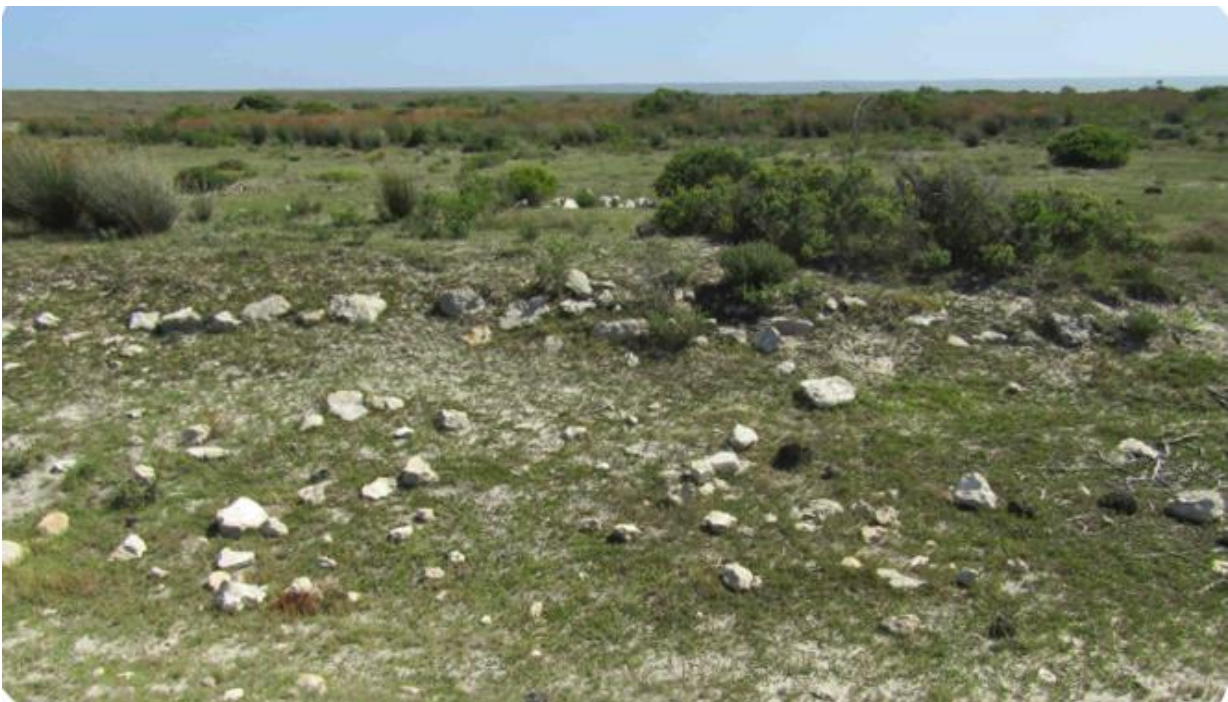
Figure 10. The walls of the canal were cladded with stones, to prevent erosion. The cladding disintegrated with time.

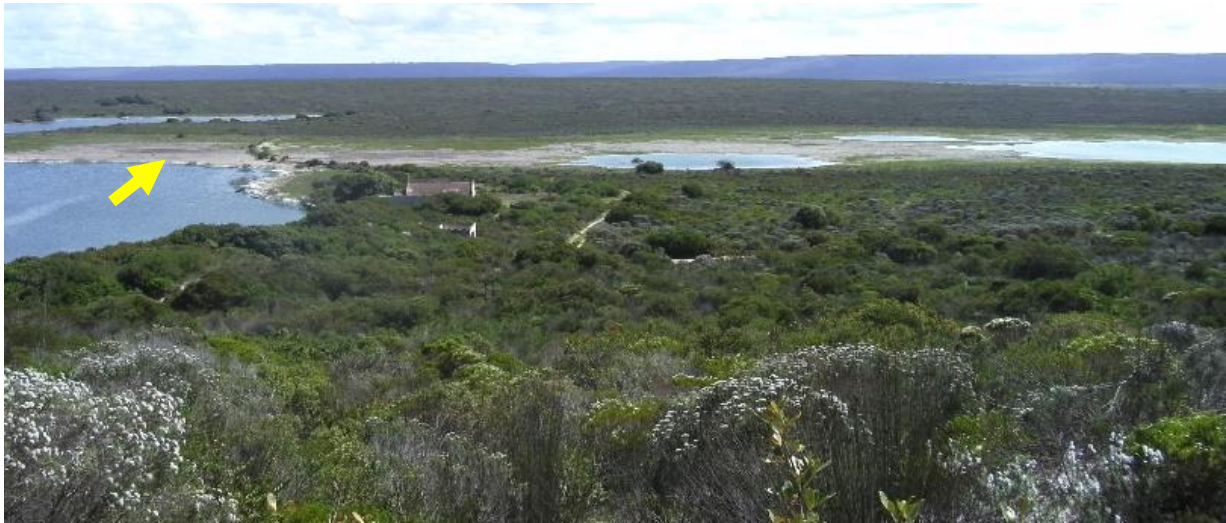
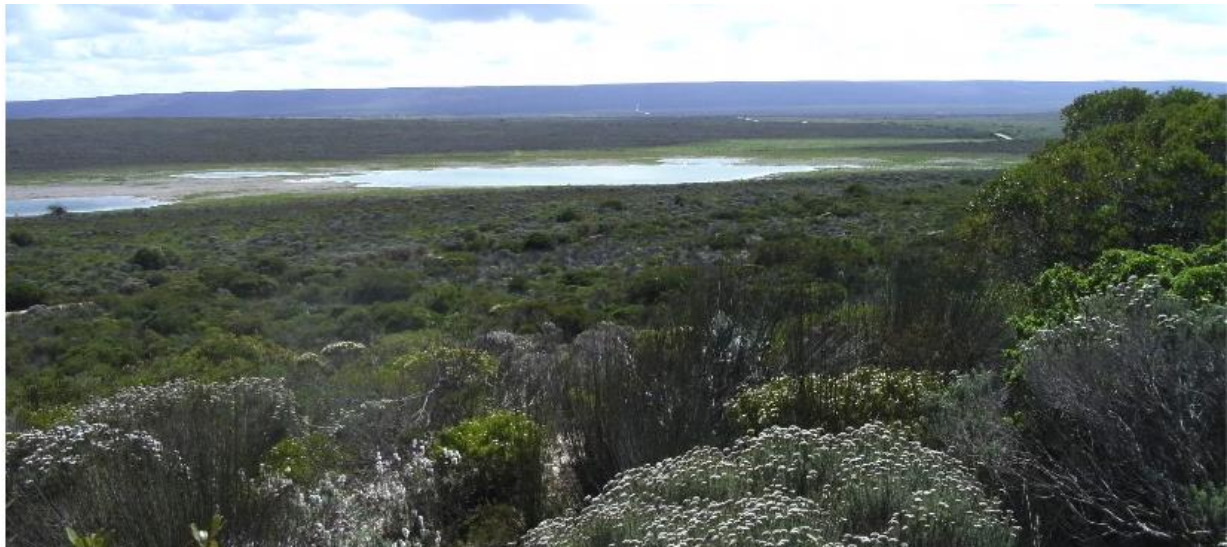
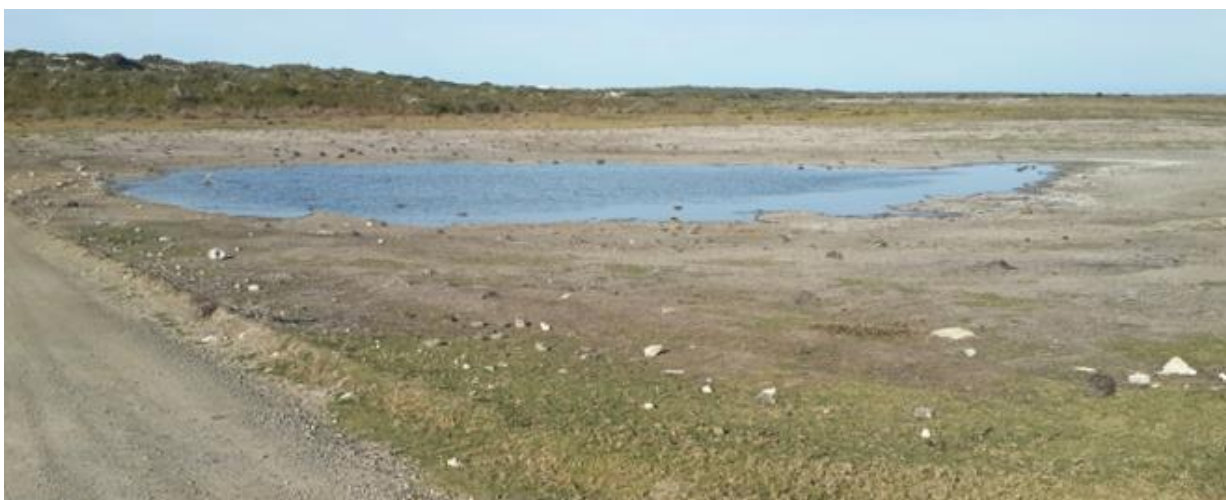
Figure 11. Views on the dolines. Top – from the south on the front (arrow) and middle dolines; middle - from the south on the back dolines; bottom – from the road to Die Mond, looking south on the northernmost back doline.

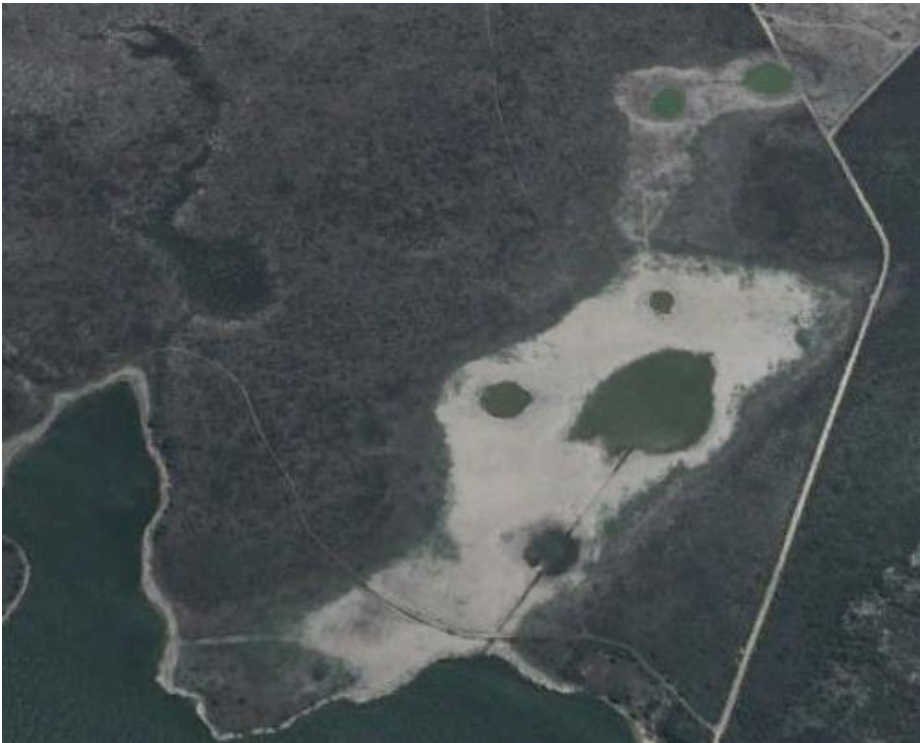
Figure 12. Satellite image of the dolines, containing water.

To store water in the depression, a dyke was built across it and a canal was dug, to deliver water from the vlei to the dolines (Figures 12 to 18).

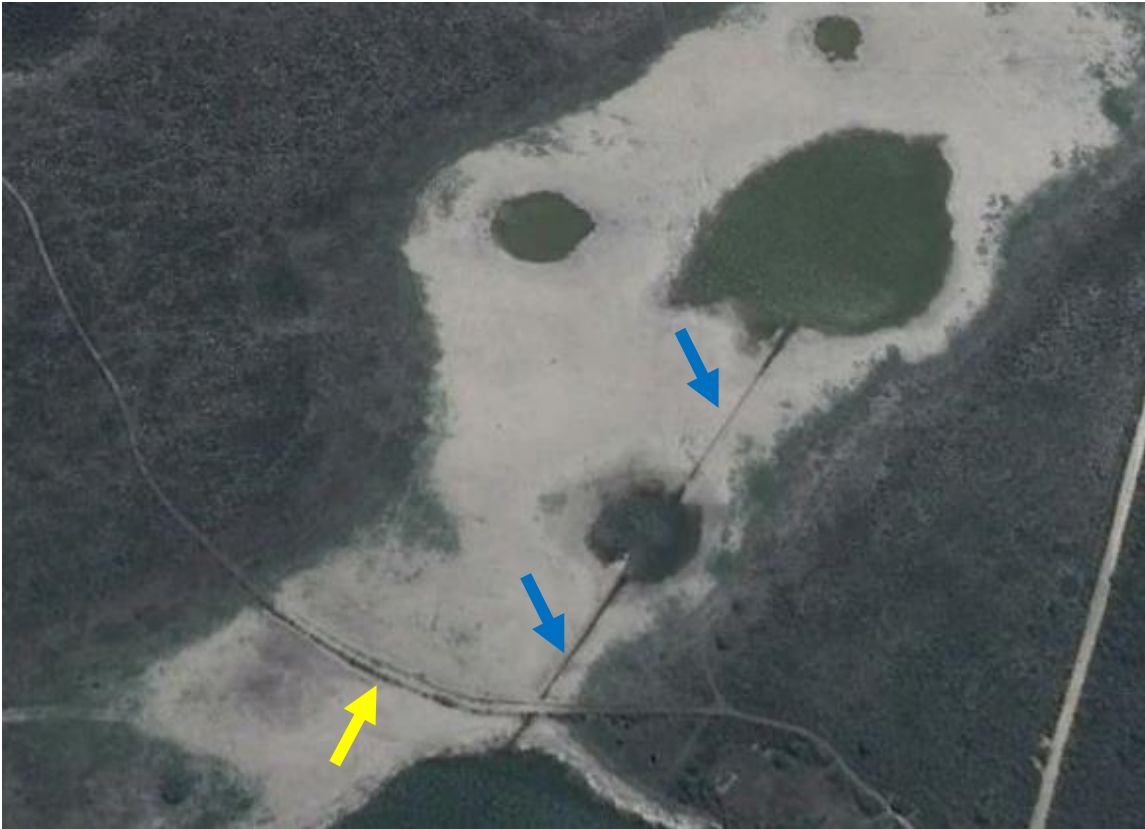
Figure 13. The middle dolines, the dyke (yellow arrow) and the canal (blue arrow).

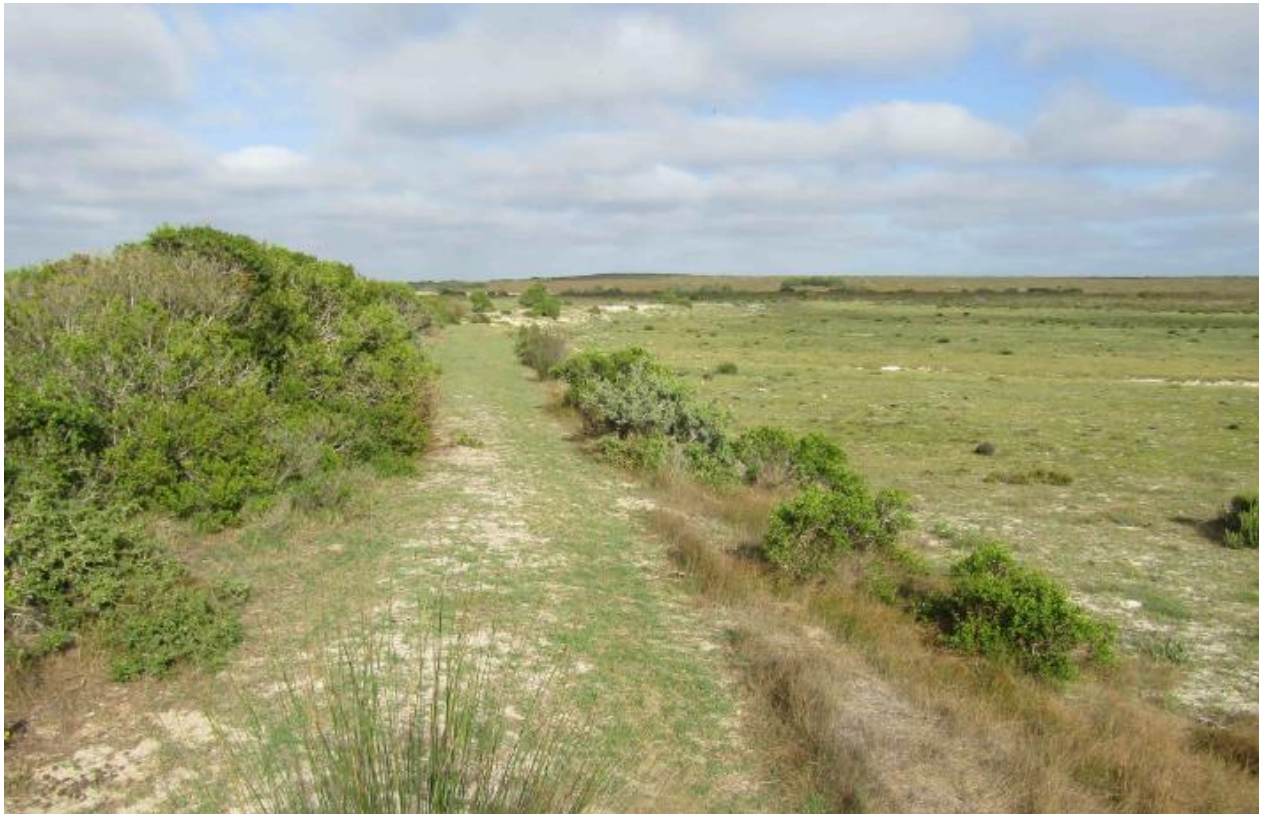
Figure 14. The dyke. View to the northwest. The depression is on the right, the vlei on the left.

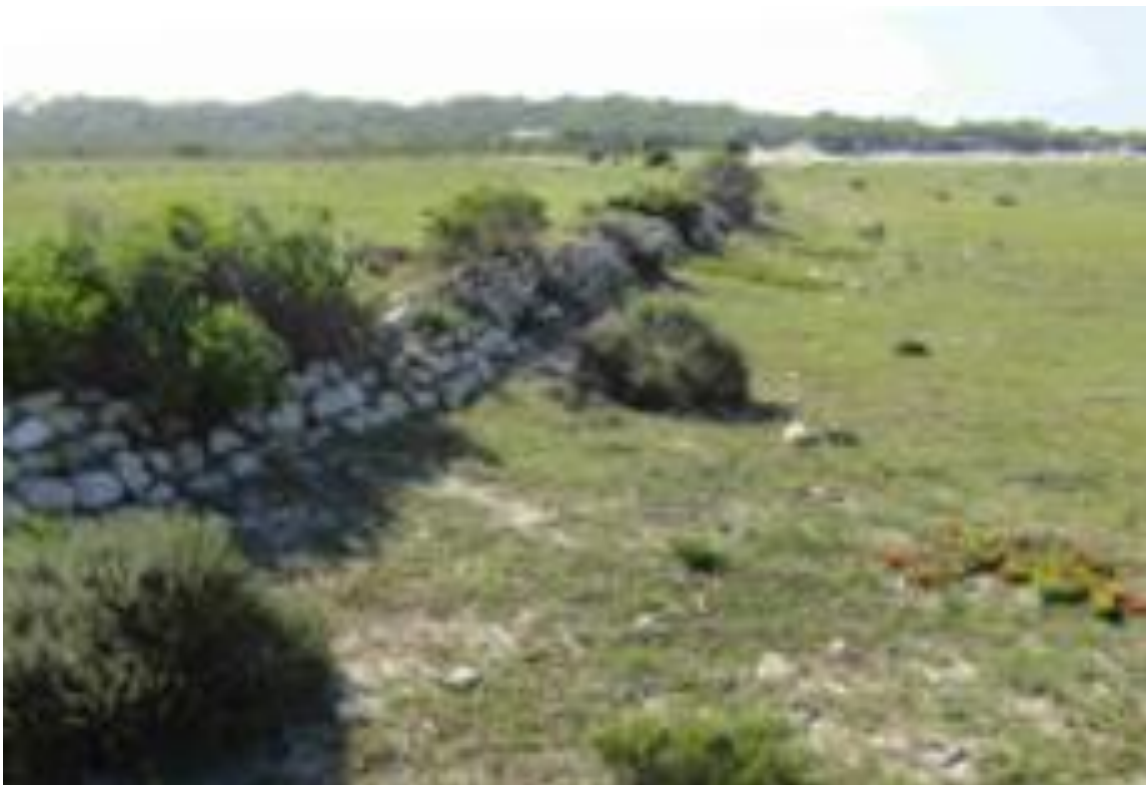
Figure 15. The dyke was cladded on the west (vlei) side. View to the east. The depression is on the left, the vlei on the right.

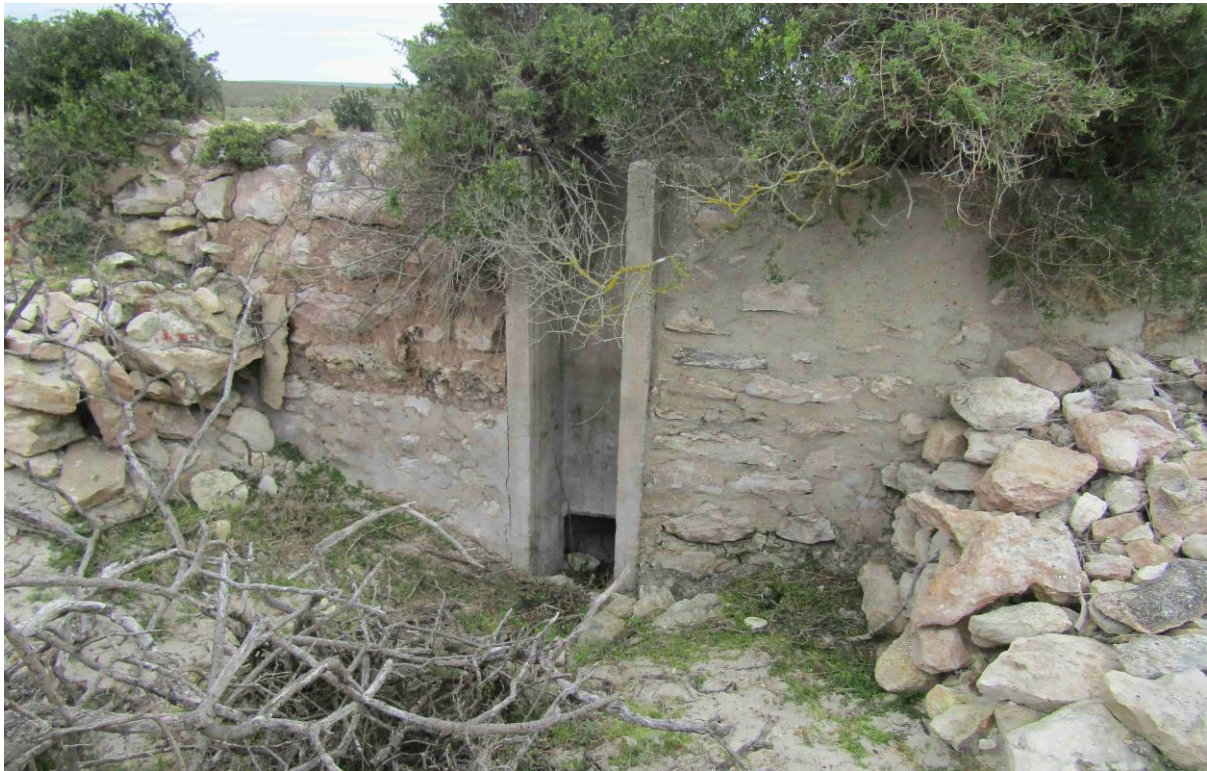
Figure 16. The vlei side of the gate in the dyke.

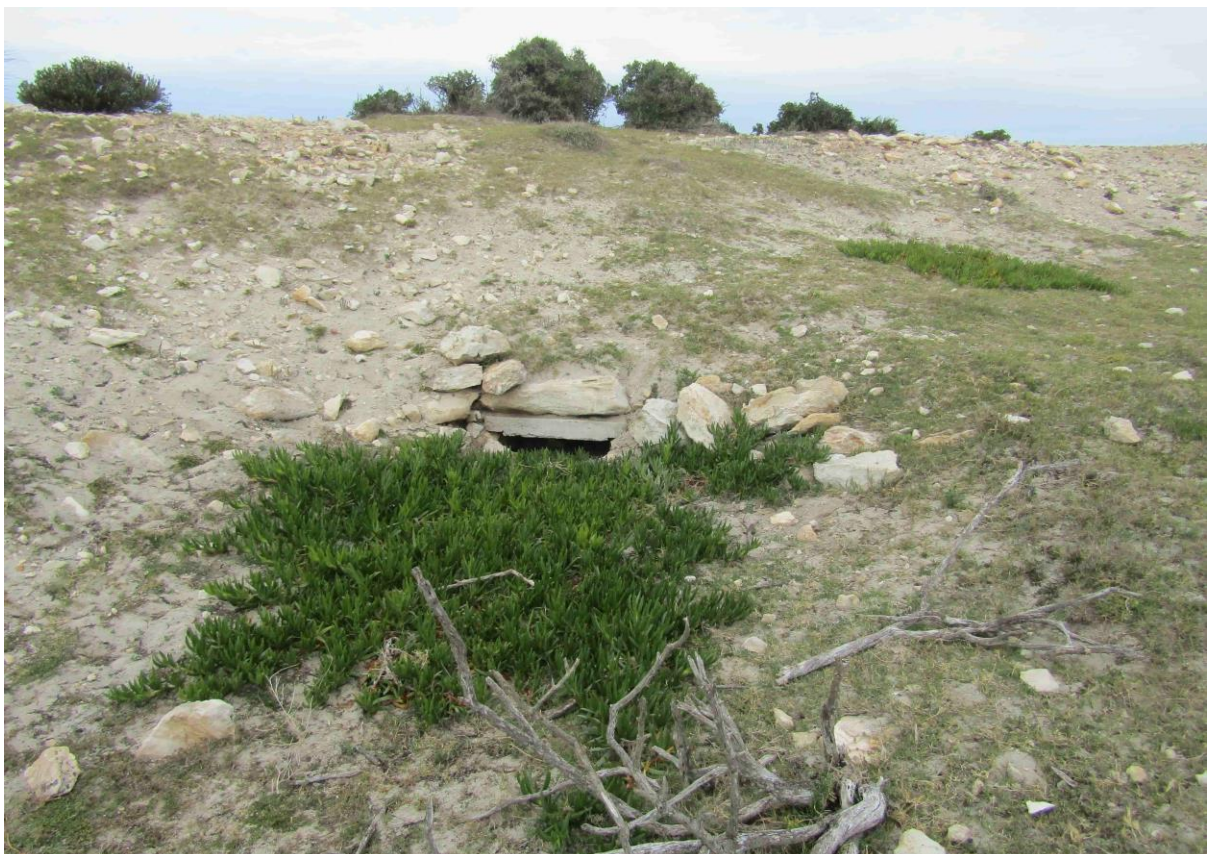
Figure 17. The depression side of the gate in the dyke.
