N. DE HOOP VLEI GORGE

Field Note N9a. Archaeology – Dams and canals

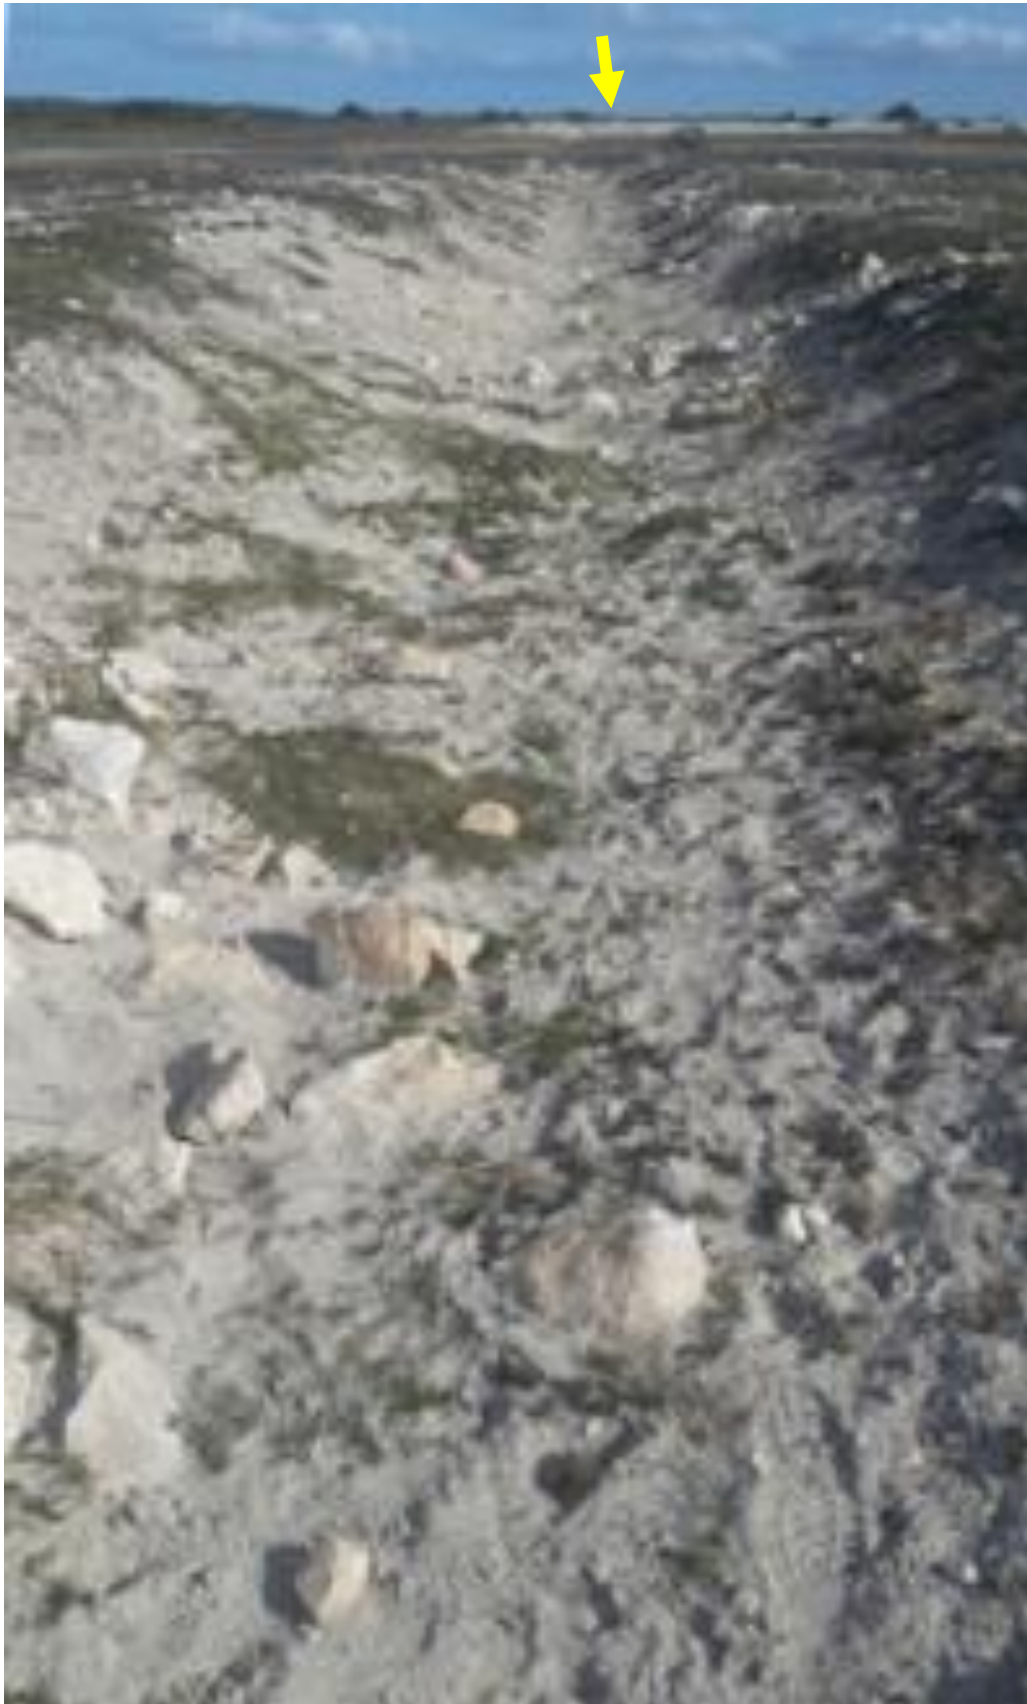
Figure 18. The canal extends from the dyke (arrow) into the middle dolines. View to the south-southwest. (This is probably “Cloete’s Sloop”; read last page of this Field Note).

To compensate for the supposed blockage of the original sinkhole, two channels were dug. The timing and sequence of these attempts is uncertain. A channel known as "Cloete's sloop" was dug in an easterly direction near to Die Mond to drain into another sinkhole which, it is claimed, is connected to the same underground watercourse as others in the area (and possibly the original sinkhole) (J. Blacquiere, pers. comm.). It is even possible that "Cloete's sloop" was dug many years previously for irrigation purposes during a period of high water levels, as Cloete was no longer associated with De Hoop at the time of the 1906 flood. The remains of this channel are still evident and "Cloete's sloop" is now operated by a sluice gate in the dyke constructed by the Cape Department of Nature Conservation in 1958 (Van der Merwe, 1976). It is still regarded as an overflow outlet and its last recorded use was during the winter of 1962 according to the diary kept by the Nature Conservation Officer at De Hoop. The channel does not have an even downward gradient and it is

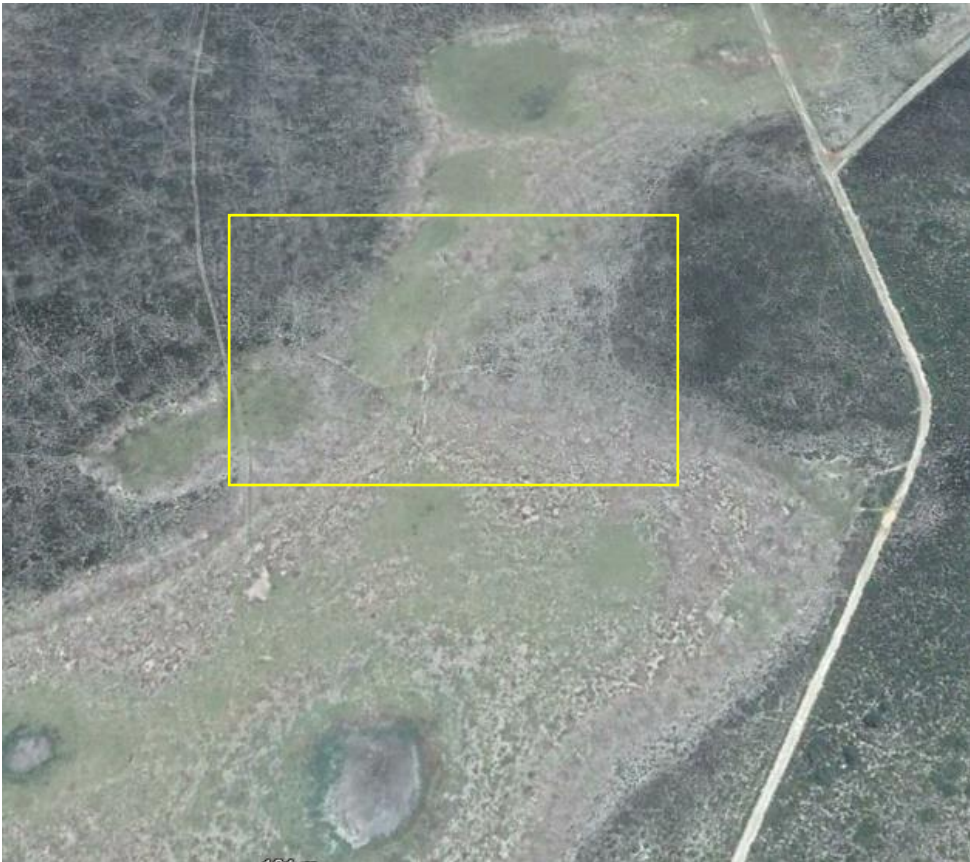
Figure 19a. The area between the middle and the back dolines, before the May 2021 flood.

The back dolines were also walled, and a canal was cut into them, from the middle dolines (Figures 19 and 20).

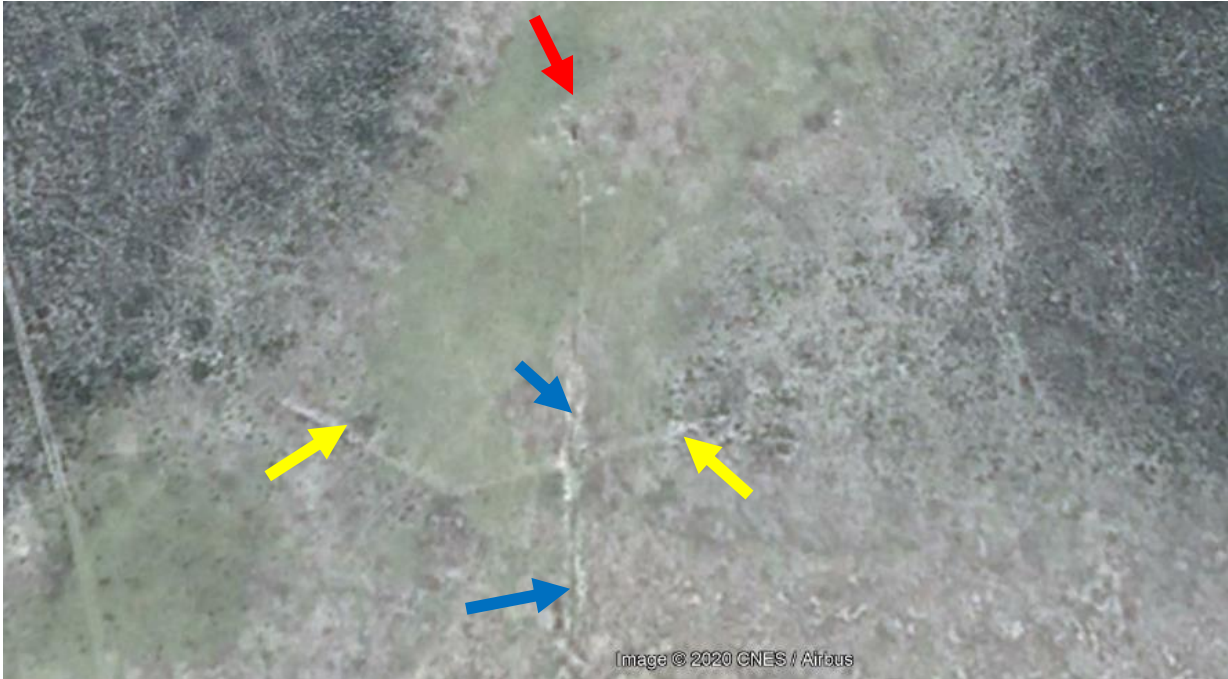
Figure 19b. Enlargement of the boxed area in Figure 19a. The low dyke (yellow arrows) and the canal (blue arrows) can be easily recognised. Red arrow points to a sinkhole (Figure 18).

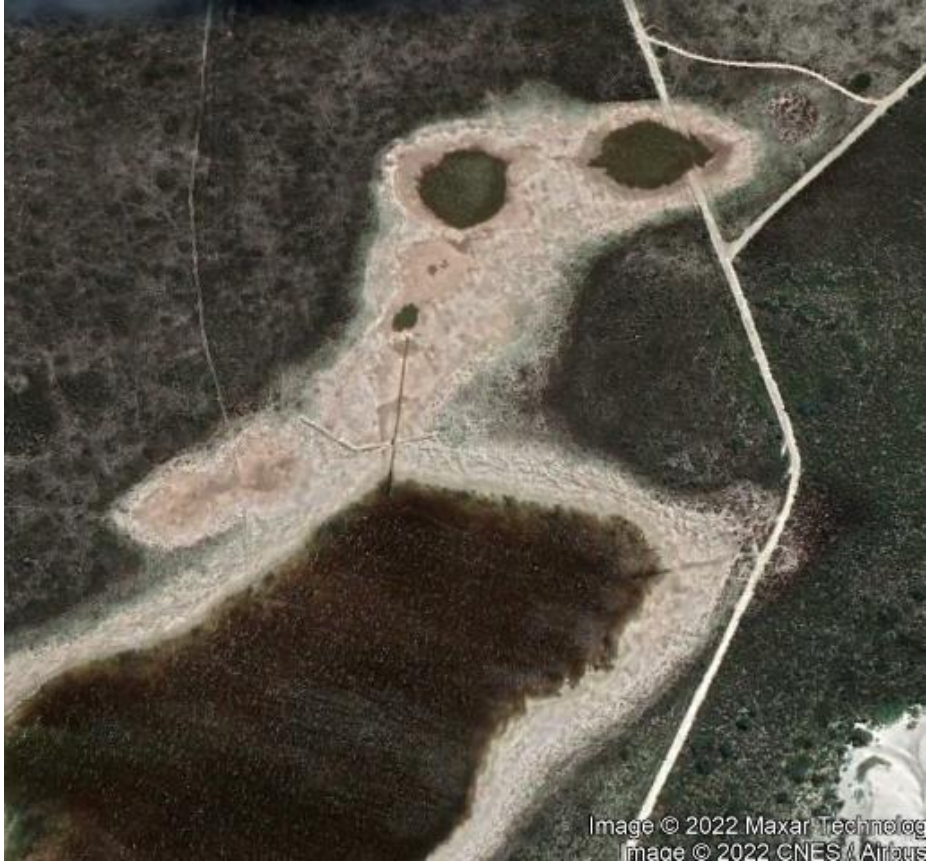
Figure 20a. The area between the middle and the back dolines

A year after the May 2021 flood, the features in discussion are more clearly visible (Figure 20).

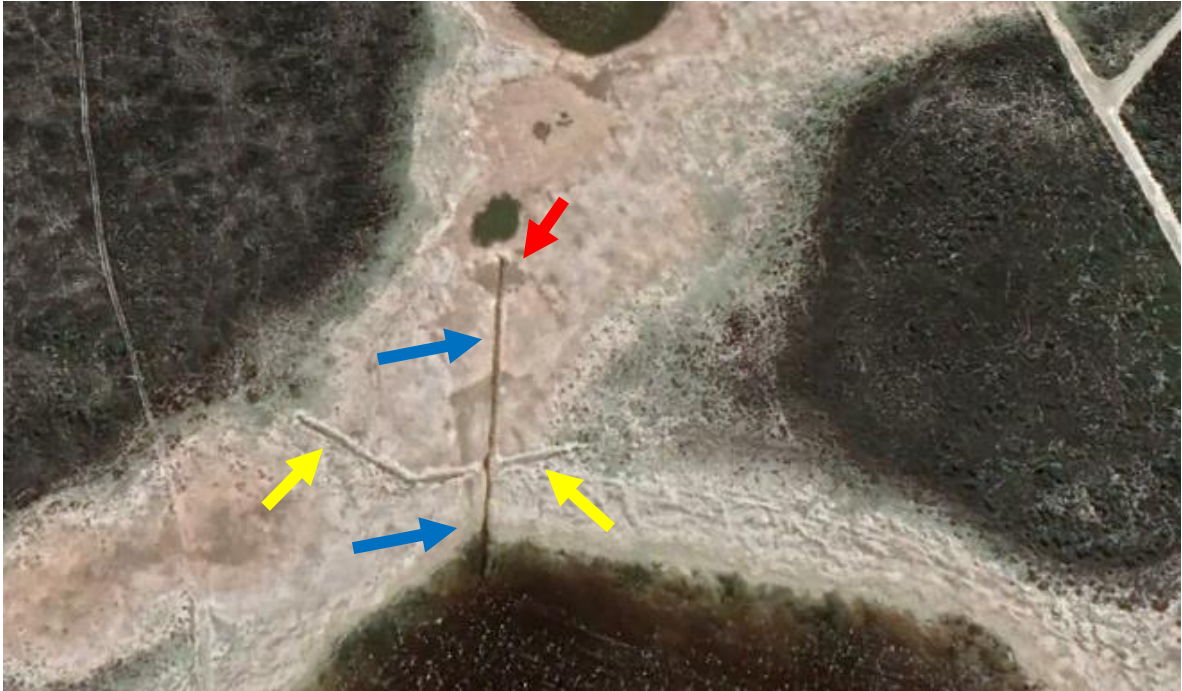
Figure 20b. Enlargement of the boxed area in Figure 20a. The low dyke (yellow arrows) and the canal (blue arrows) can be easily recognised. Red arrow points to a sinkhole (Figure 21).

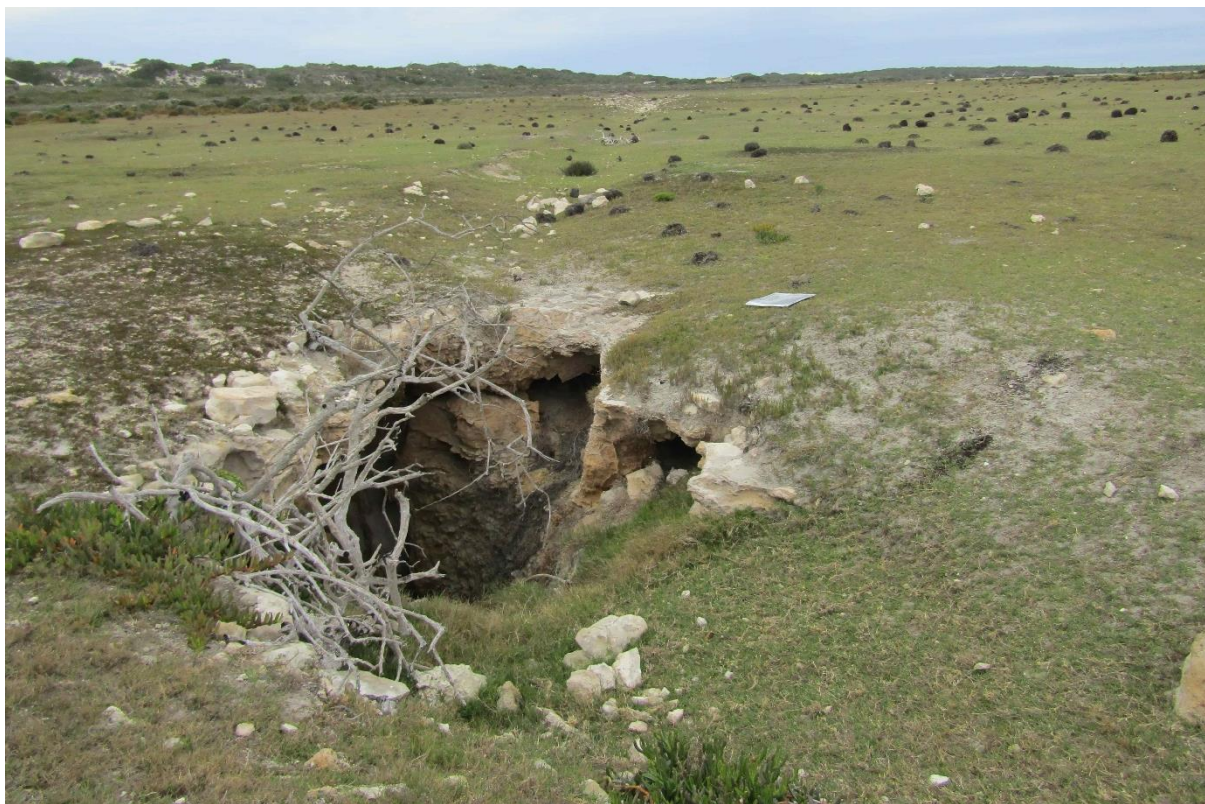
Figure 22. Sinkhole at the back dolines. When a stone was dropped into the hole (Feb 2020) it hit water. Such sinkholes are at the core of the debate on the drainage of the De Hoop Vlei (read below). See also Field Note on karst landforms in this chapter and Chapter W.

The dyke, gate, canal and sinkhole are most probably the historical features mentioned in the following paragraph (From the introduction to Shirley E Butcher's MSc thesis "Environmental factors and the water regime of De Hoop Vlei", 1993):
