Secrets of<br/>De Hoop<br/>and EnvironsField notes on the<br/>GEOMORPHOLOGY, HYDROLOGY<br/>and ARCHAEOLOGY<br/>Between CAPE AGULHAS and CAPE INFANTAGeomorphological<br/>Research

Desk Note N8d. Hydrology – De Hoop Vlei – 1960 to 2020

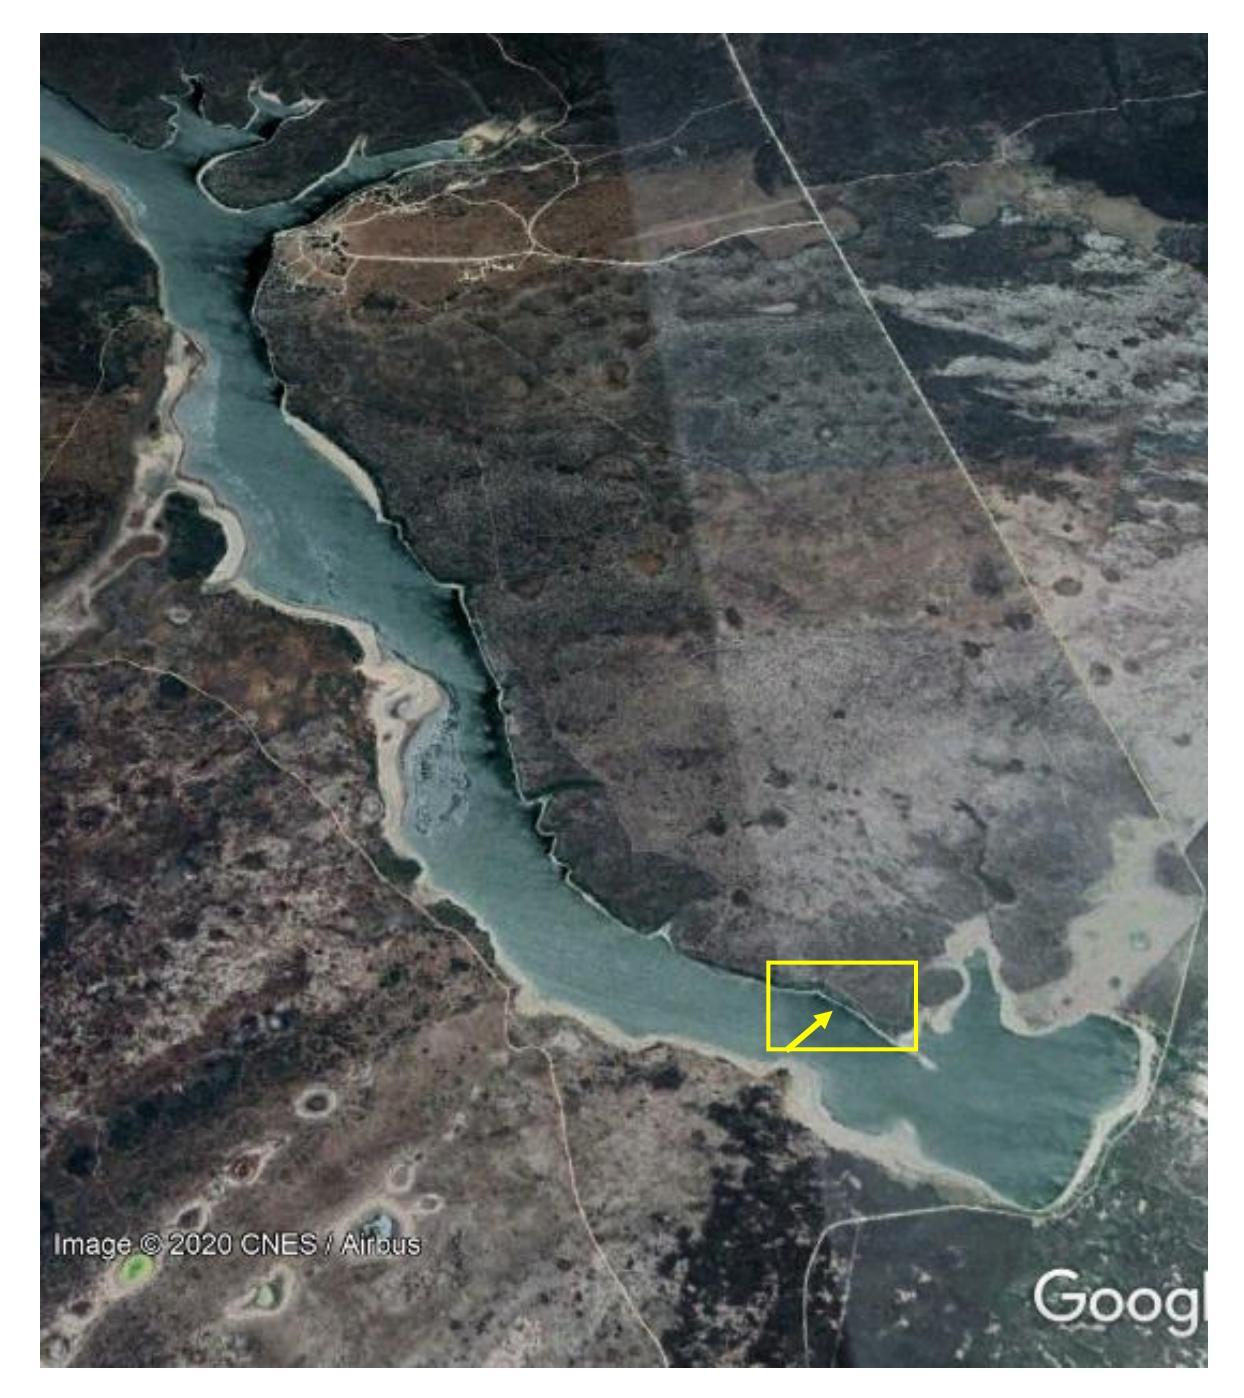
Figure 1. Satellite image of the southern part of the De Hoop Vlei. Arrow points to the location of the hydrometry station. Boxed area enlarged in Figure 2.

From 1960 onwards the De Hoop Vlei water level is monitored by the Department of Water and Sanitation at the hydrometry station on the southeast shore of the vlei, close the Die Mond (Figures 1, 2 and 3).

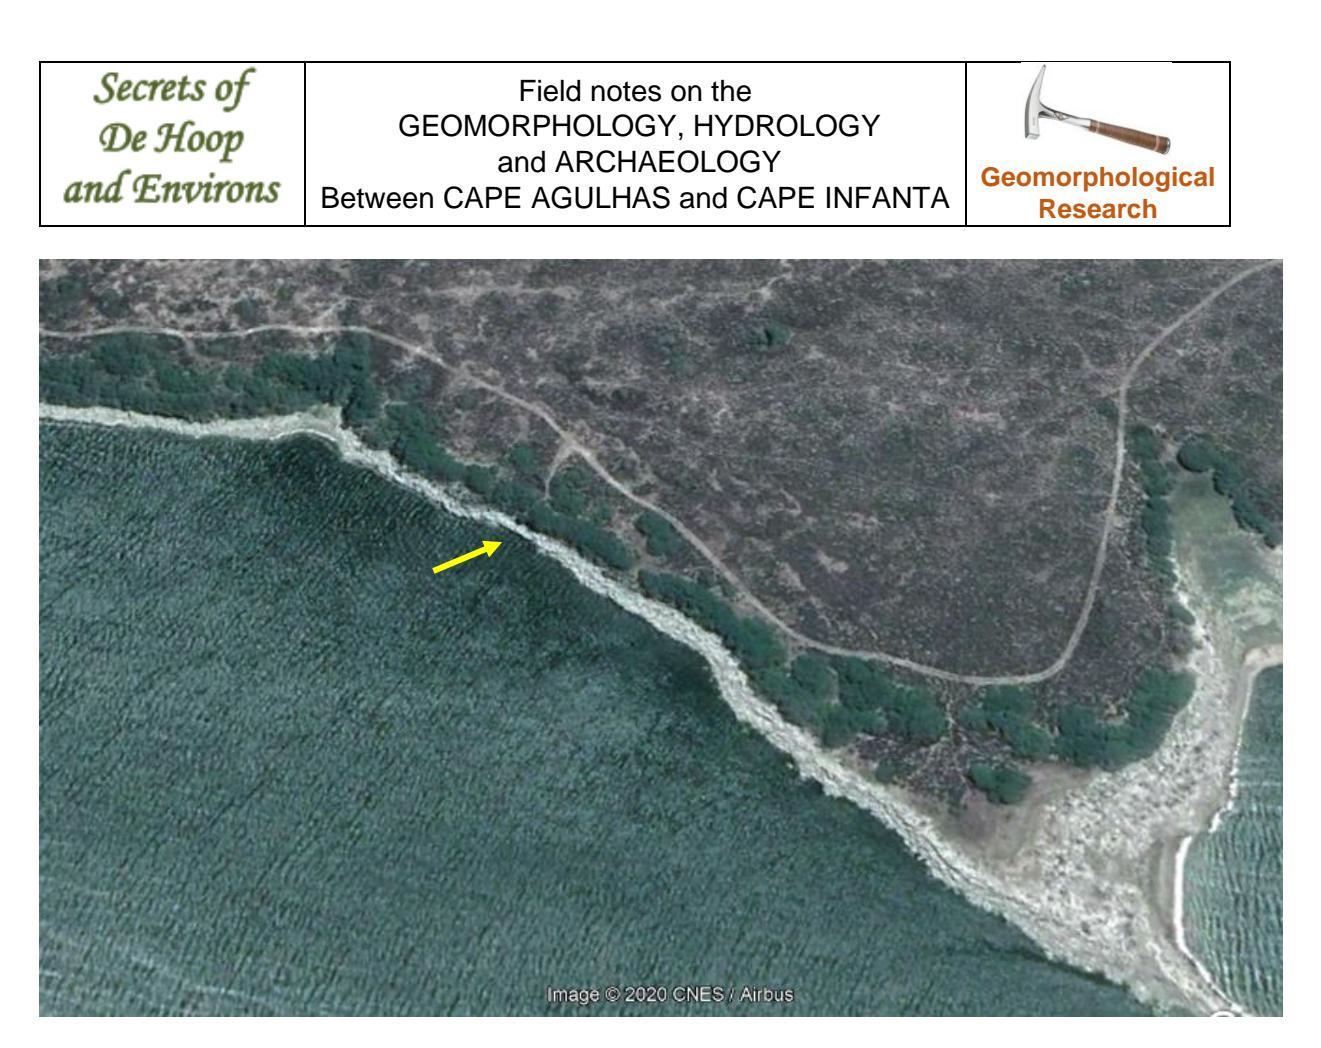
Figure 2. Satellite image of a section of the east shore of De Hoop Vlei. Arrow points to the location of the hydrometry station.

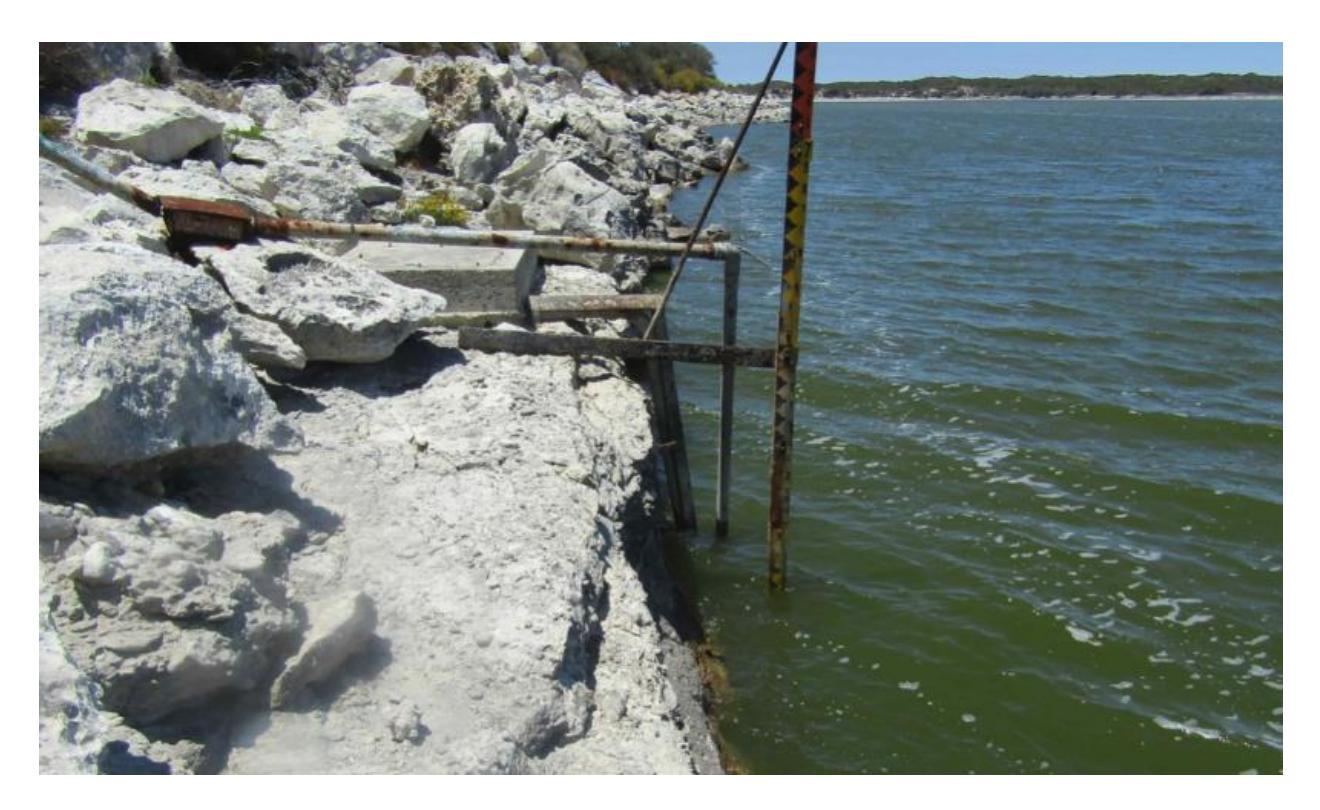
Figure 3. The hydrometer on the southeast shore of the De Hoop Vlei. The south shore of Die Mond can be seen at a distance.

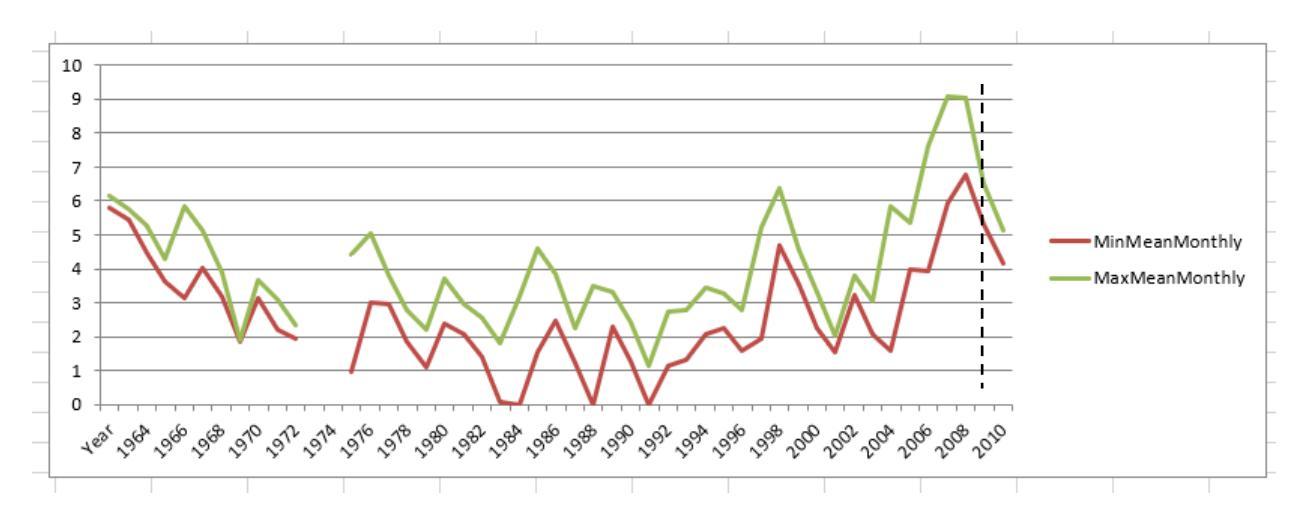
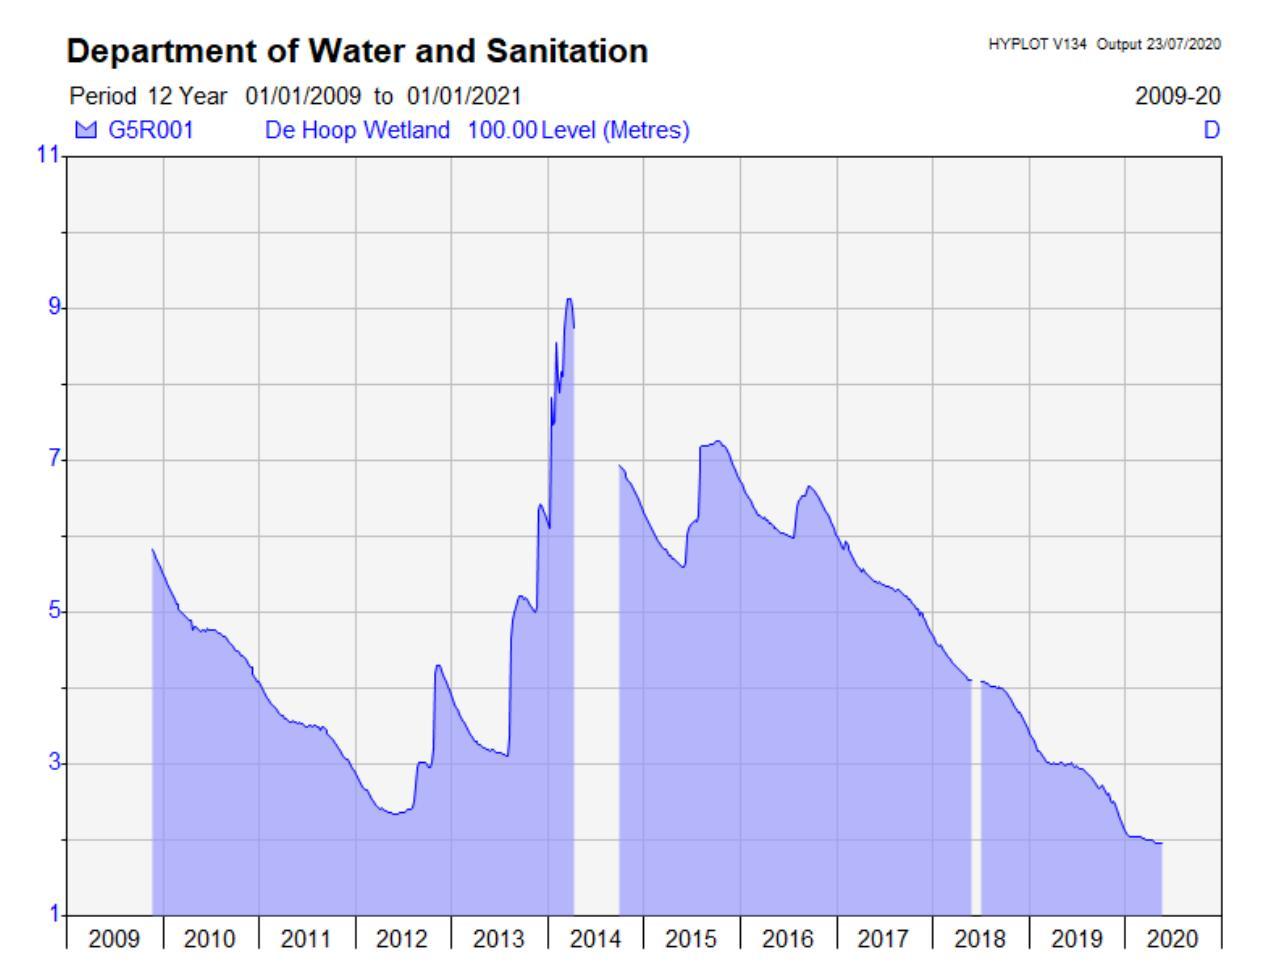
Figure 4. De Hoop Vlei water levels 1960 to 2020. Top – 1960 to 2010; dashed line indicates the start of the bottom graph. Bottom – 2010 to 2020. The water level in the beginning of 2014 was the highest during this period of 60 years. The 'zero' level – the bottom of the hydrometer- is believed to be 3-4 m above mean sealevel; it is unclear why the top graph starts at 0 m and the bottom at 1 m.

The vlei water level fluctuations since 1960 are presented in Figure 4. The water level is dropping since 2014 and in the beginning of 2021, it is as low as it was 30-40 years ago (1983, 1988 and 1992), leaving only little water were the vlei bed is the deepest, along the cliffs between the hotel and Die Mond.
